On 12/4/18 @ 2040 hrs, 1 Veh A was driving along Sengkang East Ave towards Sengkang East Drive. Veh A stop at the junction to allow the pedestrian for crossing the road. Suddenly Veh B collided onto Veh A rear. No passenger on board & no injury reported at the point of accident.

1. Policy Particulars :- THIRD PARTY CLAIM			
Insured Veh.	SJE 7264P	Veh. Inspected	SHA 7586E
Policy No.	5092311384	Coverage (\$)	0.00
Claim No.	MT/0990253-002	Excess (\$)	0.00
Assign From		Assign Date	13/04/2018

4. Description of Damages			
THE VEHICLE SUSTAINED DAMAGES AT THE REAR PORTION. DAMAGES SEE DETAILS.			
5. General Information			
Accident Date	12/04/2018	Inspection Date	13/04/2018
Survey held at	COMFORTDELGRO ENGINEERING PTE LTD 59 LOYANG DRIVE SINGAPORE 508969		
5a. Remarks			
A)THE INSPECTION WAS CONDUCTED ON A"WITHOUT PREJUDICE" BASIS. B)IN ACCORDANCE TO YOUR INSTRUCTIONS, WE HAVE NOT AUTHORISED REPAIRS.			
5b. Estimate Days of Repair			
ESTIMATED NORMAL PERIOD FOR REPAIR:		2 Working Days

ADJUSTMENT ON REPAIR COST FOR VEHICLE NO. SHA 7586E

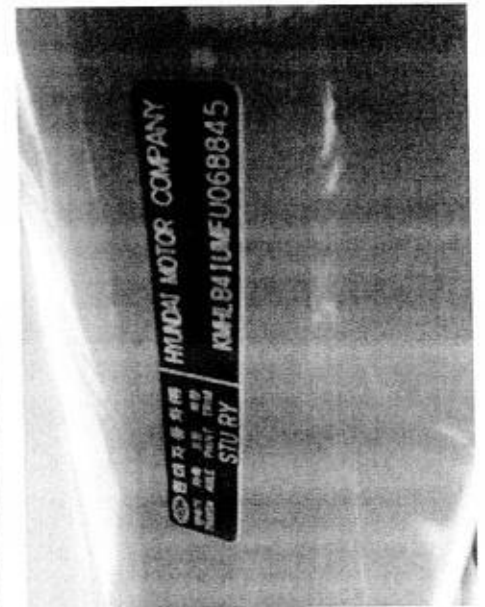
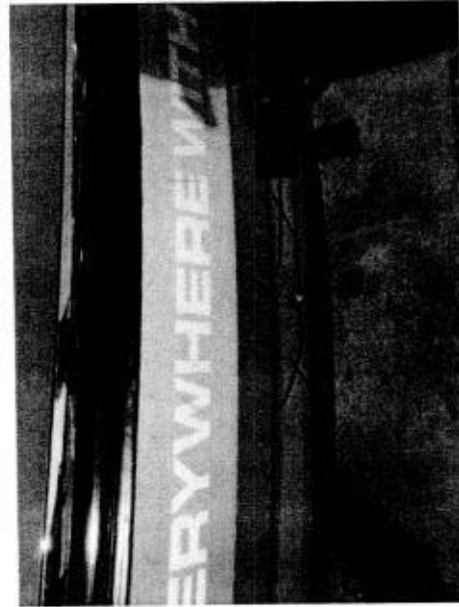
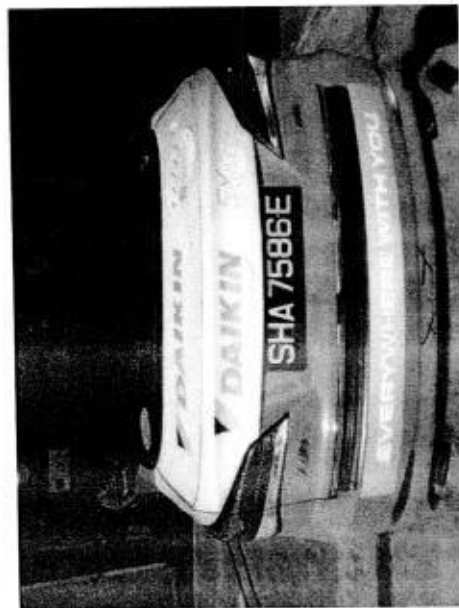
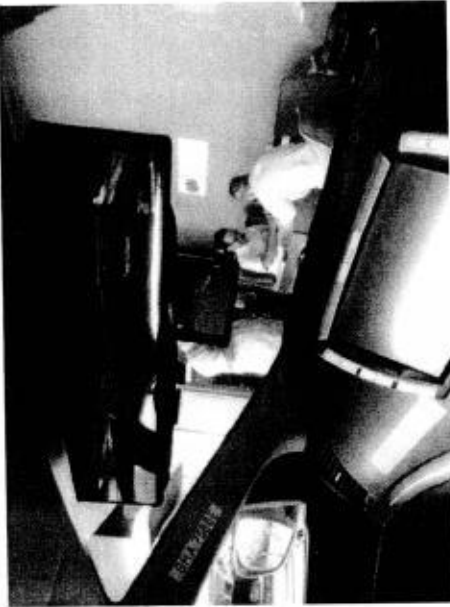
The U/C / Chassis frame / Body Structure affected due to collision.

Qty	Description of Parts	Condition	Estimate By Workshop (\$)	Our Adjusted (\$)
REPLACEMENT OF PARTS				
1	REAR BUMPER	DEFORMED	603.60	603.60
1	REAR BUMPER UNDER COVER	SERVICEABLE	225.00	-
	LESS 20% DISCOUNT		-165.72	-120.72
			662.88	482.88
SPECIAL NETT ITEMS				
1	REAR BUMPER RUBBER MAT (SN)	NECESSARY	50.00	50.00
1	REAR BUMPER ADVERTISEMENT LOGO (SN)	NECESSARY	50.00	50.00
2	REAR FENDER ADVERTISEMENT LOGO (LH/RH) @\$100.00 (SN)	NECESSARY	200.00	200.00
			300.00	300.00
LABOUR				
	THATCHAM STANDARD REPAIR TIME ON BODY WORKS.		420.00	220.00
	THATCHAM TTS STANDARD SPRAY PAINTING COST AND LABOUR.		250.00	200.00
			670.00	420.00
GRAND TOTAL			1,632.88	1,202.88
RECOMMENDED COST OF LUMP SUM REPAIRS (TO ITS PRE-ACCIDENT CONDITION) (CONFIRMED)				950.00
