Surveyor
MafimenASSIGNMENT (Office)

RE: ESTIMATED COST FOR REPAIR VEHICLE NO. YP2228S

VEHICLE DAMAGE INSPECTION REPORT

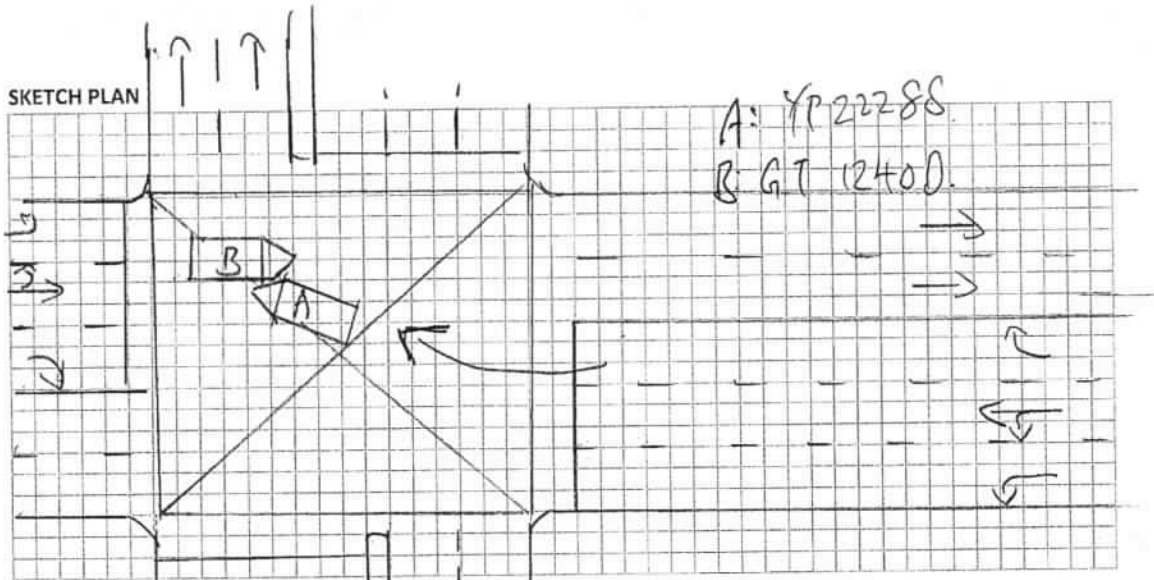
Sketch Plan #2 Pg. 1

I was negotiating a right turn at USI road 1. However, the other driver was bearing the red light & came crashing into my vehicle. The other Driver has given an admission of guilt for bearing the red light.
