VEHICLE DAMAGE INSPECTION REPORT

Our File No: CC3/TMI18007233/K1QBE2

Claimant Vehicle No : SHC8356K

Make & Model: HYUNDAI I40, 1.7 D CRDi (A)

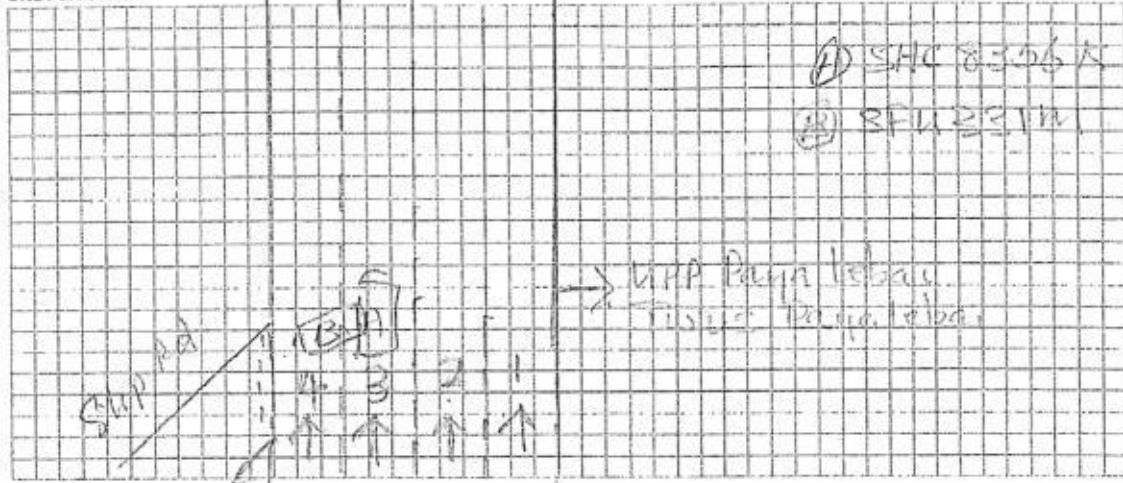
SKETCH PLAN

DESCRIBE CIRCUMSTANCES OF THE ACCIDENT

On 18/4/2018 at about 1200 hrs, I Vehicle A was driving along boundary road passed the traffic light junction, while B was on upp paya leban road on lane 3, Vehicle B dash out from a slip road and collided onto my taxi while left side body.

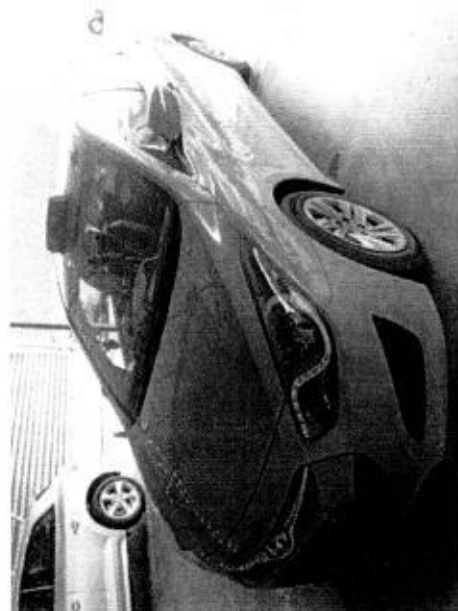
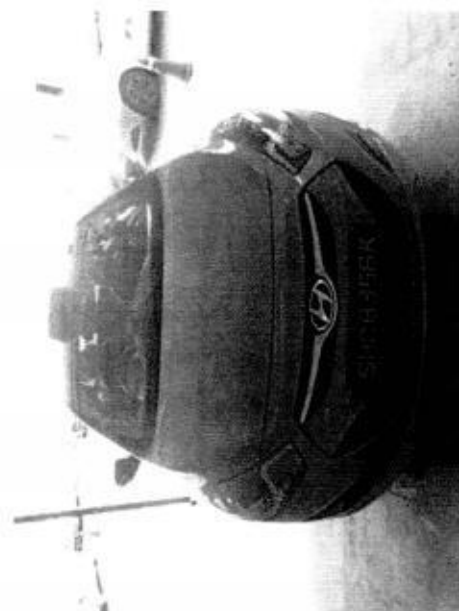
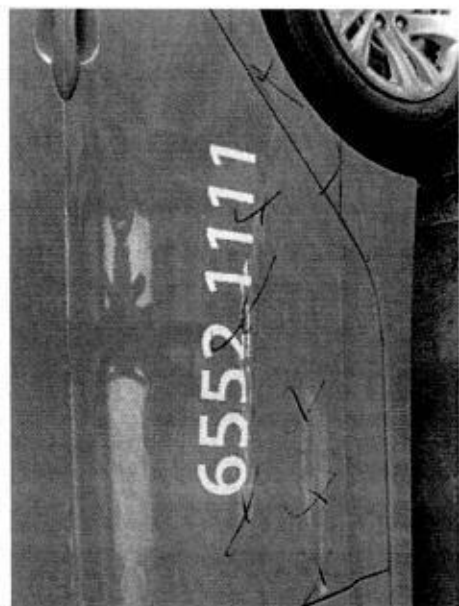
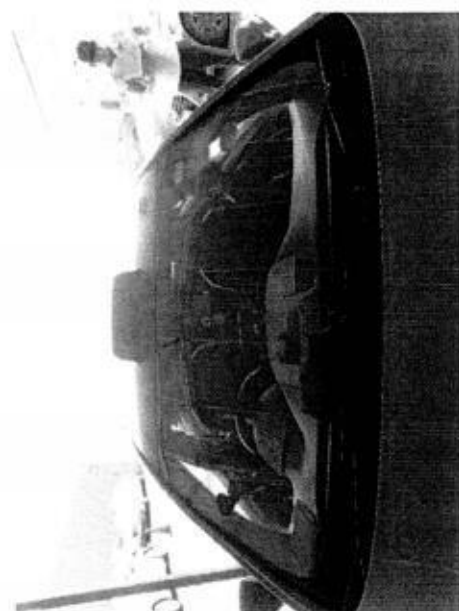
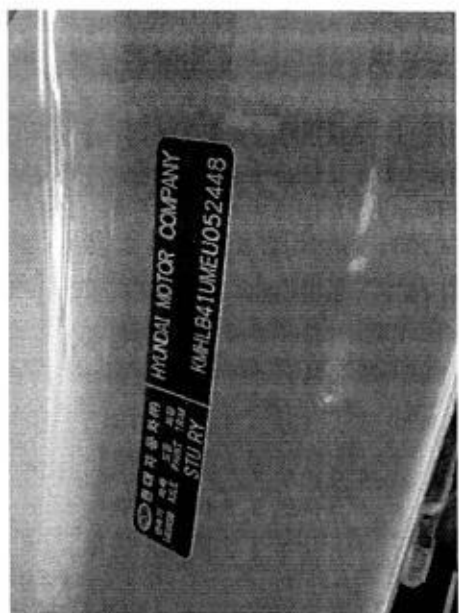
Des. of Damages: Frt / Rear / O/S / N/S / U/C / Rooftop or

N/S Body.

The U/C / Chassis frame / Body Structure affected due to collision.

DAMAGES CONSISTENT TO ACCIDENT REPORT.

No.	Qty	Part No.	Particulars	Condition	Repairer's	Amount
1	1		*REAR DOOR LH	Dented	1,351.10 FL	*1,351.10 FL
2	1		*REAR TYRE RIM LH	Serviceable	351.90 FL	*- FL
3	1		*REAR WHEEL HUP-CAP LH	Grazed	150.70 FL	*150.70 FL
4	1		*REAR DOOR COMFORTDELGRO & APPS STICKER LH	Necessary	80.00 F	*80.00 FS
5	1		*FRT DOOR COLOURED COMFORT LOGO LH	Necessary	75.00 F	*75.00 FS
6	1		*REAR TYRE LH (50%)	Cut	216.00 F	*108.00 FS
7	1		*FRONT DOOR (LH) (NPA)	Repair	-	*- FL
8	1		*REAR FENDER (LH) (NPA)	Repair	-	*- FL
9	1		*ROCKER PANEL GARNISH (LH) (NPA)	Repair	-	*- FL
					Sub Total (S\$)	2,224.70 1,764.80
					- List Item Discount on L Items 20.00/20.00% (S\$)	370.74 300.36
					Total Parts (S\$)	1,853.96 1,464.44

No	Particulars	Lab.Type	Repairer's	Amount
<u>Labour Items</u>				
1	PANEL BEATING - Repair Fender	New	1,000.00	400.00
2	SPRAY PAINTING CHARGE - Door x2/ Fender/ Rocker Panel	New	1,000.00	800.00
3	WIRING CHARGE	New	50.00	0.00
4	TUFF KOTE	New	50.00	20.00
5	REAR WHEEL ALIGNMENT	New	120.00	0.00
Gross Labour Cost (S\$)			2,220.00	1,220.00
