National Assessment Centre Services

1. Policy Particulars :- THIRD PARTY CLAIM

4. Description of Damages				
THE VEHICLE SUSTAINED DAMAGES AT THE FRONT O/S PORTION. DAMAGES SEE DETAILS.				
5. General Information				
Accident Date	17/04/2018	Inspection Date	18/04/2018	
Survey held at	COMFORTDELGRO ENGINEERING PTE LTD 59 LOYANG DRIVE SINGAPORE 508969			
5a. Remarks				
A)THE INSPECTION WAS CONDUCTED ON A"WITHOUT PREJUDICE" BASIS. B)IN ACCORDANCE TO YOUR INSTRUCTIONS, WE HAVE NOT AUTHORISED REPAIRS.				
5b. Estimate Days of Repair				
ESTIMATED NORMAL PERIOD FOR REPAIR:		2 Working Days

ADJUSTMENT ON REPAIR COST FOR VEHICLE NO. SH 6210D

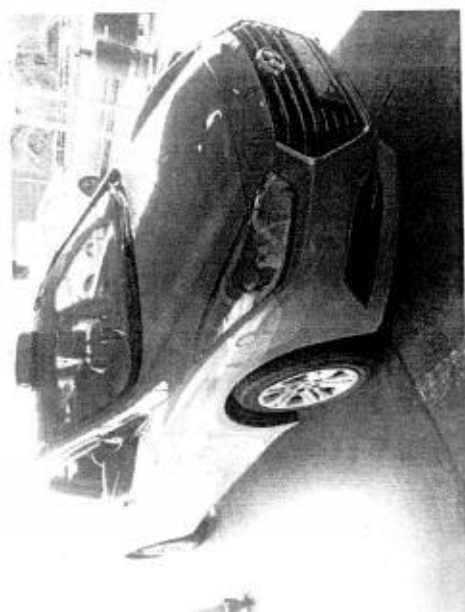
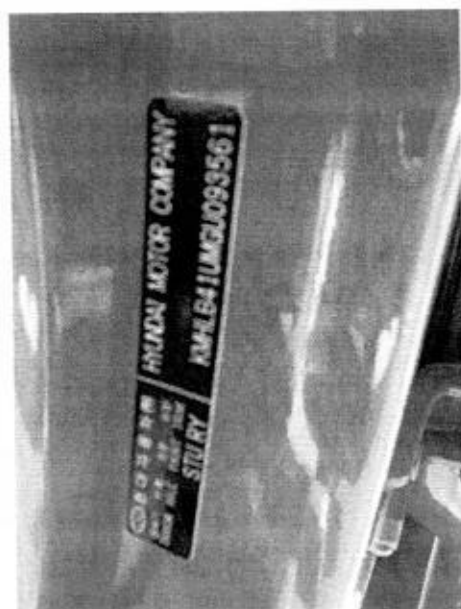
In the process the rear right of the car hit the front right of my stationary taxi.

Qty	Description of Parts	Condition	Estimate By Workshop (\$)	Our Adjusted (\$)
REPLACEMENT OF PARTS				
1	RADIATOR GRILLE	CRACKED	1,480.00	1,480.00
1	RADIATOR GRILLE H EMBLEM	NOT NECESSARY	113.65	-
1	FRONT BUMPER COVER	CRACKED	1,052.20	1,052.20
1	FRONT BUMPER SPONGE	SERVICEABLE	142.20	-
1	FRONT BUMPER REINFORCEMENT	SERVICEABLE	526.10	-
1	FRONT BUMPER BRACKET TOP (LH)	SERVICEABLE	22.40	-
1	FRONT BUMPER SIDE BRACKET	SERVICEABLE	14.30	-
	LESS 20% DISCOUNT		-670.17	-506.44
			2,680.68	2,025.76
LABOUR				
	THATCHAM STANDARD REPAIR TIME ON BODY WORKS.		250.00	200.00
	THATCHAM TTS STANDARD SPRAY PAINTING COST AND LABOUR.		250.00	200.00
			500.00	400.00
GRAND TOTAL			3,180.68	2,425.76
RECOMMENDED COST OF REPAIRS (CONFIRMED)				2,425.76
