SINGAPORE ACCIDENT STATEMENT

1. Policy Particulars :- THIRD PARTY CLAIM			
Insured Veh.	FBK 791T	Veh. Inspected	SHD 6658Y
Policy No.	5092295858	Coverage (\$)	0.00
Claim No.	MT/0990979-002	Excess (\$)	0.00
Assign From		Assign Date	19/04/2018

4. Description of Damages			
THE VEHICLE SUSTAINED DAMAGES AT THE N/S FRONT PORTION. DAMAGES SEE DETAILS.			
5. General Information			
Accident Date	18/04/2018	Inspection Date	19/04/2018
Survey held at	COMFORTDELGRO ENGINEERING PTE LTD 59 LOYANG DRIVE SINGAPORE 508969		
5a. Remarks			
A)THE INSPECTION WAS CONDUCTED ON A"WITHOUT PREJUDICE" BASIS. B)IN ACCORDANCE TO YOUR INSTRUCTIONS, WE HAVE NOT AUTHORISED REPAIRS.			
5b. Estimate Days of Repair			
ESTIMATED NORMAL PERIOD FOR REPAIR:		2 Working Days

ADJUSTMENT ON REPAIR COST FOR VEHICLE NO. SHD 6658Y

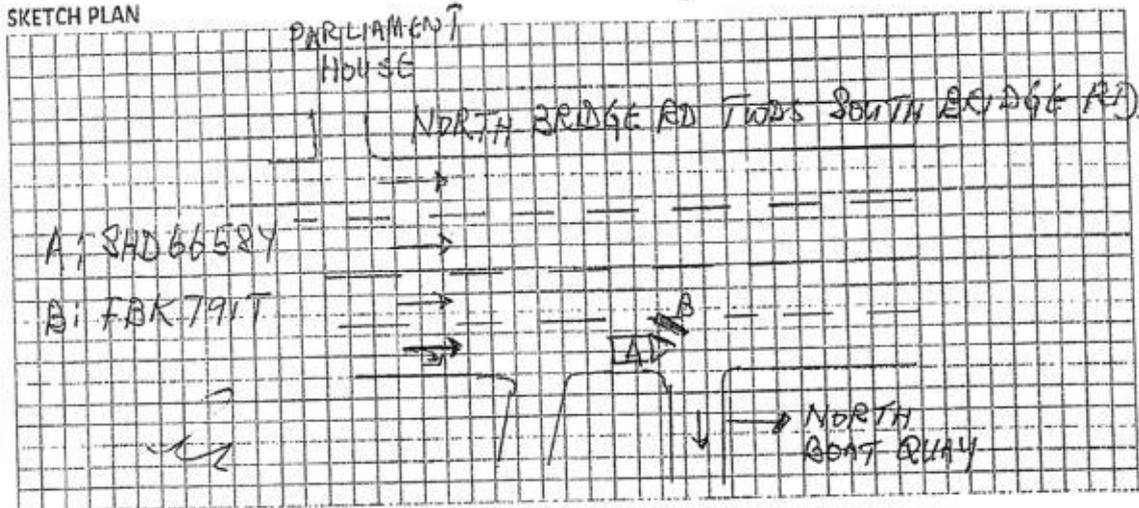
SKETCH PLAN

Describe Circumstances of the Accident.
On 18 Apr 2018 at about 16:10 hrs I was slowly driving straight on the extreme right lane along
North Bridge Rd heading towards the direction of South Bridge Rd.
As I was about to drive passed the junction of North Boat Quay which is on my right suddenly
a motorcycle FBK791T coming from my left make a sharp right turn towards North Boat Quay
in a reckless manner. As it was too sudden I have no time to react at all.
In the process the right hand side front of the motorcycle hit and grazed the left hand side
front of my taxi.
Shortly after I stopped out from my taxi and render assistance to the motorcyclist at the
same time asked him whether he is okay or not. He told me he felt some pain to his right
shoulder. Later the ambulance arrived at the scene followed by the Police. The paramedics
attended to him but did not send him to hospital.
03 passengers on board my taxi.

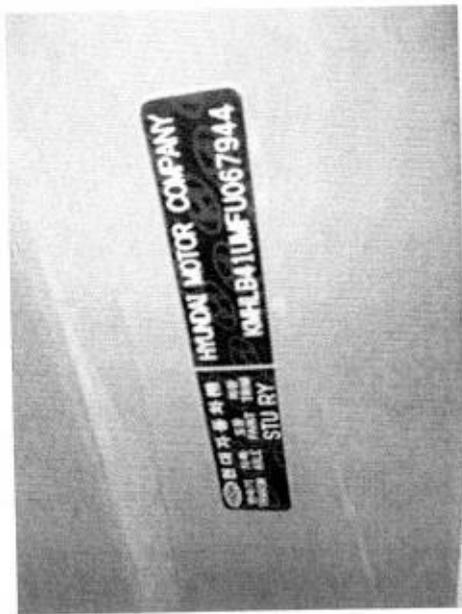
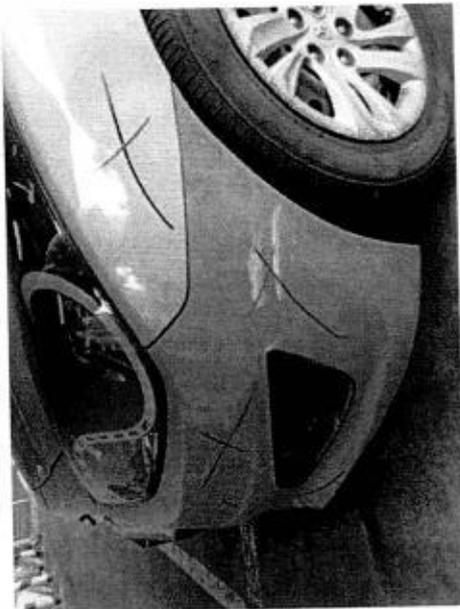
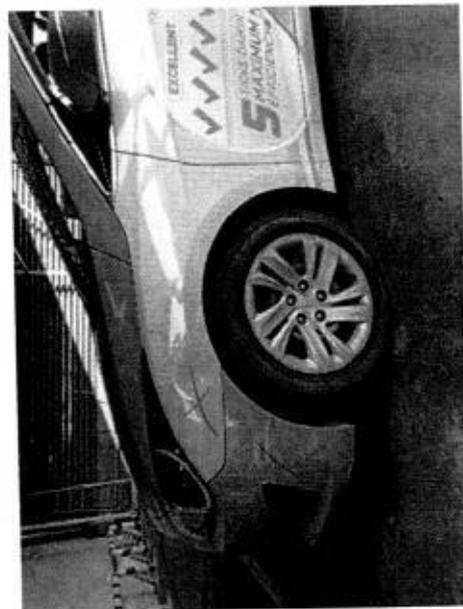
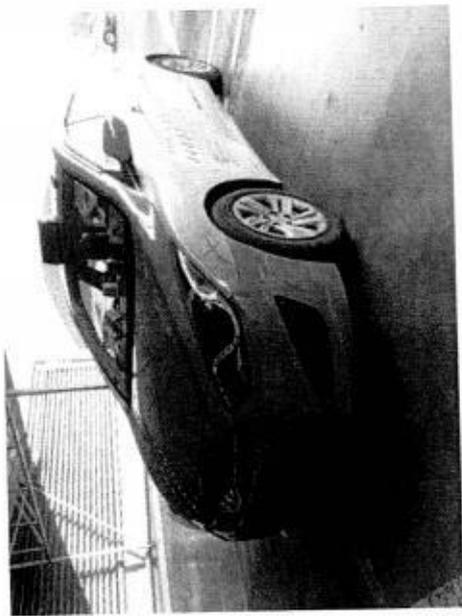
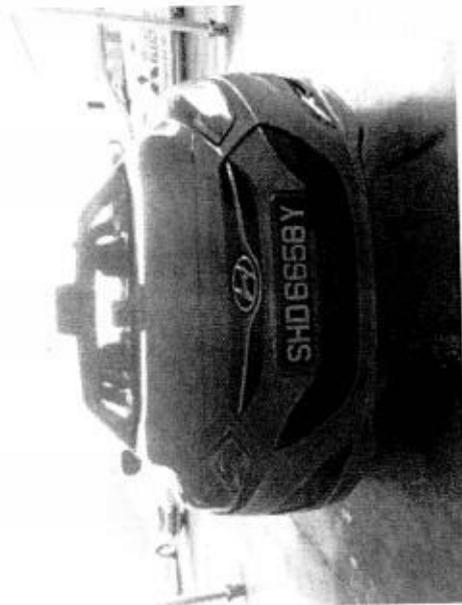
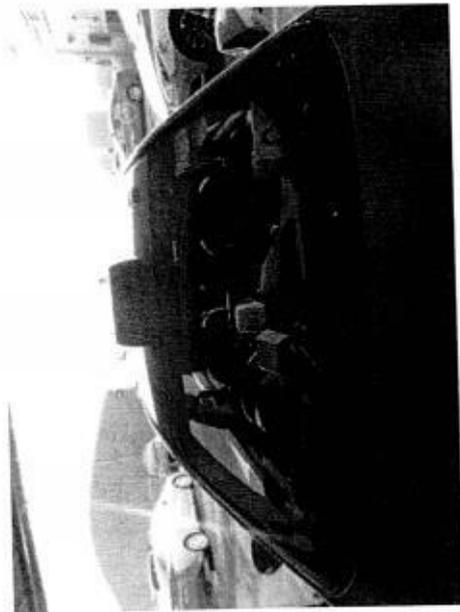
Qty	Description of Parts	Condition	Estimate By Workshop (\$)	Our Adjusted (\$)
REPLACEMENT OF PARTS				
1	FRONT BUMPER COVER	DEFORMED	562.30	562.30
1	FRONT BUMPER SPONGE	SERVICEABLE	142.20	-
1	FRONT BUMPER REINFORCEMENT	SERVICEABLE	526.10	-
1	FRONT BUMPER GRILLE (LH)	CUT	40.30	40.30
1	FRONT BUMPER BRACKET TOP (LH)	SERVICEABLE	22.40	-
1	FRONT BUMPER SIDE BRACKET (LH)	CRACKED	14.30	14.30
1	FRONT FENDER (LH)	TO REPAIR	619.00	-
1	FRONT FENDER SHIELD (LH)	SERVICEABLE	169.80	-
1	FRONT FENDER RETAINER (LH)	SERVICEABLE	9.20	-
	LESS 20% DISCOUNT		-421.12	-123.38
			1,684.48	493.52
SPECIAL NETT ITEMS				
1	FRONT FENDER ADVERTISEMENT LOGO (LH)(SN)	NECESSARY	100.00	100.00

100.00	100.00
LABOUR				
	THATCHAM STANDARD REPAIR TIME ON BODY WORKS.		500.00	300.00
	THATCHAM TTS STANDARD SPRAY PAINTING COST AND LABOUR.		550.00	400.00
			1,050.00	700.00
GRAND TOTAL			2,834.48	1,293.52
RECOMMENDED COST OF LUMP SUM REPAIRS (TO ITS PRE-ACCIDENT CONDITION) (CONFIRMED)				1,050.00
