CS/TML18007356/Nrbez

SHA 7134B

## ...CLAIM SUBFOLDER...(New Assignment)

**VEHICLE DAMAGE INSPECTION REPORT****Our File No:** CS/TMI18007356/NRBE2**Date:** 09/05/2018**REFERENCE****Handling Insurer:** Tokio Marine Insurance Singapore Ltd**Policy No:** MU011043**Claimant Vehicle No :** SHA7134B**Insured Vehicle No :** GBC2609S**Date of Loss:** 19/04/2018**Nature of Claim:** TP**Claim No:** M1802081**DESCRIPTION & IDENTIFICATION OF VEHICLE****Reg No:** SHA7134B**Make & Model:** HYUNDAI I40, 1.7 D CRDi (A)**Engine No:** D4FDFU605345**Reg. Date:** 24/03/2016 (Man. Year: 2015)**Chassis No:** KMHLB41UMGU086622**Colour:** Blue**Odometer:** 251841 km**Engine Capacity:** 1685 cc**Market Value/New Car Price:** N/A**Sum Insured (S\$):** Market Value/New Car Price**CONDITION OF VEHICLE AT THE TIME OF SURVEY****General Condition:** Fair **Steering (Serviceable):****Yes** **Footbrake (Serviceable):****Yes****Handbrake (Serviceable):** Yes **Engine Modification:****No** **Pre-accident Condition:****Average****CONDITION OF TYRES****Front Tyre Size:** 205/60 R16**Rear Tyre Size:** 205/60 R16**Front Left Side:** West Lake 5 mm**Rear Left Side:** West Lake 5 mm**Front Right Side:** West Lake 5 mm**

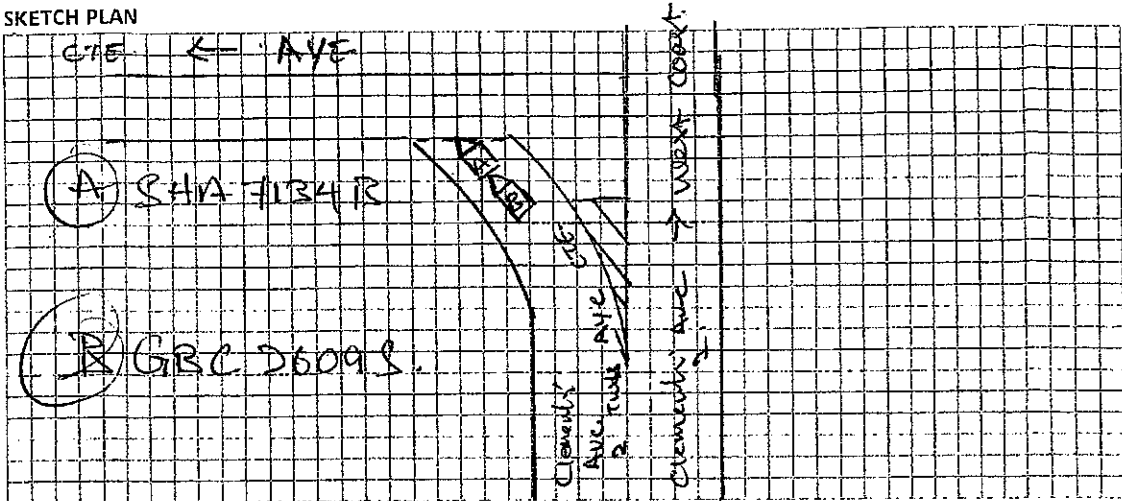
## SKETCH PLAN

ON. 19 April 2018 @ 1000hr. I VEH

A was driving along Clementi Ave 2  
towards Ship Rd of Ave to cte.

I veh A slow down and stop at Ship  
Rd gave way sign. Suddenly veh B from  
Rear hit veh A Rear. at the point  
of accident I veh A ferry a male  
passenger he near cte.

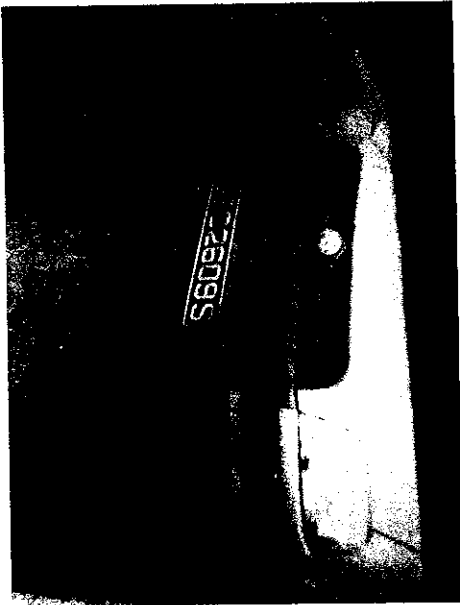
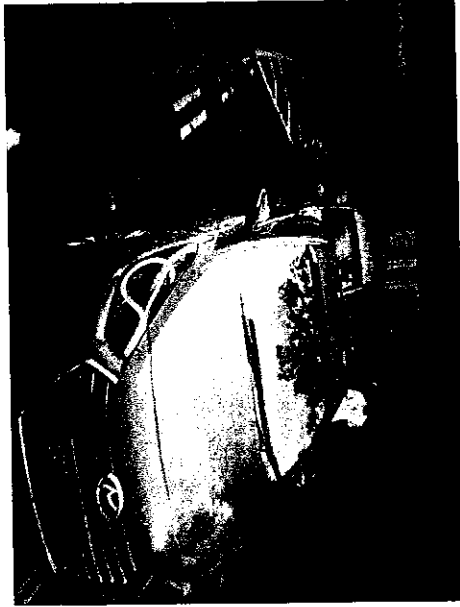
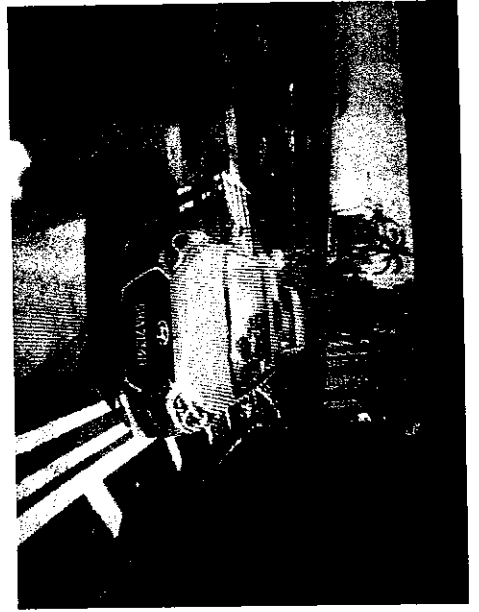
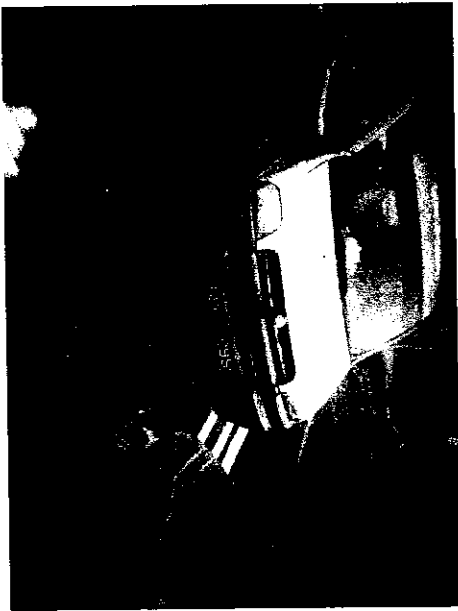
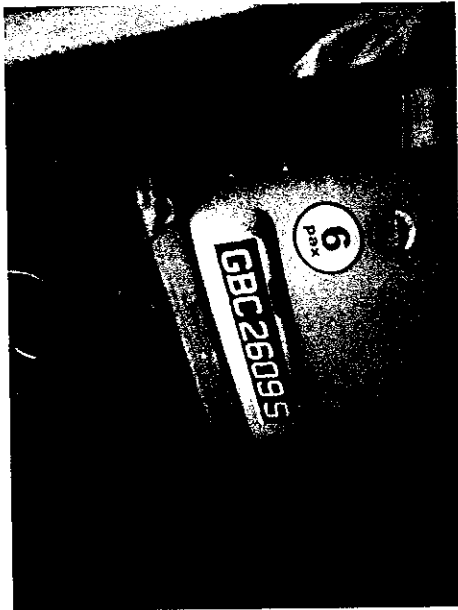
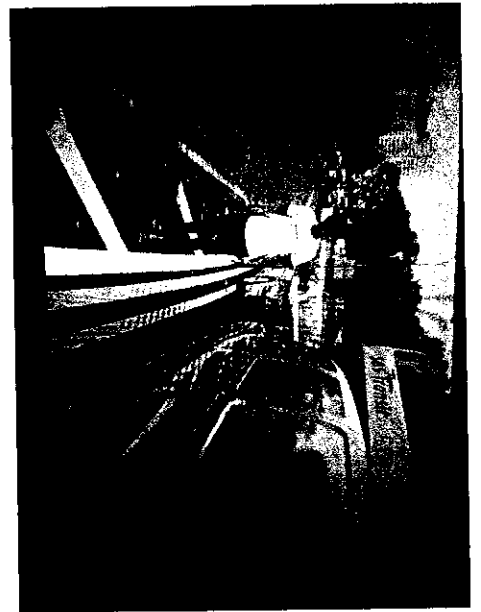
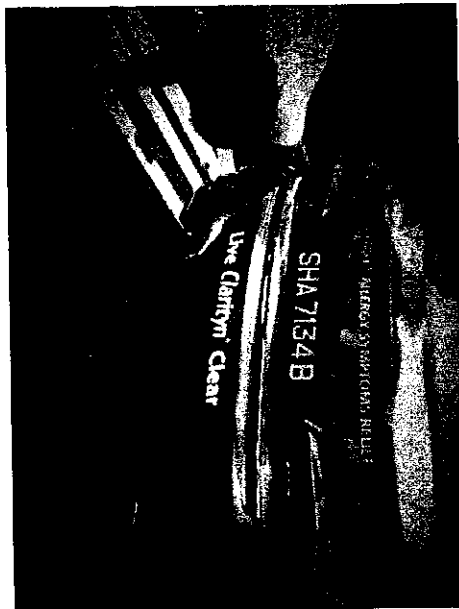
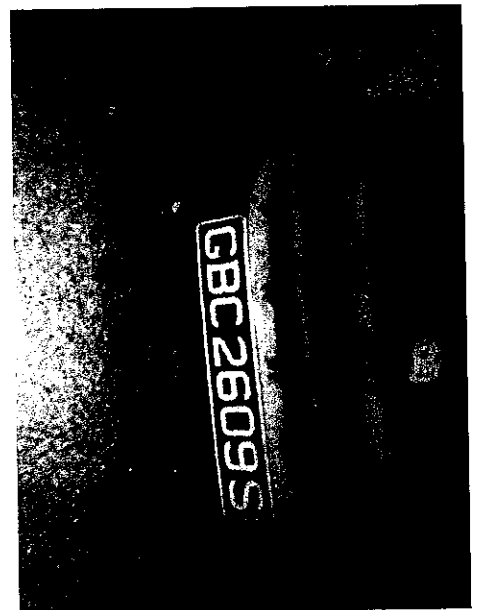
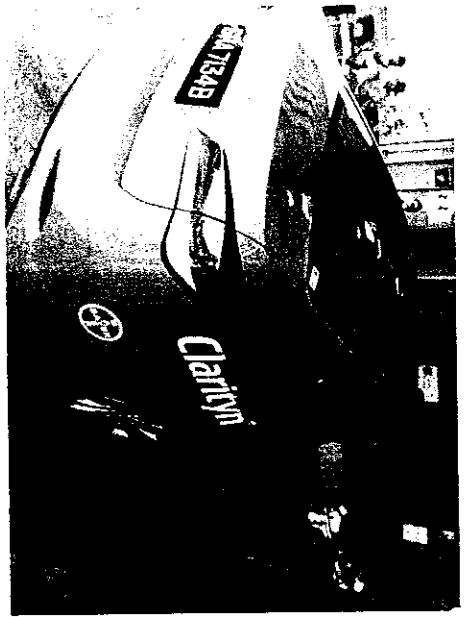
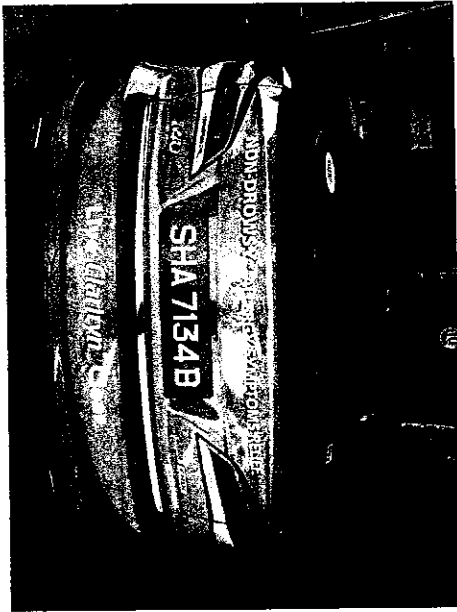
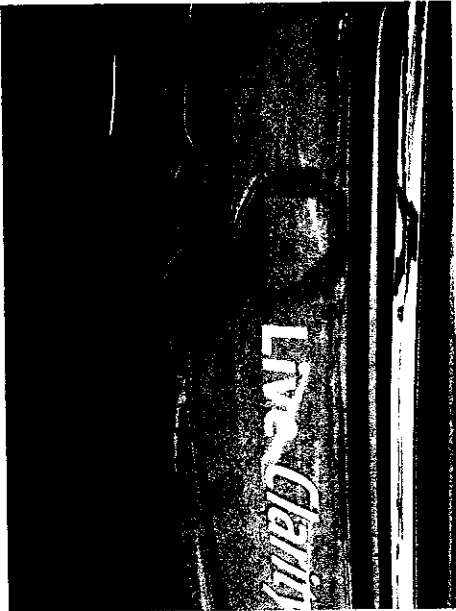
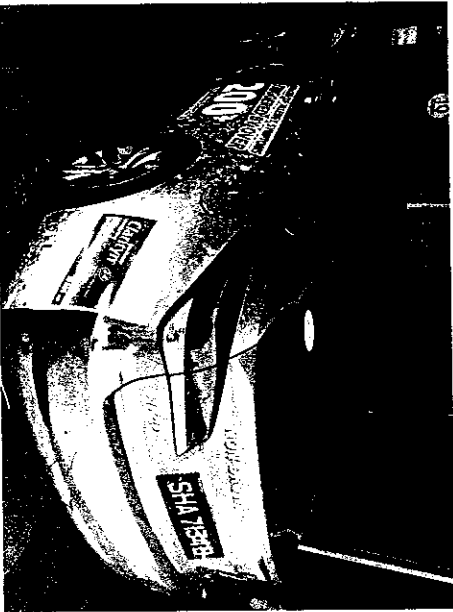
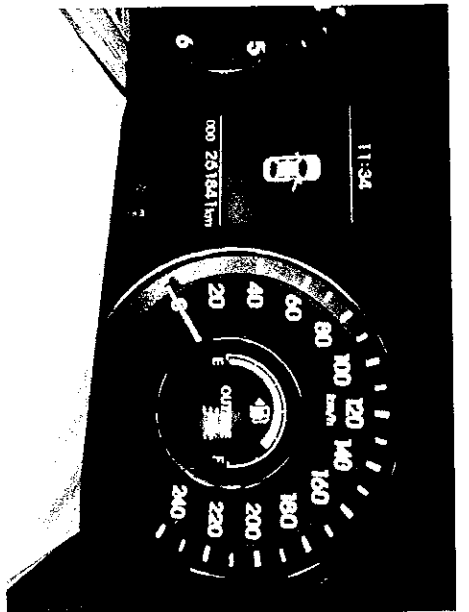
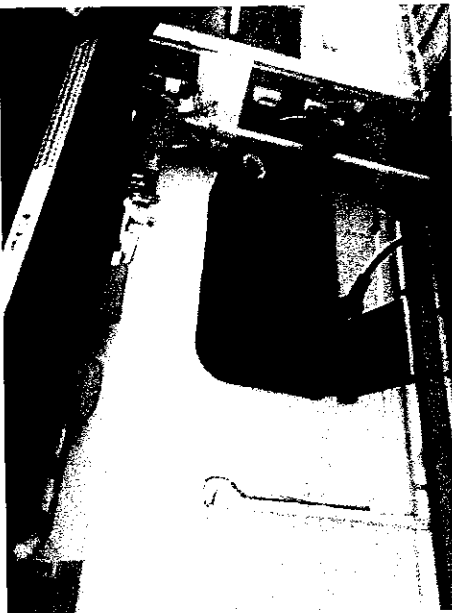
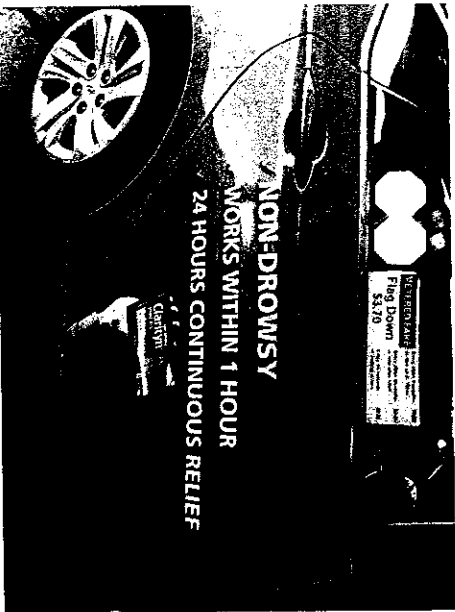
The U/C / Chassis frame / Body Structure affected due to collision.

No.	Qty	Part No.	Particulars	%Disc	%Depr	Amount
1	1		*REAR BUMPER	20.00	0.00	*603.60 FL ✓ crack
2	1		*REAR BUMPER REINFORCEMENT	20.00	0.00	*504.35 FL ✓ Svc
3	1		*REAR BUMPER REINFORCEMENT BRACKET LH	20.00	0.00	*180.00 FL ✓ Svc
4	1		*REAR BUMPER REINFORCEMENT BRACKET RH	20.00	0.00	*180.00 FL ✓ Svc
5	10		*REAR BUMPER REINFORCEMENT CLIPS	20.00	0.00	*22.00 FL ✓ Svc
6	1		*REAR BUMPER SPONGE	20.00	0.00	*143.40 FL ✓ Svc
7	1		*REAR BUMPER UNDER COVER	20.00	0.00	*225.00 FL ✓ dent
8	1		*REVERSE SENSOR	0	0.00	*135.70 FS X S/N 109516
9	1		*REAR BUMPER ADVERTISEMENT LOGO	0	0.00	*50.00 FS ✓ ncl

No.	Qty	Part No.	Particulars	Condition	Repairer's	Amount
1	1		*REAR BUMPER	Cracked	603.60 FL	*603.60 FL
2	1		*REAR BUMPER REINFORCEMENT	Serviceable	504.35 FL	*- FL
3	1		*REAR BUMPER REINFORCEMENT BRACKET LH	Serviceable	180.00 FL	*- FL
4	1		*REAR BUMPER REINFORCEMENT BRACKET RH	Serviceable	180.00 FL	*- FL
5	10		*REAR BUMPER REINFORCEMENT CLIPS	Serviceable	22.00 FL	*- FL
6	1		*REAR BUMPER SPONGE	Serviceable	143.40 FL	*- FL
7	1		*REAR BUMPER UNDER COVER	Dented	225.00 FL	*225.00 FL
8	1		*REVERSE SENSOR	Serviceable	135.70 FS	*- FS
9	1		*REAR BUMPER ADVERTISEMENT LOGO	Necessary	50.00 FS	*50.00 FS
					<b>Sub Total (S\$)</b>	<b>2,044.05      878.60</b>
					<b>- List Item Discount on L Items 20.00/20.00% (S\$)</b>	<b>371.67      165.72</b>
					<b>Total Parts (S\$)</b>	<b>1,672.38      712.88</b>

1. The repair job shall bill to: TOKIO MARINE --- GBC2609S
2. The finalized amount shall be:
  - (a) Spare Parts after List discount \$662.88
  - (b) Labour Charges \$480.00
  - Total for Part-By-Part Repair Cost** \$1,142.88
  - (c.) Lumpsum Repair (if applicable)  
Total for Lumpsum repair cost after Less: 20% \$0.00  
**Final Lumpsum Repair cost** \$0.00

No	Particulars	Lab.Type	Repairer's	Amount
<b>Labour Items</b>				
1	PANEL BEAT	New	300.00	200.00
2	SPRAY PAINTING CHARGE	New	300.00	200.00
3	WIRING CHARGE	New	30.00	0.00
4	REMOVE/REFIX REVERSE SENSOR	New	120.00	20.00
Gross Labour Cost (\$)			750.00	420.00
