NTUC INCOME INSURANCE CO-OPERATIVE LTD Ref: NS/INC18007464/K1rbn2			
73 BRAS BASAH ROAD #05-01 NTUC TRADE UNION HOUSESINGAPORE 189556		Date: 03-05-2018

1. Policy Particulars :- THIRD PARTY CLAIM			
Insured Veh.	SLS 1369M	Veh. Inspected	SHA 7627X
Policy No.	5094430631	Coverage (\$)	0.00
Claim No.	MT/0991265-002	Excess (\$)	0.00
Assign From		Assign Date	23/04/2018

4. Description of Damages			
THE VEHICLE SUSTAINED DAMAGES AT THE REAR PORTION. DAMAGES SEE DETAILS.			
5. General Information			
Accident Date	21/04/2018	Inspection Date	23/04/2018
Survey held at	COMFORTDELGRO ENGINEERING PTE LTD 59 LOYANG DRIVE SINGAPORE 508969		
5a. Remarks

ADJUSTMENT ON REPAIR COST FOR VEHICLE NO. SHA 7627X

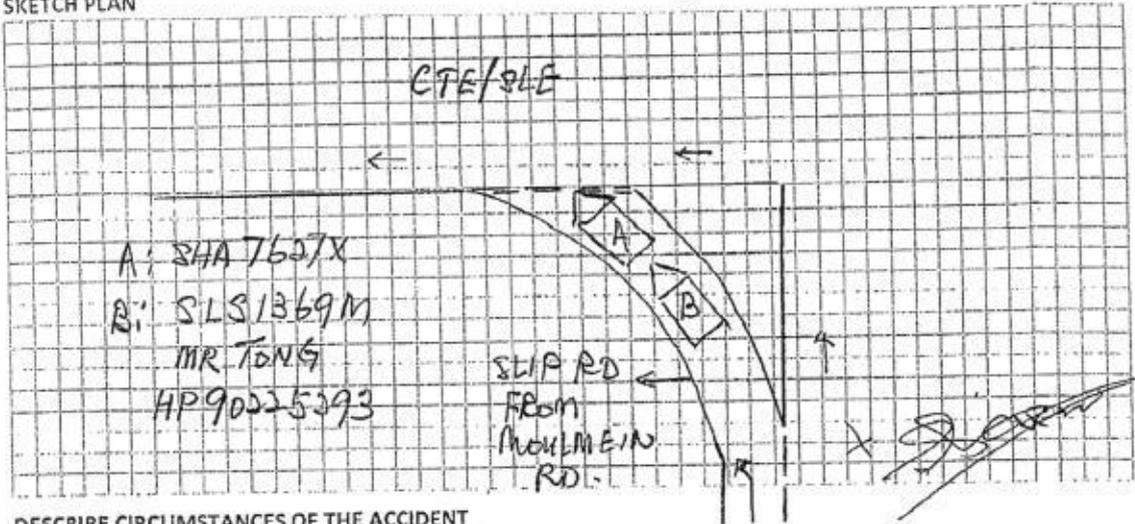
SKETCH PLAN

AS per attached

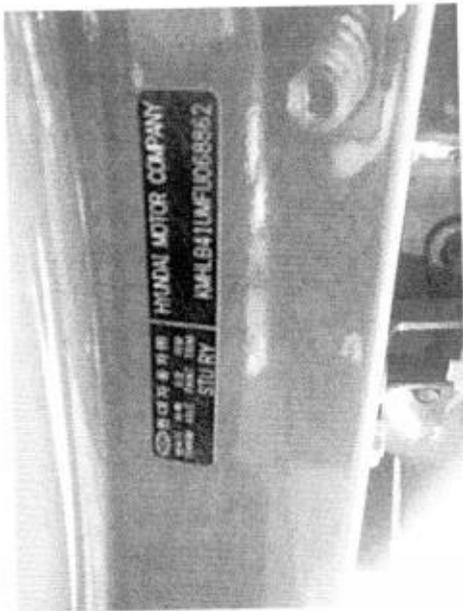
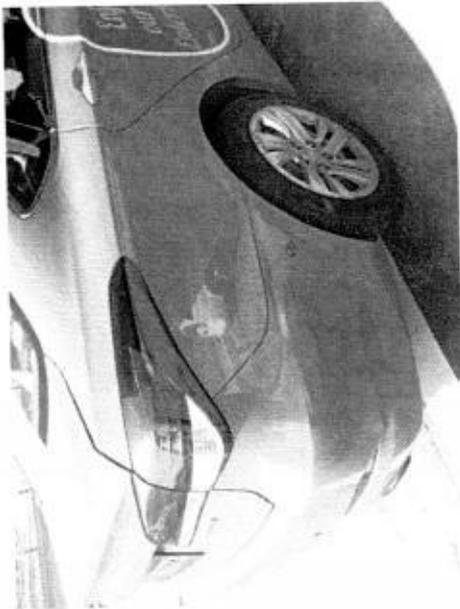
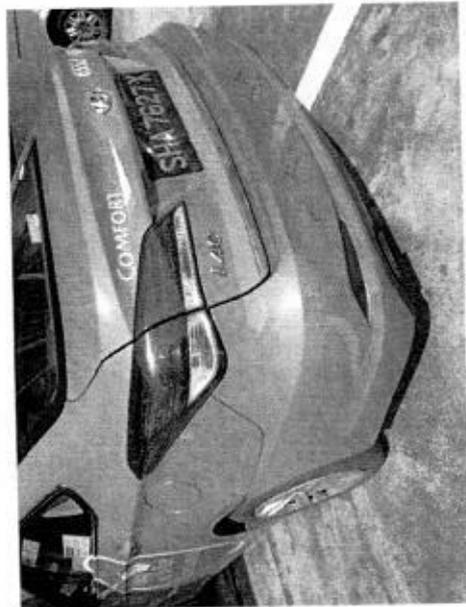
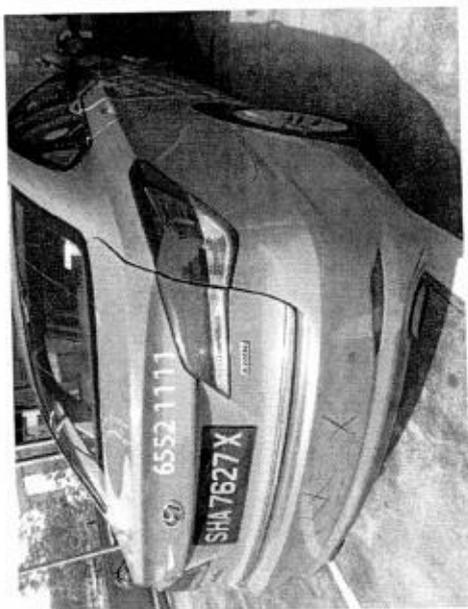
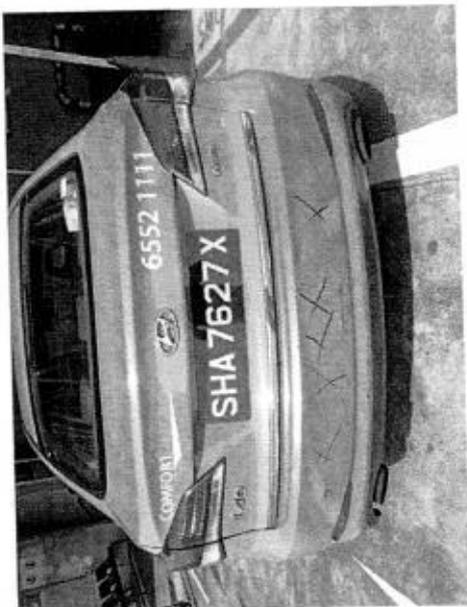
Qty	Description of Parts	Condition	Estimate By Workshop (\$)	Our Adjusted (\$)
REPLACEMENT OF PARTS				
1	REAR BUMPER	DEFORMED	603.60	603.60
1	REAR BUMPER REINFORCEMENT	SERVICEABLE	504.35	-
1	REAR BUMPER SPONGE	SERVICEABLE	143.40	-
10	REAR BUMPER CLIPS @\$2.20	NECESSARY	22.00	22.00
1	REAR BUMPER UNDER COVER	CUT	225.00	225.00
1	REAR BUMPER STAY-RH	SERVICEABLE	180.00	-
1	REAR BUMPER STAY-LH	SERVICEABLE	180.00	-
	LESS 20% DISCOUNT		-371.67	-170.12
			1,486.68	680.48
SPECIAL NETT ITEMS				
1	REAR BUMPER REVERSE SENSOR (SN)	SERVICEABLE	135.70	-
			135.70	-
LABOUR				
	THATCHAM STANDARD REPAIR TIME ON BODY WORKS.		370.00	220.00
	THATCHAM TTS STANDARD SPRAY PAINTING COST AND LABOUR.		250.00	200.00
			620.00	420.00
GRAND TOTAL			2,242.38	1,100.48
RECOMMENDED COST OF LUMP SUM REPAIRS (TO ITS PRE-ACCIDENT CONDITION) (CONFIRMED)				900.00

A) THE INSPECTION WAS CONDUCTED ON A "WITHOUT PREJUDICE" BASIS. B) IN ACCORDANCE TO YOUR INSTRUCTIONS, WE HAVE NOT AUTHORISED REPAIRS.			
5b. Estimate Days of Repair			
ESTIMATED NORMAL PERIOD FOR REPAIR:		2 Working Days
