To Inspect Vehicle No: SKE 7857S Insured: SJQ 6689R
at Workshop m/s Kent Auto Tel: 6741 2539
of 2 Kaki Bukit Ave 2 #01-21

ACCIDENT ON 09 DECEMBER 2017 INVOLVING SKE 7857S AND SJQ 6689R ALONG 369 TELOK KURAU ROAD

4. DESCRIPTION OF DAMAGE

VEHICLE DAMAGE INSPECTION REPORT

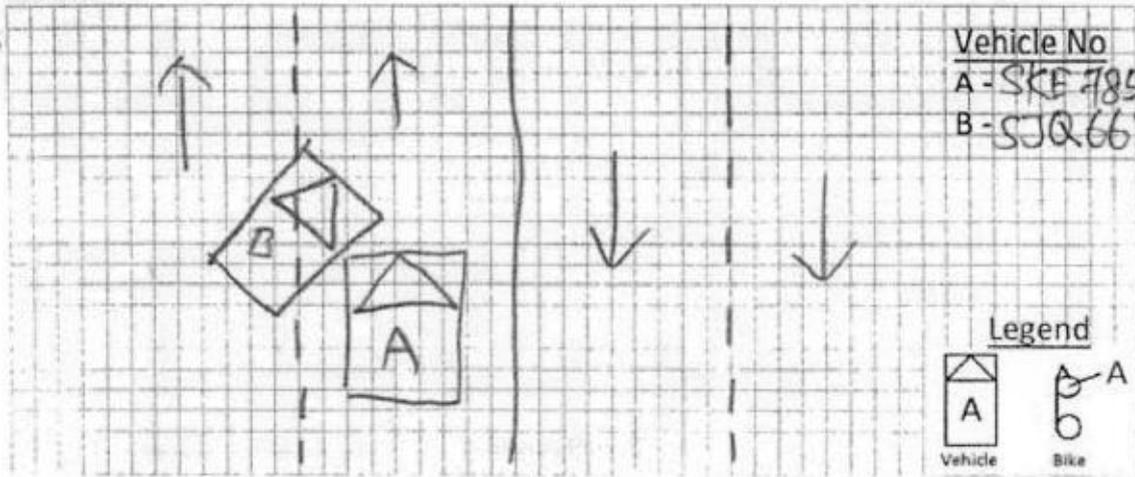
SKETCH PLAN

DESCRIBE CIRCUMSTANCES OF THE ACCIDENT

refer to police report.

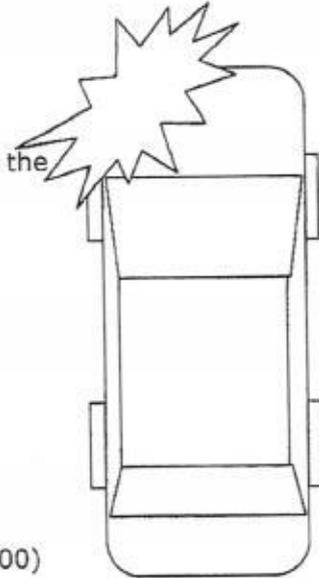
At the time of the inspection, the vehicle sustained damages to the FRONT portion.

Estimated Amount: \$ 46,830.98
Adjusted Amount: \$ 44,897.98 (Lump Sum of \$35,500.00)
Estimated Repair Days: 12 days

Pursuant to your instruction, we have **NOT AUTHORISED** repair.
