## National Assessment Centre Services

### 1. Policy Particulars :- THIRD PARTY CLAIM

### 4. Description of Damages

### ADJUSTMENT ON REPAIR COST FOR VEHICLE NO. SHC 7718G

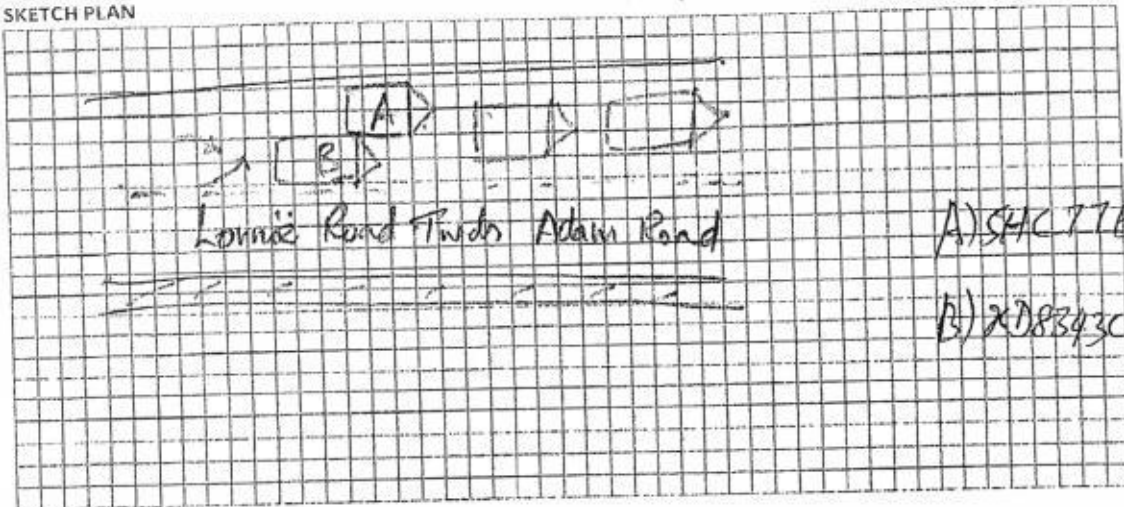
## SKETCH PLAN

A) SHC 778G

B) XD8343C

On 24/4/18 at about 0735hrs while I Veh A was driving along the merging lane ahead of Veh B that was on the right side of the same lane. Veh B collided on the right rear door portion of my vehicle.
