NTUC INCOME INSURANCE CO-OPERATIVE LTD Ref: NS/INC18007806/K1rb

1. Policy Particulars :- THIRD PARTY CLAIM

4. Description of Damages

ADJUSTMENT ON REPAIR COST FOR VEHICLE NO. SH 6997S

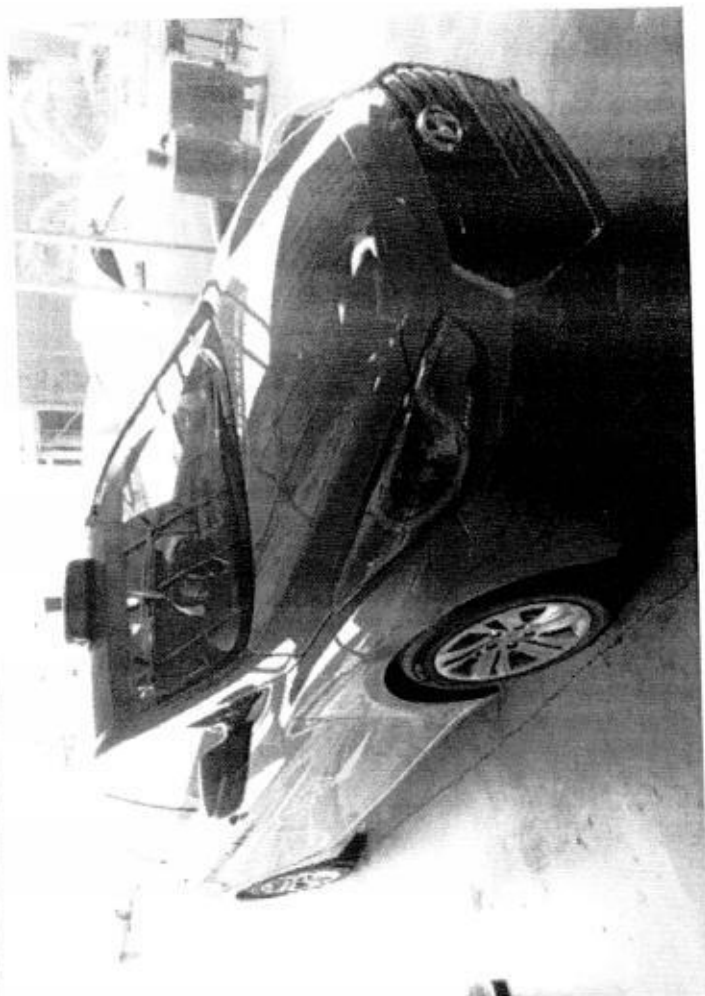
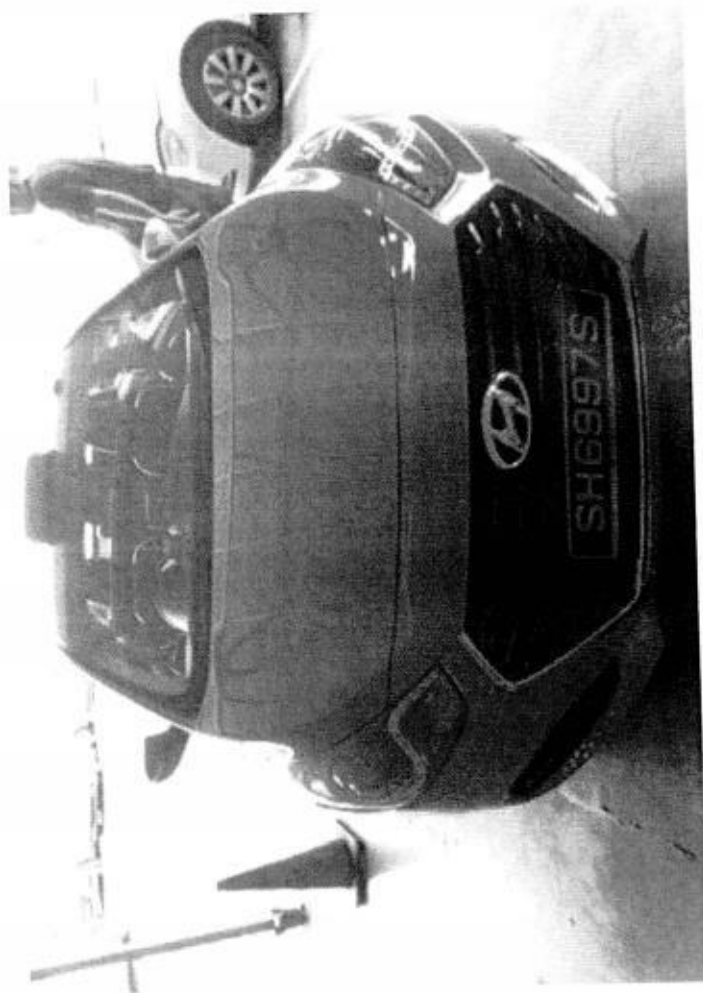
The U/C / Chassis frame / Body Structure affected due to collision.

4. Description of Damages			
THE VEHICLE SUSTAINED DAMAGES AT THE O/S FRONT PORTION. DAMAGES SEE DETAILS.			
5. General Information			
Accident Date	26/04/2018	Inspection Date	27/04/2018
Survey held at	COMFORTDELGRO ENGINEERING PTE LTD 59 LOYANG DRIVE SINGAPORE 508969		
5a. Remarks

Qty	Description of Parts	Condition	Estimate By Workshop (\$)	Our Adjusted (\$)
	REPLACEMENT OF PARTS			
1	FRONT BUMPER COVER	CUT	1,052.20	1,052.20
1	FRONT BUMPER SPONGE	SERVICEABLE	142.20	-
1	FRONT BUMPER REINFORCEMENT	SERVICEABLE	526.10	-
1	FRONT BUMPER GRILLE (RH)	SERVICEABLE	40.30	-
1	FRONT BUMPER BRACKET TOP (RH)	SERVICEABLE	22.40	-
1	FRONT BUMPER SIDE BRACKET	SERVICEABLE	14.30	-
1	HEADLAMP SUPPORT PANEL ASSY	SERVICEABLE	1,067.50	-
1	HEADLAMP (RH)	CRACKED	1,388.00	1,388.00
	LESS 20% DISCOUNT		-850.60	-488.04
			3,402.40	1,952.16
	LABOUR			
	THATCHAM STANDARD REPAIR TIME ON BODY WORKS.		760.00	320.00
	THATCHAM TTS STANDARD SPRAY PAINTING COST AND LABOUR.		450.00	360.00
			1,210.00	680.00
	GRAND TOTAL		4,612.40	2,632.16
	RECOMMENDED COST OF LUMP SUM REPAIRS (TO ITS PRE-ACCIDENT CONDITION) (CONFIRMED)			2,100.00
