The U/C / Chassis frame / Body Structure affected due to collision.

**From:** Janice Goh Siew Geok (ECICS, Claims)  
**Sent:** Wednesday, 2 May, 2018 3:25 PM  
**To:** 'vincent.sim@alpinemotors.sg'; 'assignments'  
**Cc:** motorsurvey  
**Subject:** SLV2147P- OPEL CROSSLAND X 1.2- Undercarriage Damaged Own Damaged Claim ;DOA 26-4-2018

## Preliminary Advice

## VEHICLE DAMAGE INSPECTION REPORT

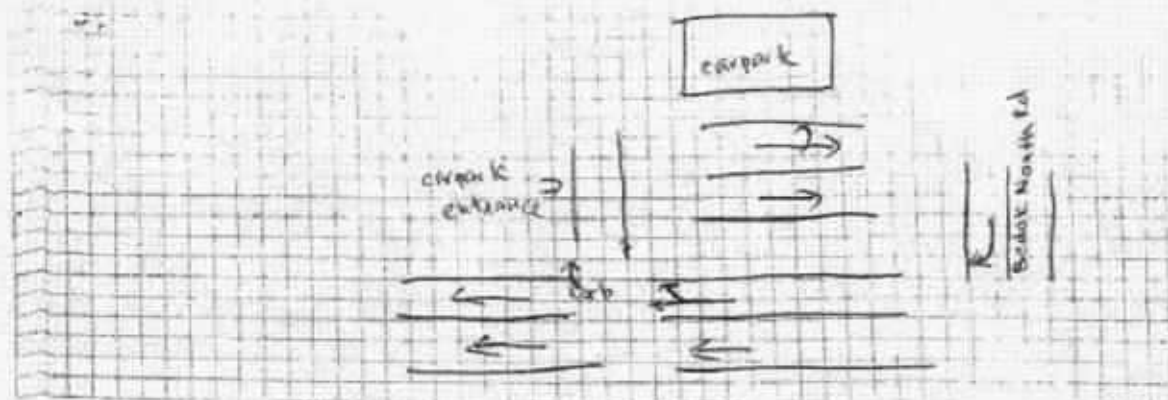
## SKETCH PLAN

I was driving from Bedok North turning to Chai Chee St. As I was turning from Chai Chee St to the carpark, left side of my car hit hard the ~~left~~ left side kerb. Luckily no other vehicles ~~was~~ <sup>was</sup> around the accident spot.

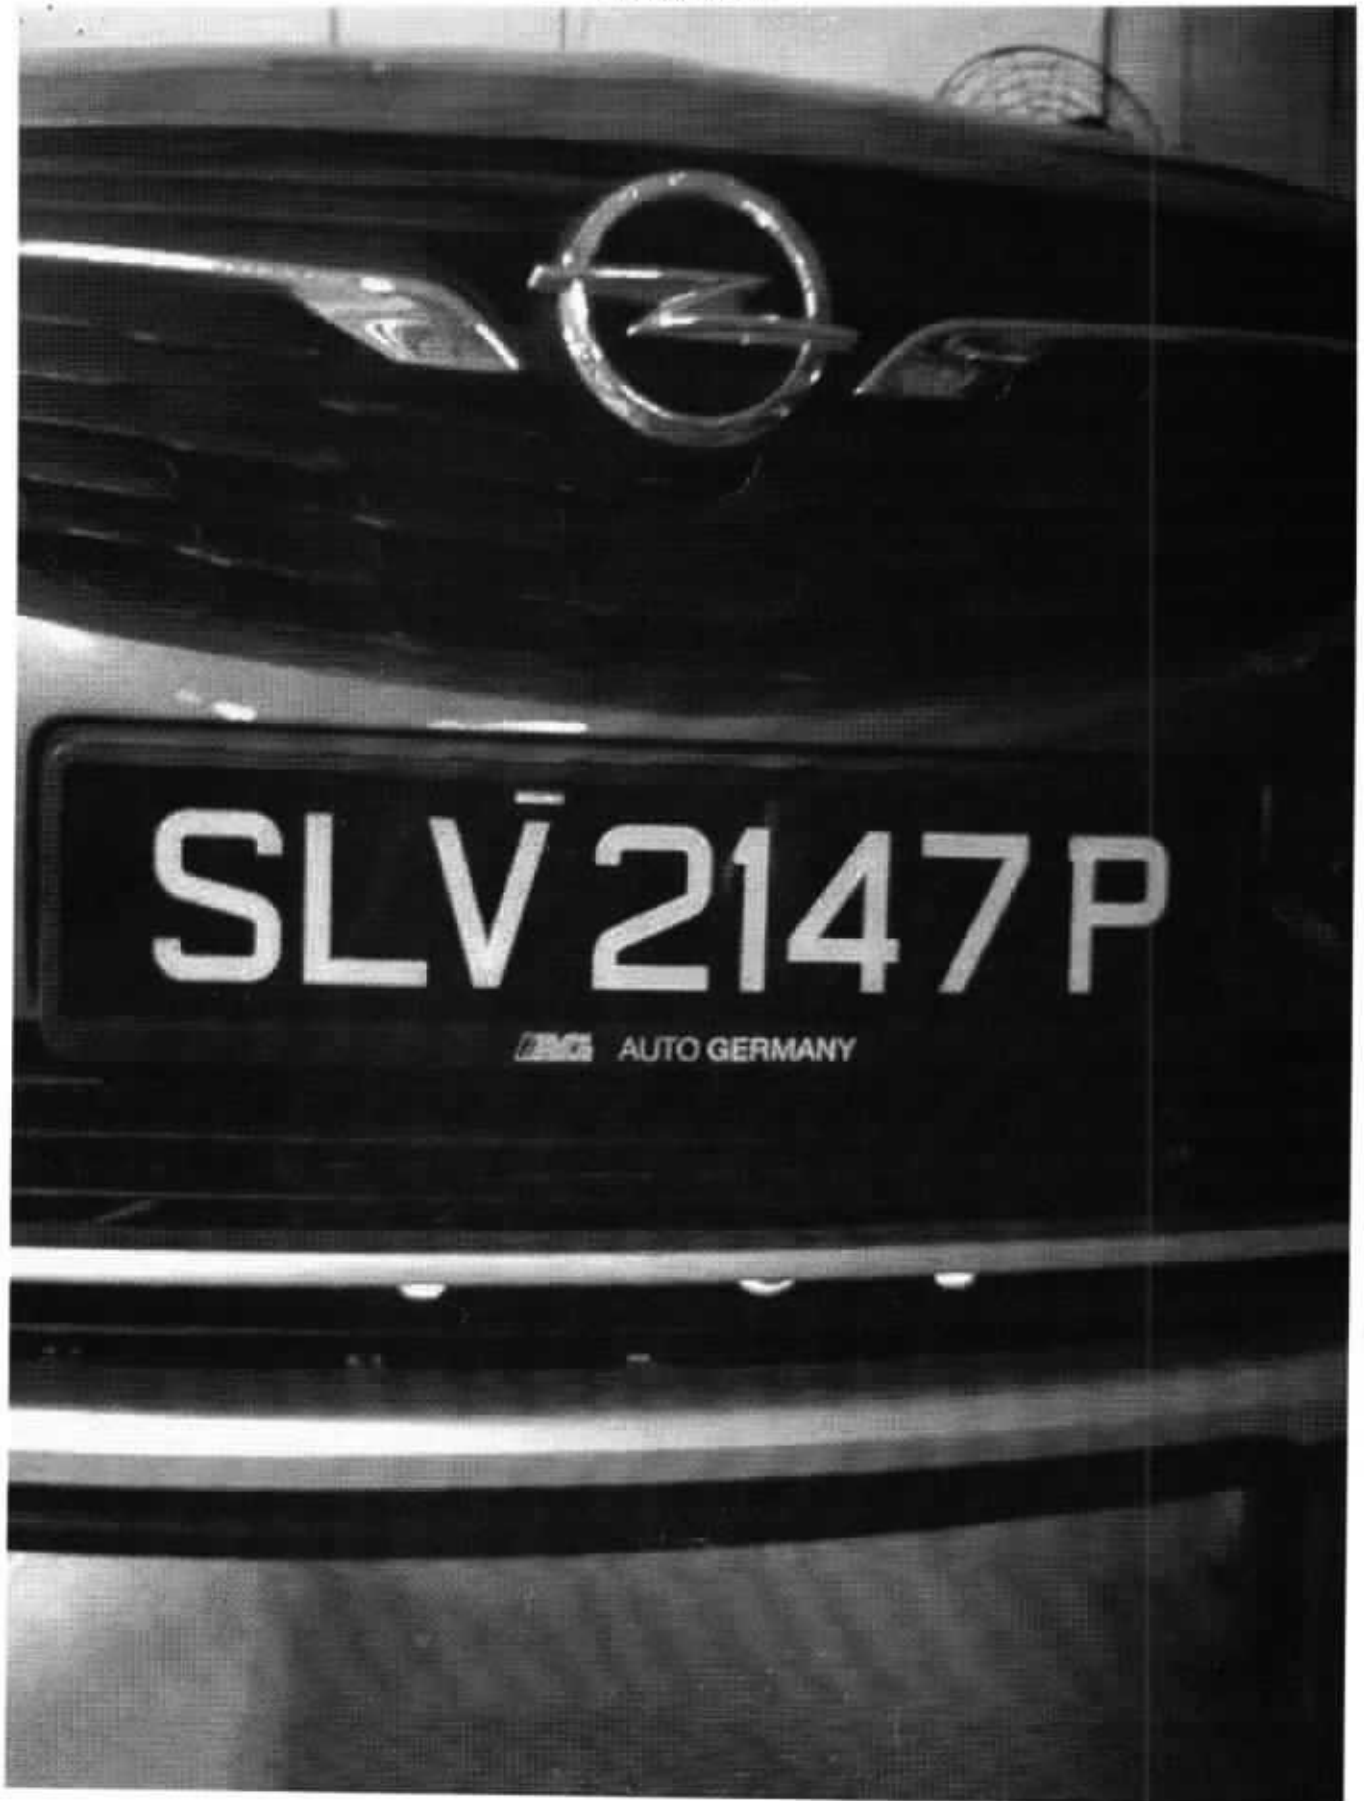
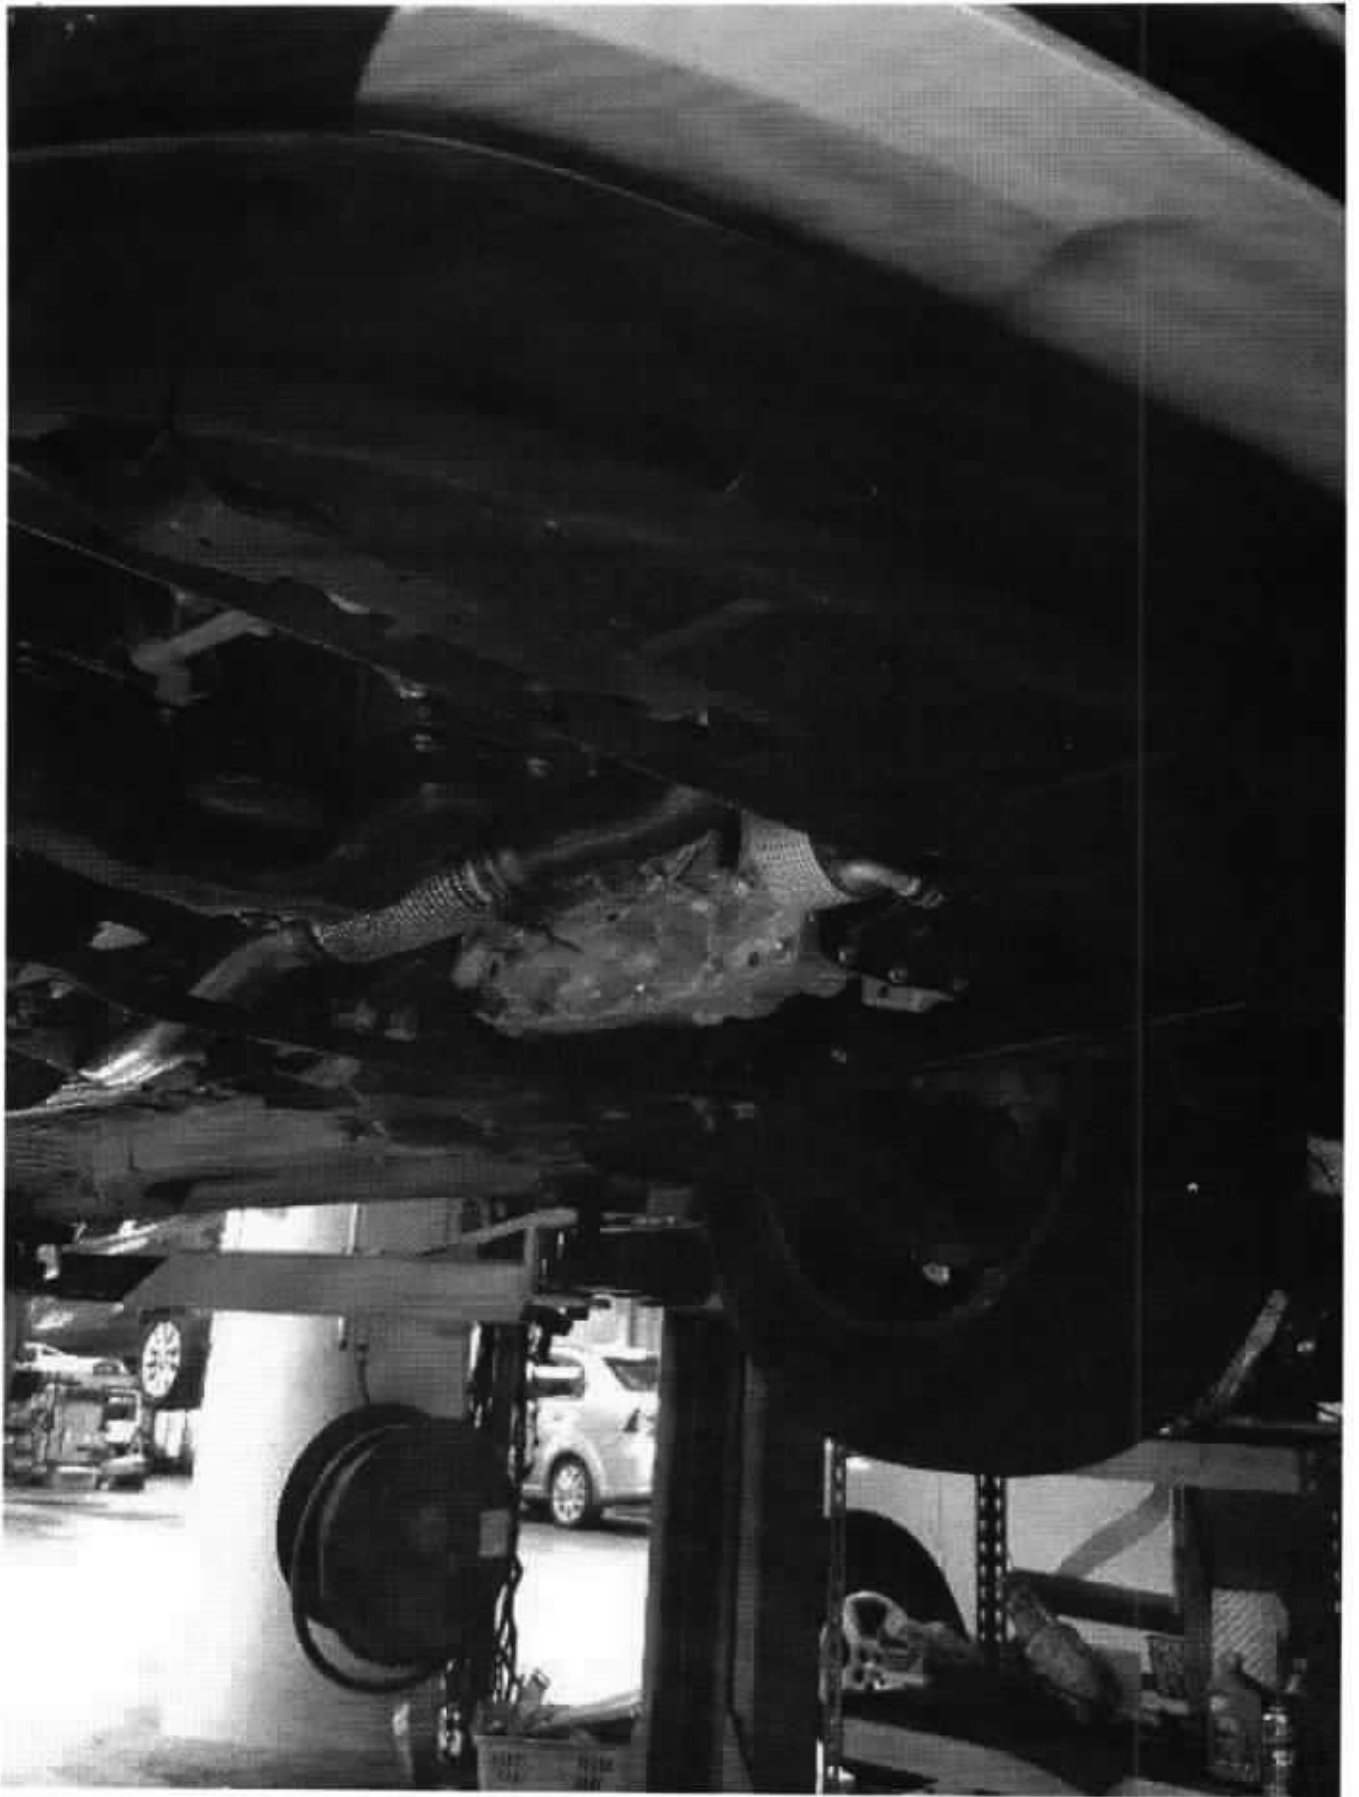
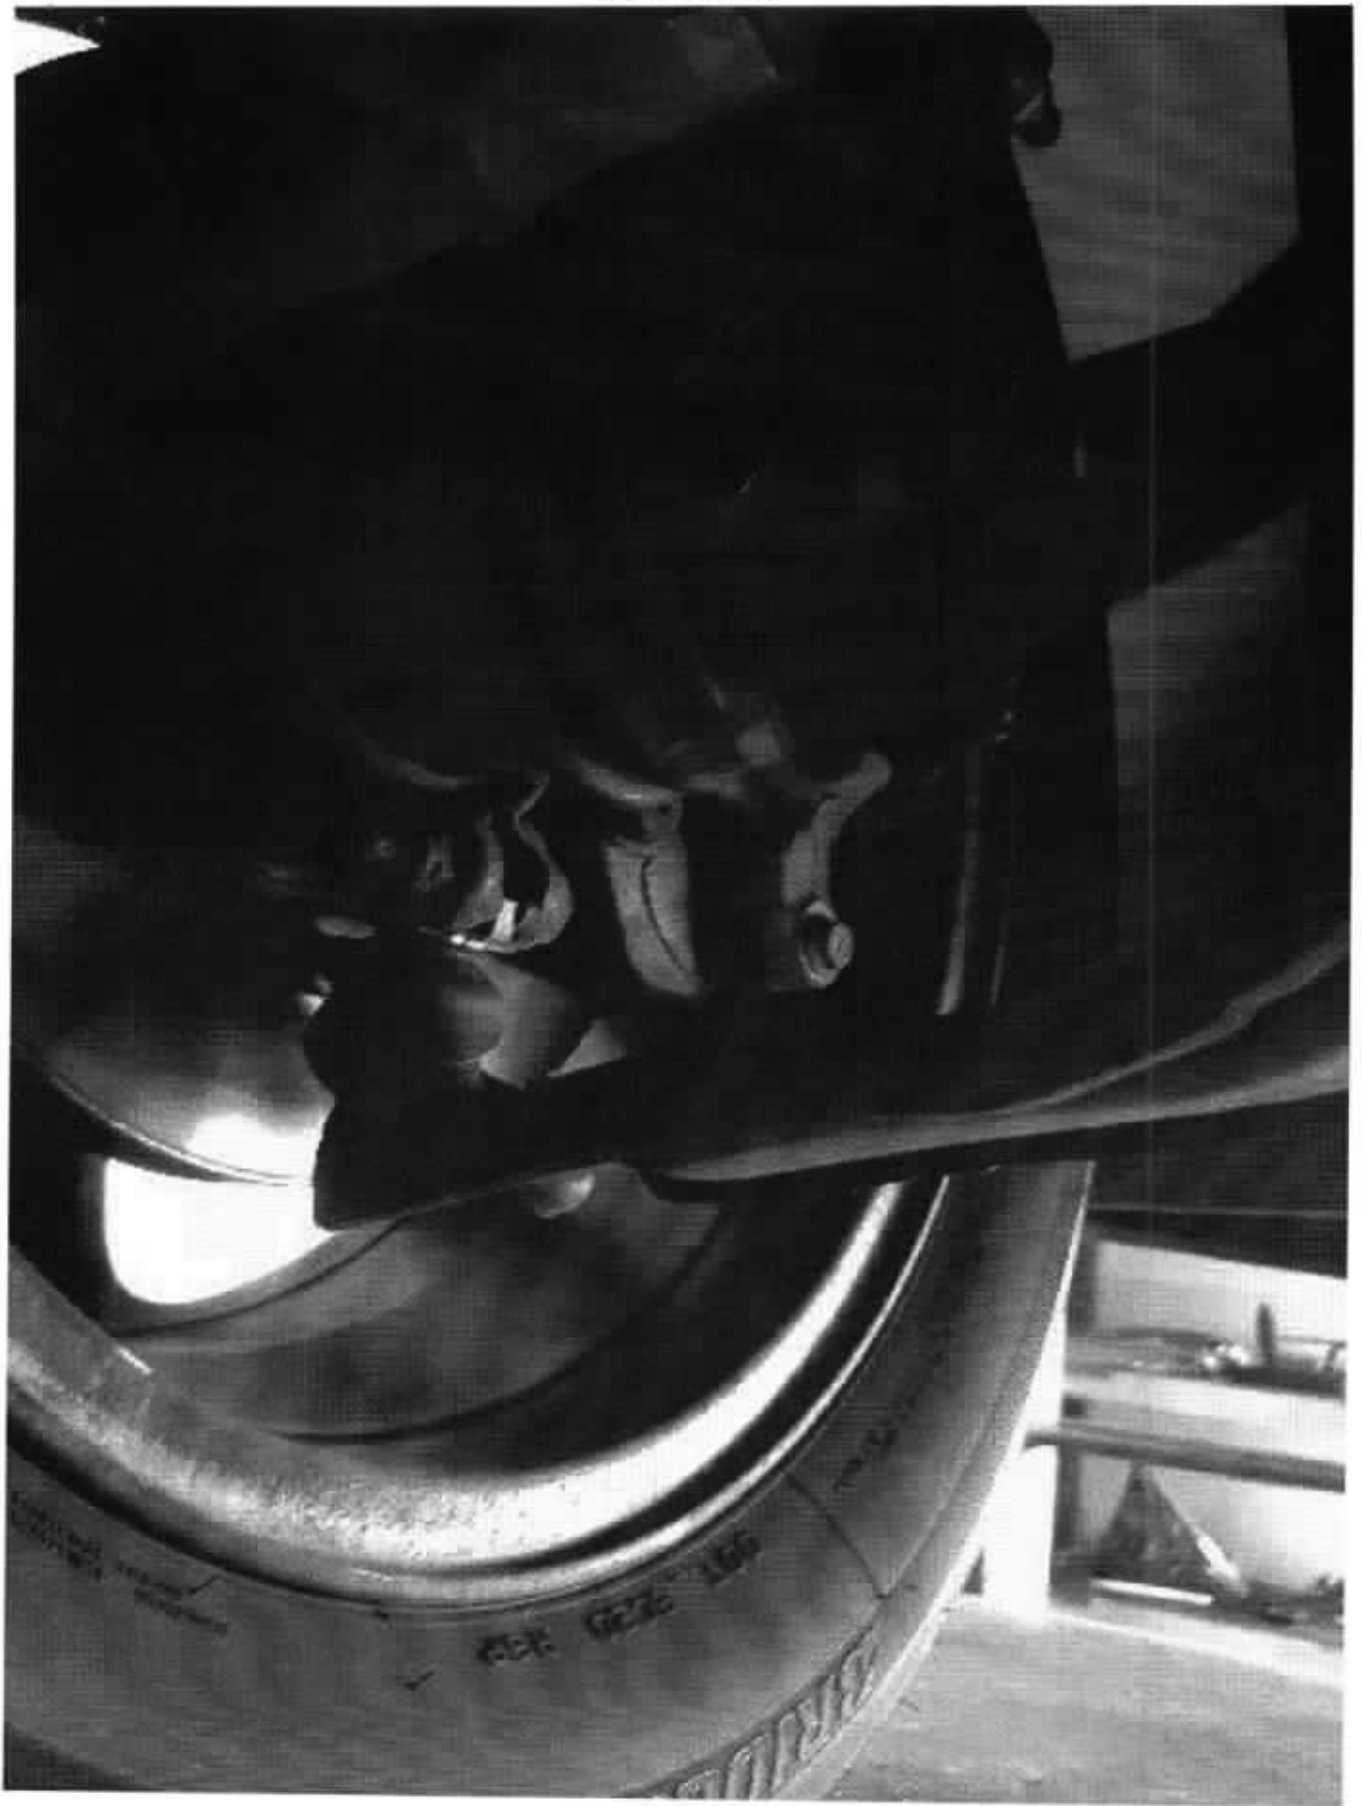
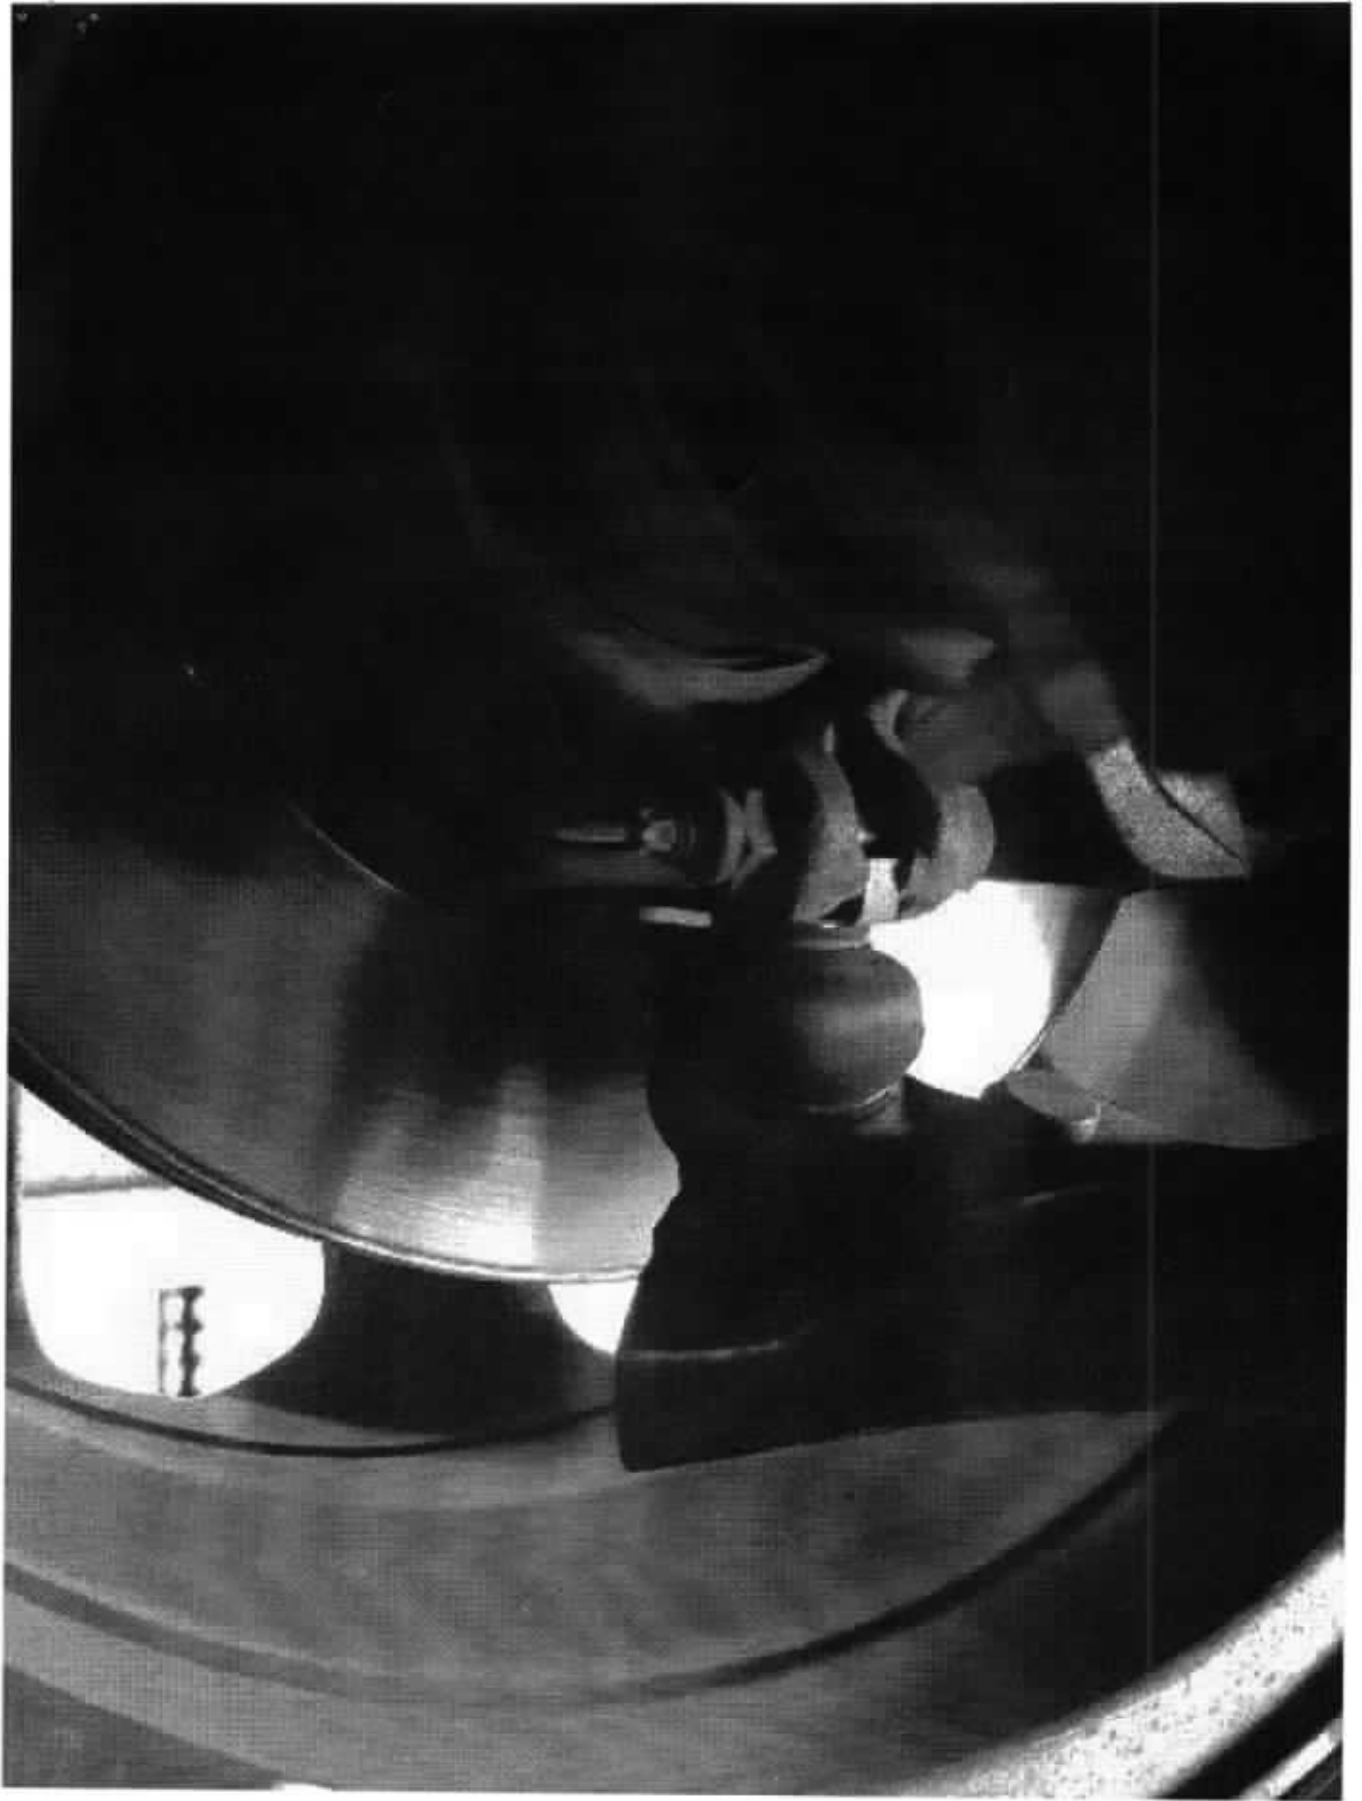
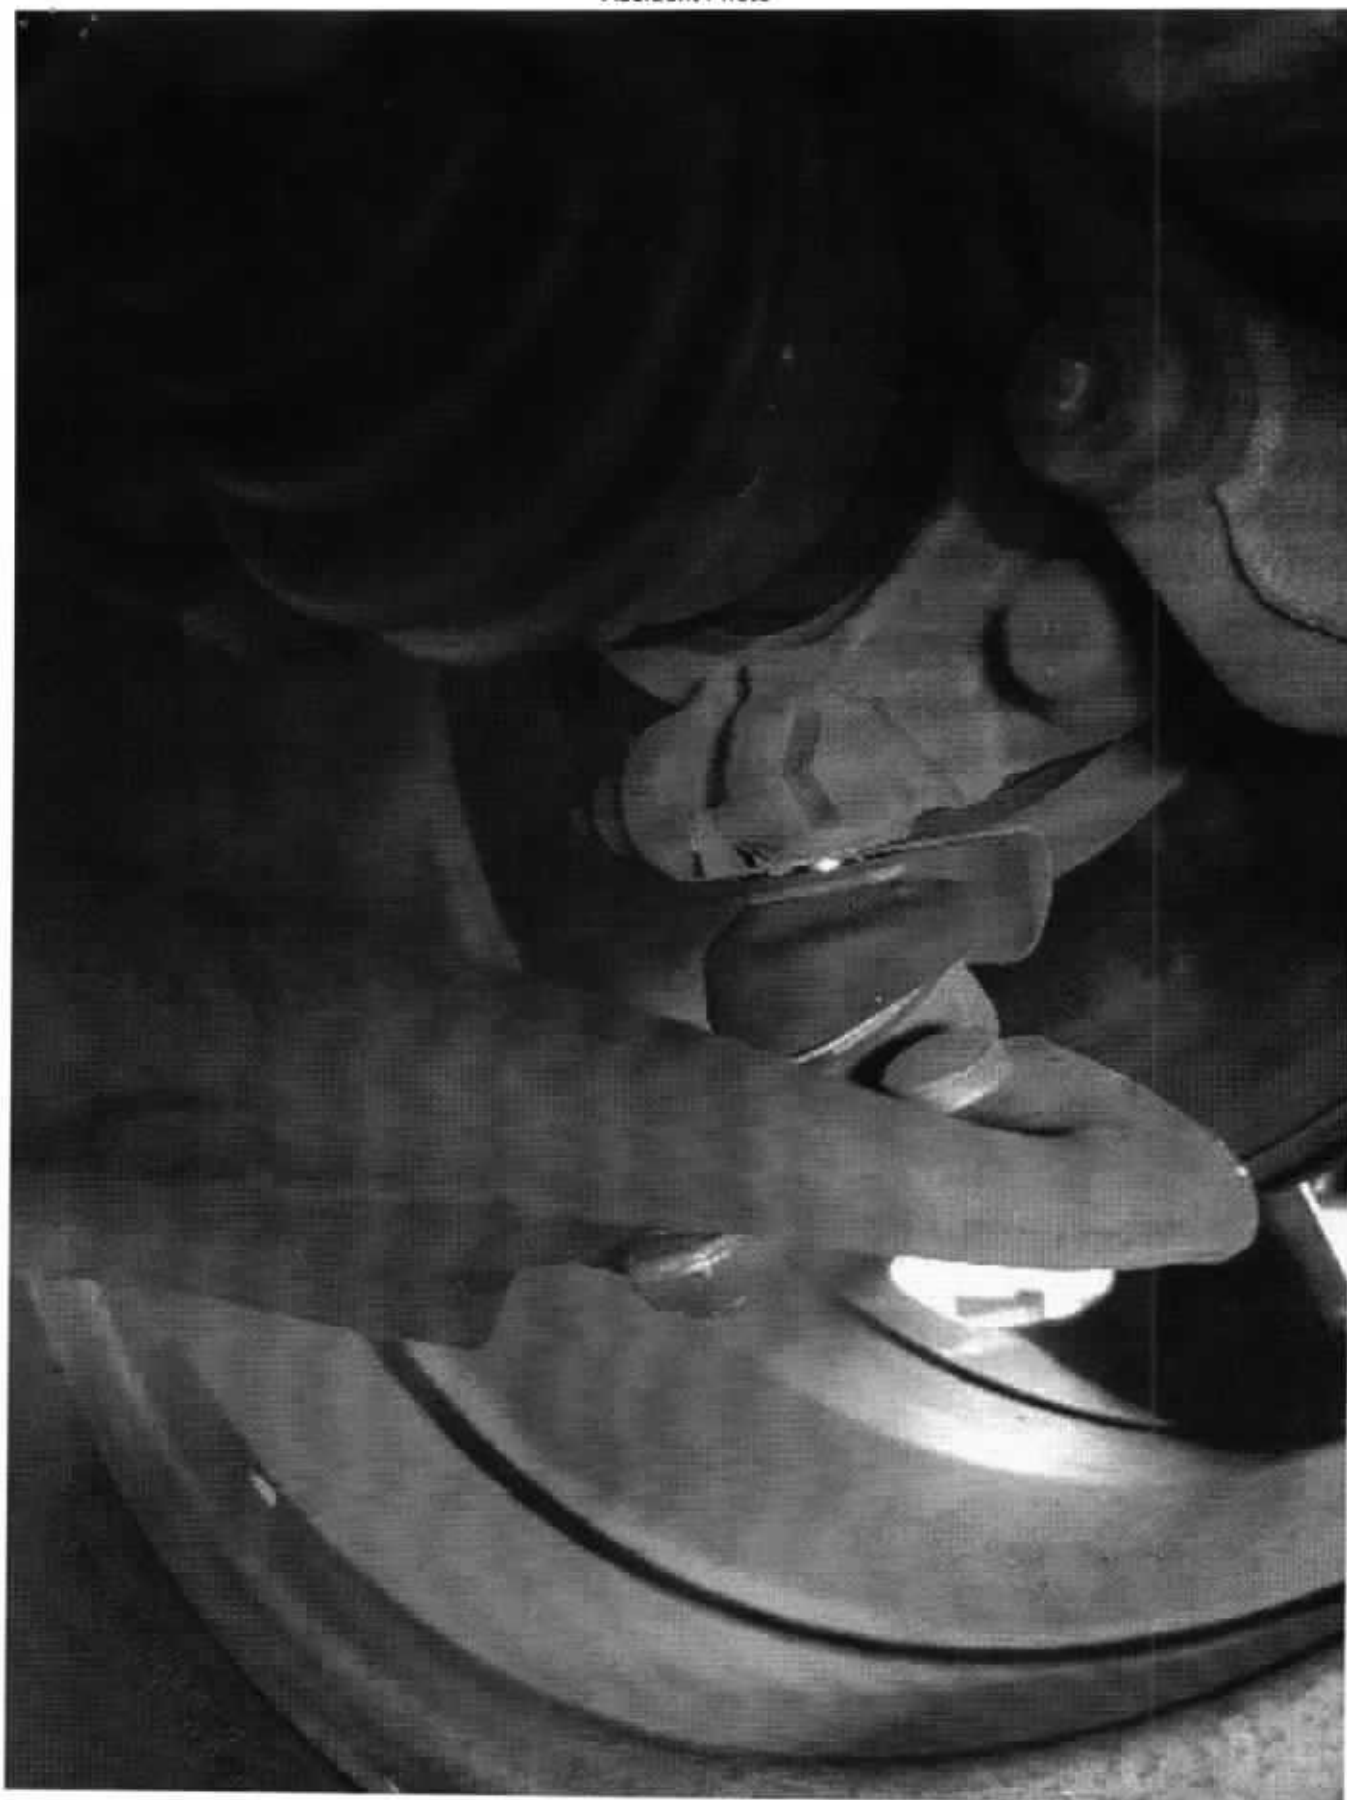
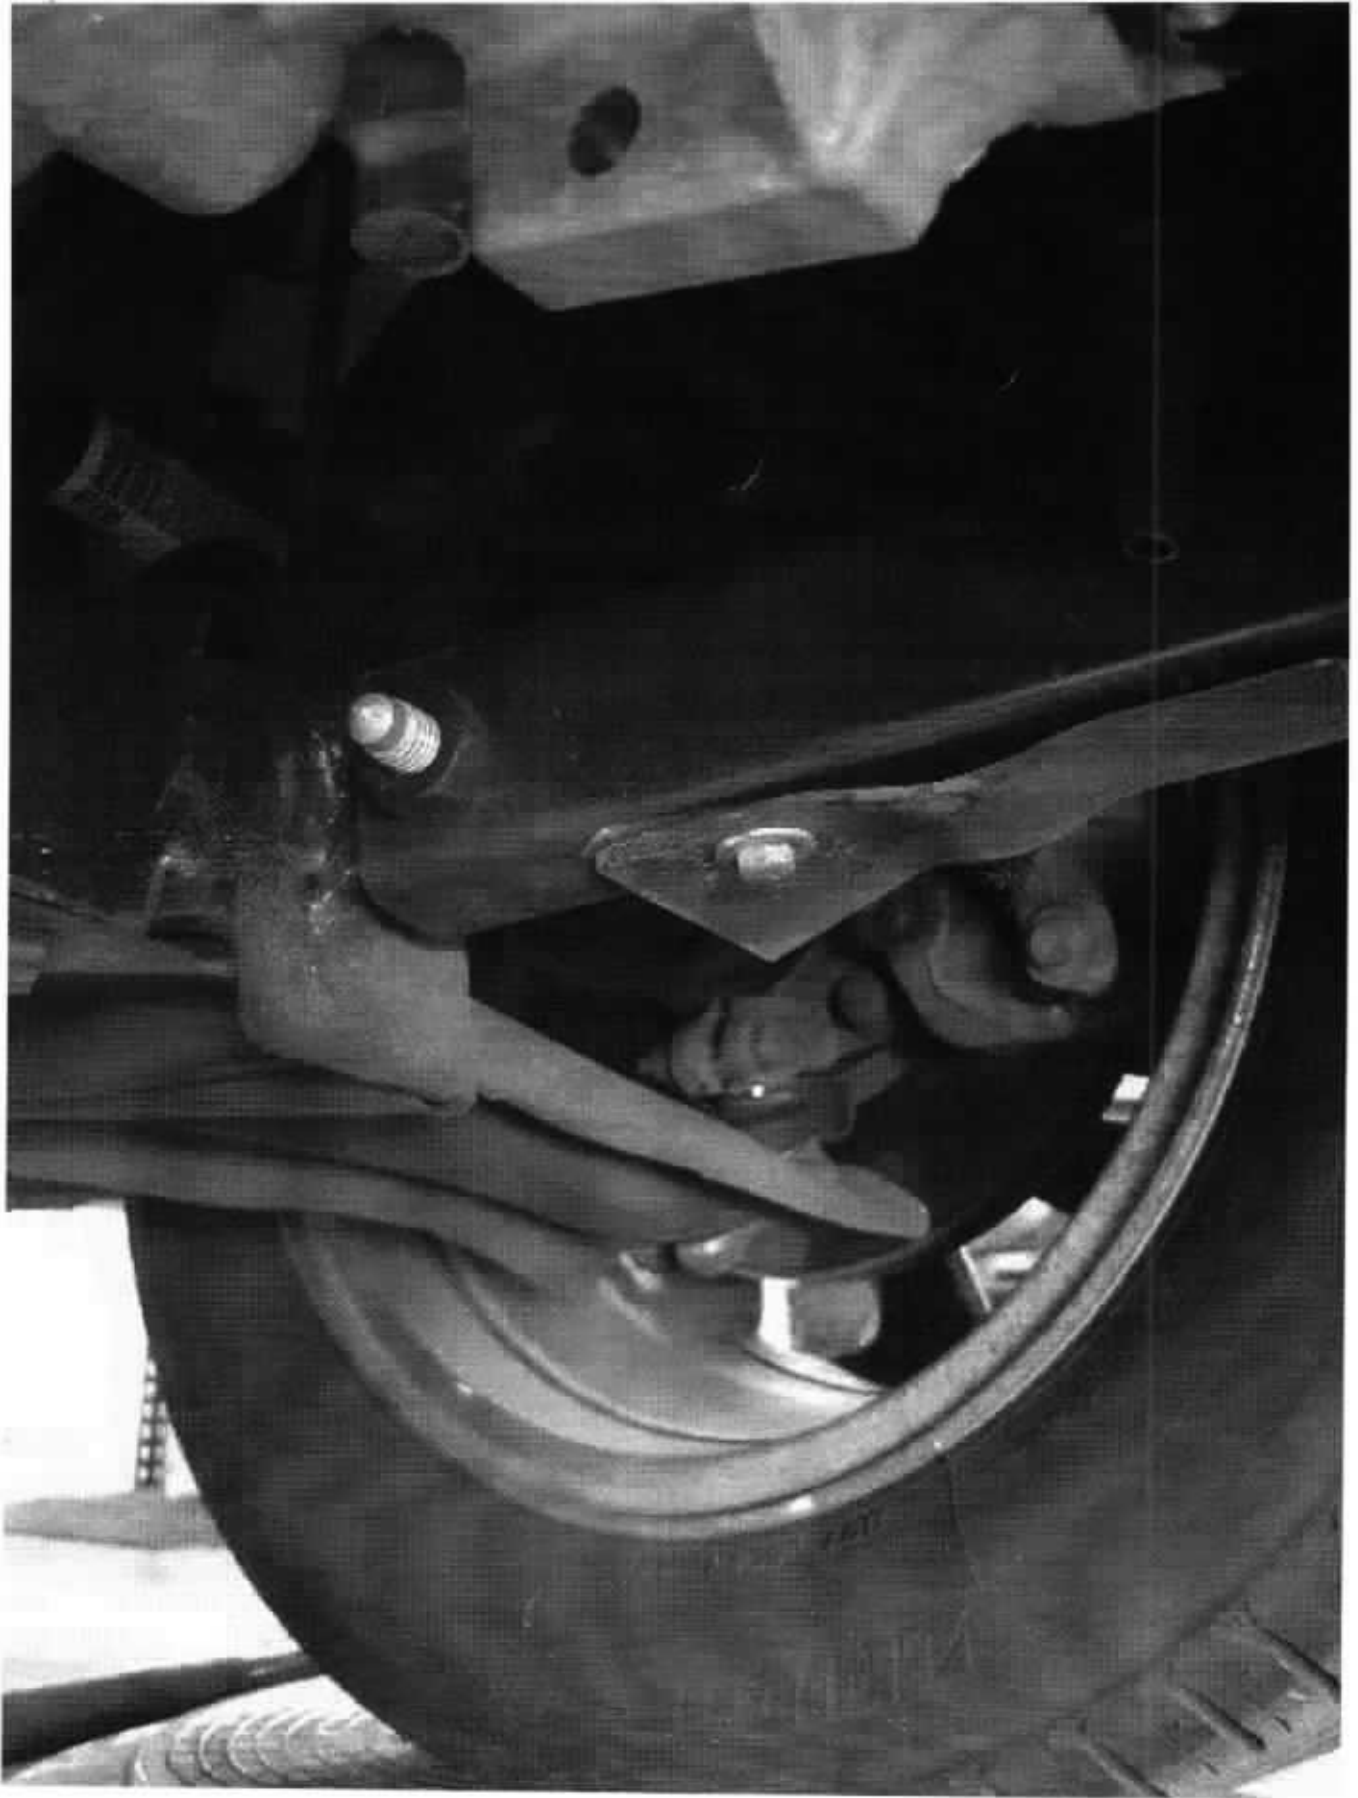
Accident Photo

The vehicle sustained impact / damages undercarriage and parts claimed are consistent to the accident.

| No. | Qty | Part No. | Particulars | Condition | Repairer's | Amount |
|---|---|---|---|---|---|---|
| 2 | 1 | | *FRT KNUCKLE ARM LH | Damaged | 778.00 FL | *778.00 FL |
| 9 | 1 | | *FRT STEERING RACK & PINION ASSY | Damaged | 3,900.00 FL | *3,900.00 FL |

| No | Particulars | Lab.Type | Repairer's | Amount |
|---|---|---|---|---|
| 3 | TO REMOVE AND REPLACE LHF UNDER CARRIAGE PARTS | New | 650.00 | 400.00 |
