VEHICLE DAMAGE INSPECTION REPORT

Our File No: CS/CT118008390/KSBQ2

Handling Insurer: China Taiping Insurance (Singapore) Pte. Ltd.	Policy No: DMPCSN3076421701	
Claimant Vehicle No: SGG4525G	Insured Vehicle No: SLD4208D	
Date of Loss: 05/05/2018	Nature of Claim: TP	Claim No: SNM18D02301C02

Reg No: SGG4525G	Engine No: 1NZX425955
Make & Model: TOYOTA VIOS, 1.5 (A)	Chassis No: MR053HY4204185903
Reg. Date: 11/05/2006 (Man. Year: 2006)	Odometer: 226288 km
Colour: Metallic Grey	
Engine Capacity: 1497 cc	
Market Value/New Car Price: N/A	
Sum Insured (S\$): Market Value/New Car Price

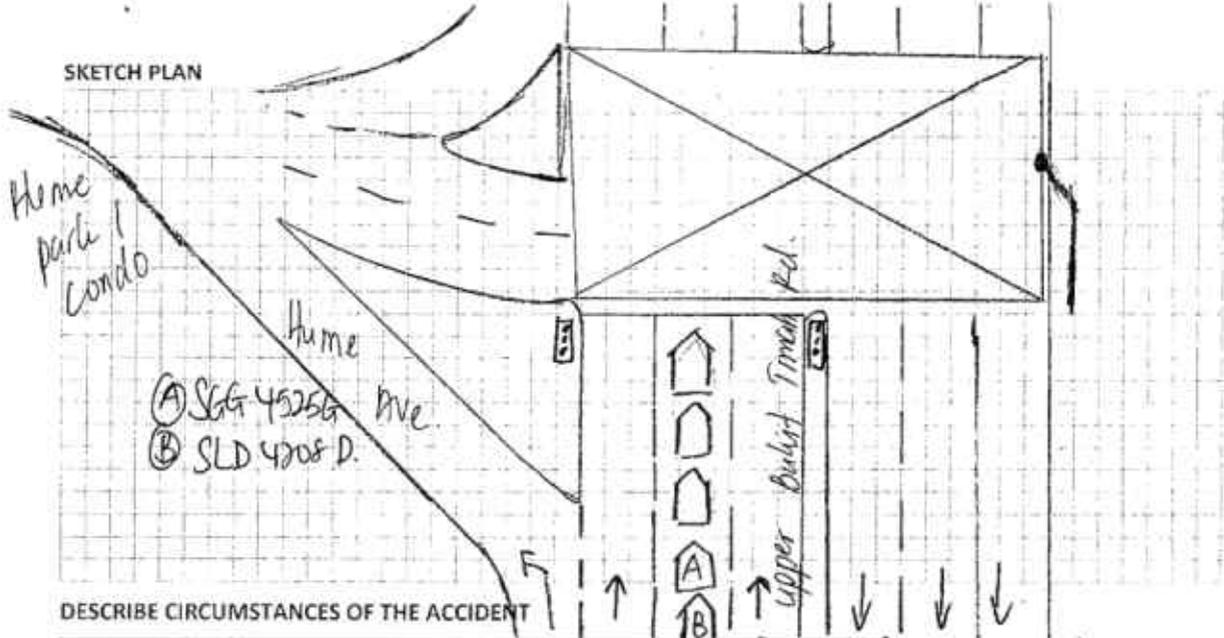
SKETCH PLAN

(A) SGG 45256 NVE.
 (B) SLD 4208 D.

All vehs was stationary at the traffic light junction.
 Suddenly I felt an impact. Veh B had hit the rear
 of my veh. No one was injured. I am filing this report
 for insurance claims.
