REPAIR ESTIMATE FOR TOYOTA DYNA 150 - 3.0 D 1KD (M) - GBG 9028

VEHICLE DAMAGE INSPECTION REPORT

Handling Insurer:	MSIG Insurance (Singapore) Pte. Ltd.	Policy No:	MSD/VPCP/17-001639
Claimant Vehicle No :	GBG9028B	Insured Vehicle No :	SLP8434C
Date of Loss:	04/05/2018	Nature of Claim:	TP
		Claim No:	MSC/V/18-000638

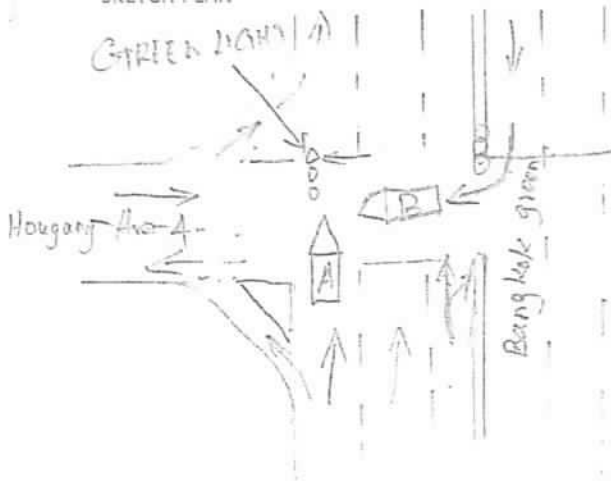
SKETCH PLAN

A car going Green light.

A - LORRY-GIBB 902E.

B- (AY-SLP-8439)

On 04-05-2018 at 1.30pm It was green light and
I was going ^{straight} towards byangkak green. SLP 8434C
Car suddenly turn right and hit my lorry. GBS 9028 B
