Affiliated to Federation Internationale Des Experts En Automobile				
CHINA TAIPING INSURANCE (S) PTE LTD		Ref : CS/CTI18009066/R1qd3		
3 ANSON ROAD #16-00 SPRINGLEAF TOWERS SINGAPORE 079909		Date : 18-05-2018		 
		Code : CTI

1. Policy Particulars :- THIRD PARTY CLAIM				
Insured Veh.	SLP 1806J	Veh. Inspected	SJX 3326X	
Policy No.	DMHCSN1739411700	Coverage (\$)	0.00	
Claim No.	SNM18D02426C02	Excess (\$)	0.00	
Assign From	MERIMEN (IRENE TAY)	Assign Date	18/05/2018

Vehicle No. : SJX3326X Submitted by : Ben
 Make & Model : Toyota Vellfire 2.4 COE expiry : 31-05-2020
 Chassis No. : _____ Engine No. : _____
 Date of survey : _____

VEHICLE DAMAGE INSPECTION REPORT

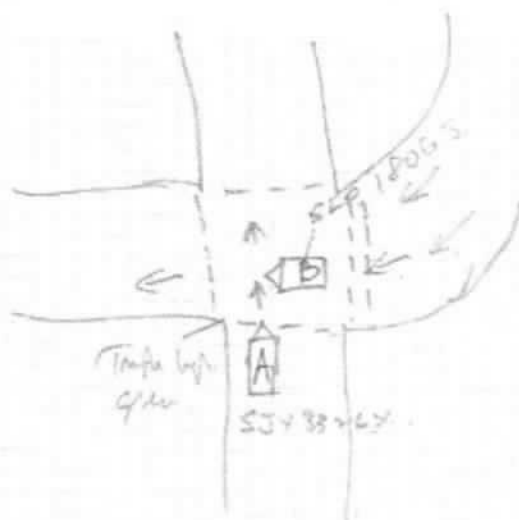
SKETCH PLAN

A = SJX 3326X

B = SUP 1806J

At 11:45. I was driving towards Adairth Road west towards junction of Sembang Road. In the lane of my green traffic light. All a sudden a Honda Civic car turning right into my lane and I hit the left side of the car.
