The U/C / Chassis frame / Body Structure affected due to collision.

**- PRE-REPAIR INSPECTION - ACCIDENT INVOLVING OUR INSURED VEHICLE
SLD614R AND SJH196H ON 20/05/2018**

VEHICLE DAMAGE INSPECTION REPORT

Our File No: CS3/AIG18009301/NZ4D3E2

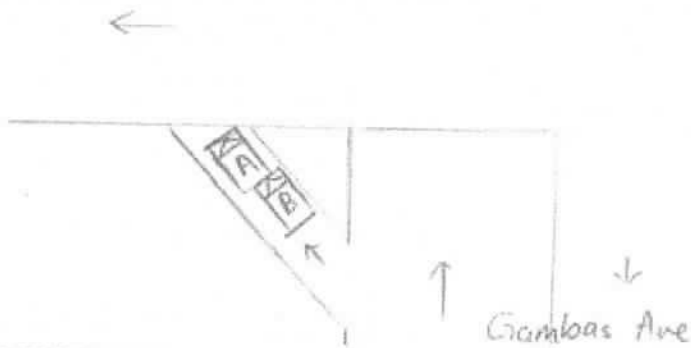
SKETCH PLAN

Woodlands Ave 12

Accident Date: 20-5-18

A = SJH196H

B = SLD614R

My vehicle was stopped at the slip road to give way to the main road traffic when SLD614R collided into the rear portion of my vehicle.
No one was injured.
