SCY 40S

Survey held at KING'S AUTO

- Pre repair inspection request - SCY40S VS SDR9618S (OI) DOA: 22/05/2018

VEHICLE DAMAGE INSPECTION REPORT

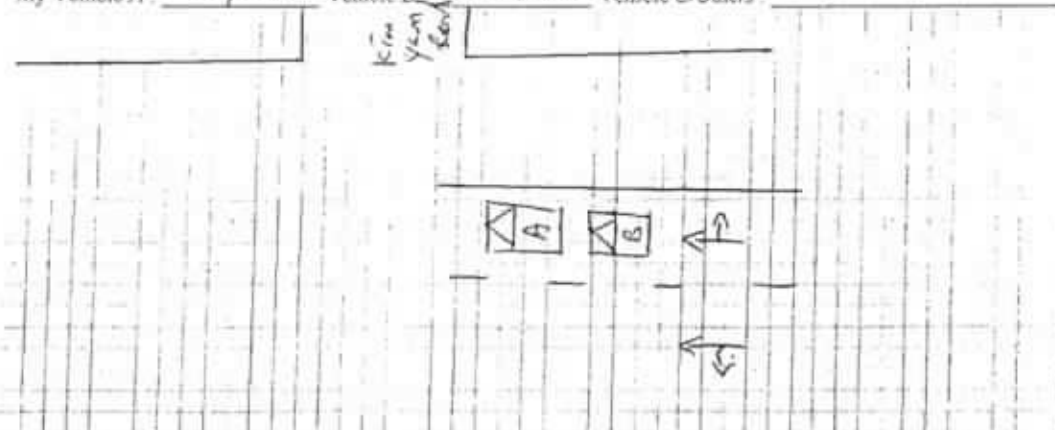
SKETCH PLAN

Date of Accident: 22/5/18 Time: 1955L Location: Petioir Valley Rd & Kim Yew Rd
 My Vehicle A: OCY 403 Vehicle B: SDR 9618S Vehicle C/Others: _____

- 1) Front vehicle did not turn on "right indicator signal", but suddenly slowed down to turn right.
- 2) I reacted accordingly to avoid a collision and slowed down.
- 3) Spit second later, I was hit on the rear by vehicle SDR 9618S.
