ASSESSMENT OF REPAIRS AND SPARE PARTS COSTS

## ACCIDENT DAMAGED VEHICLE INSPECTION REPORT

Date : 08 June  
Our Ref : WG/TP/2018-176

Registration No : SFR8879M  
Make : B.M.W.  
Model : 216D GRAN TOURER LED NAV 7  
Year : 2018

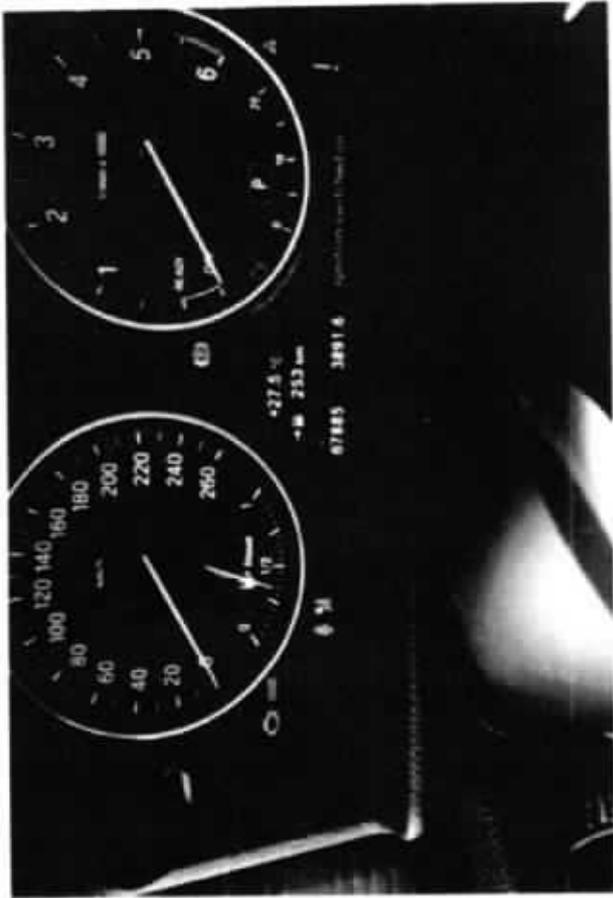
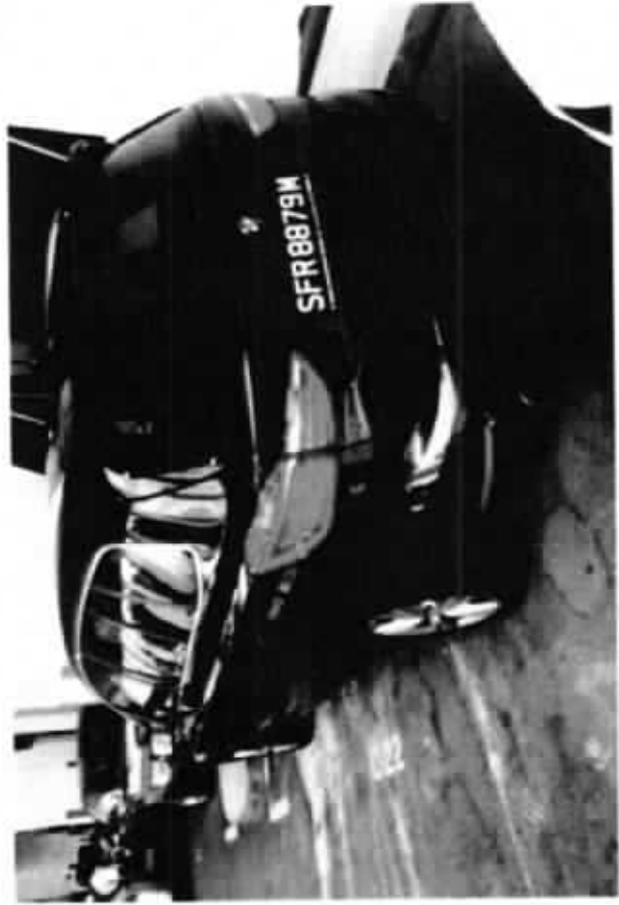
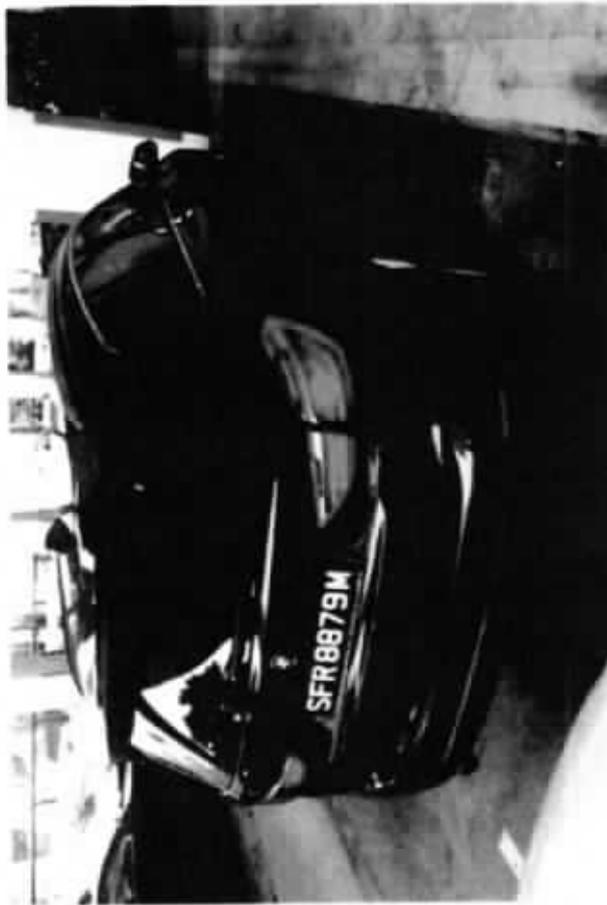
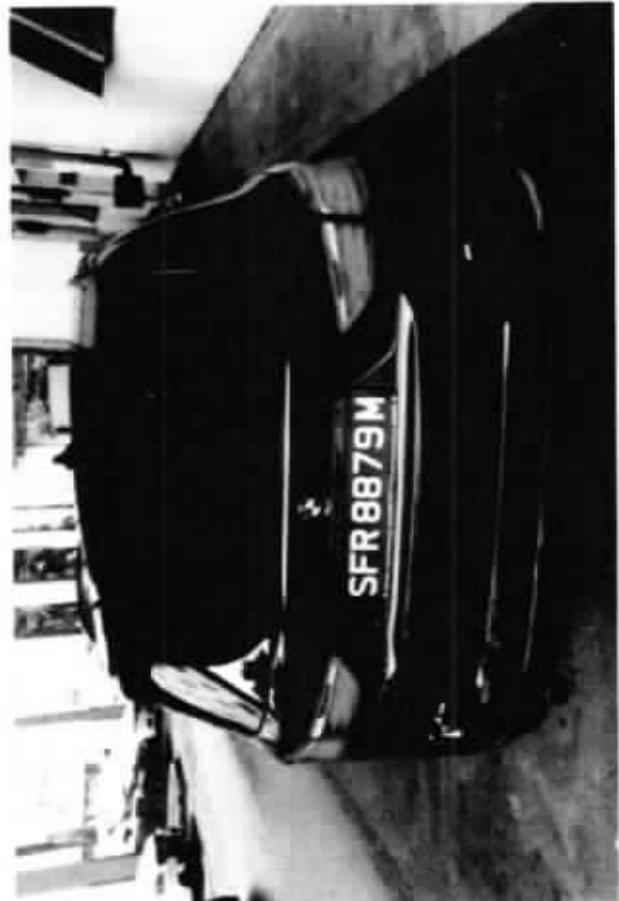
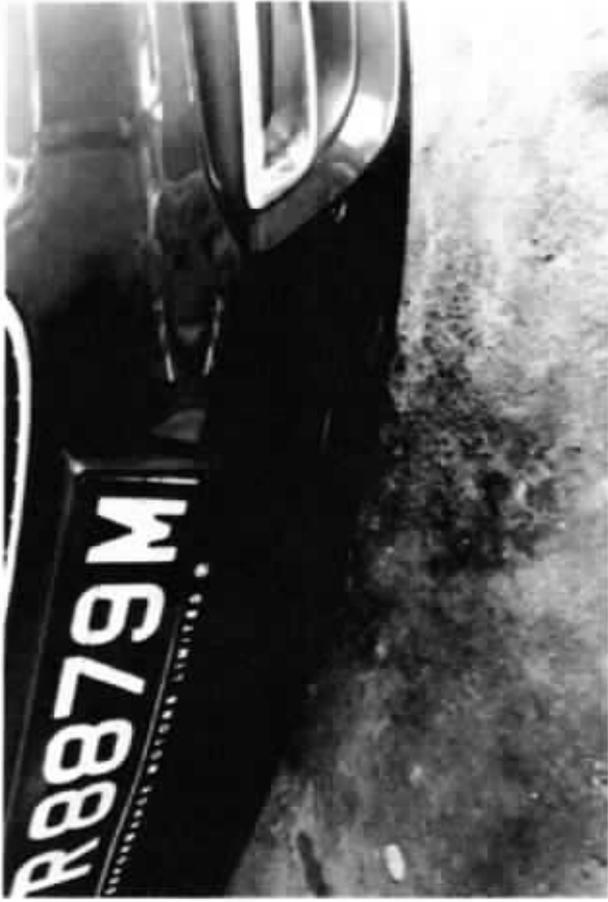
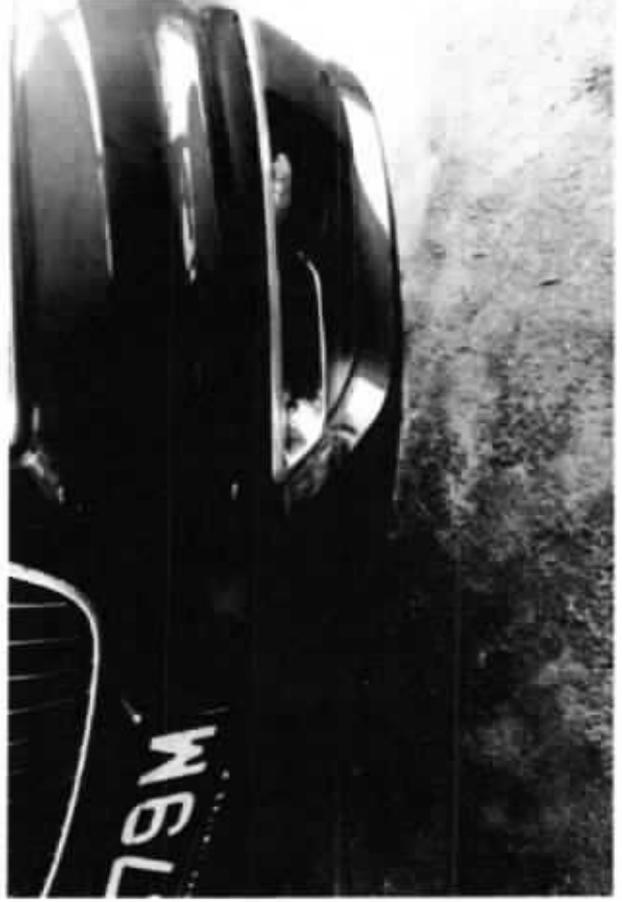
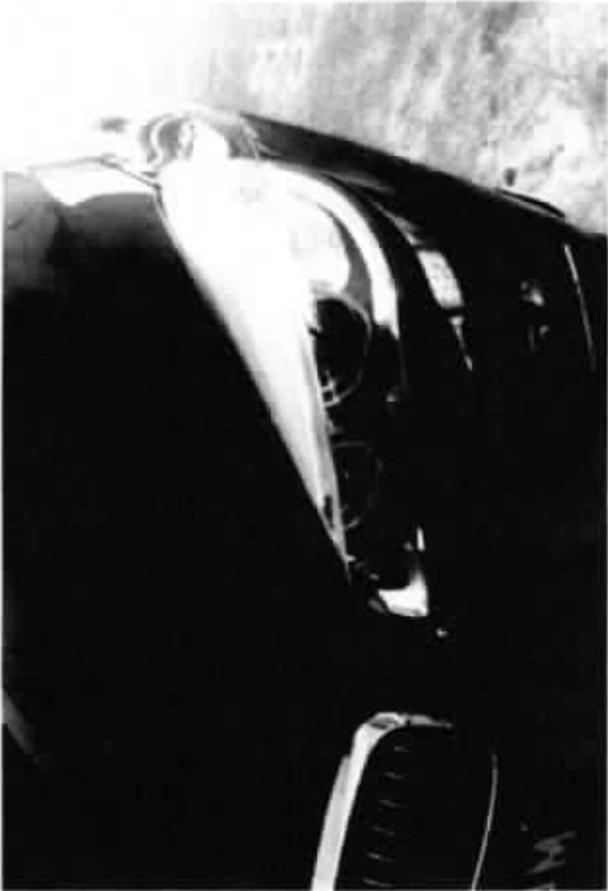
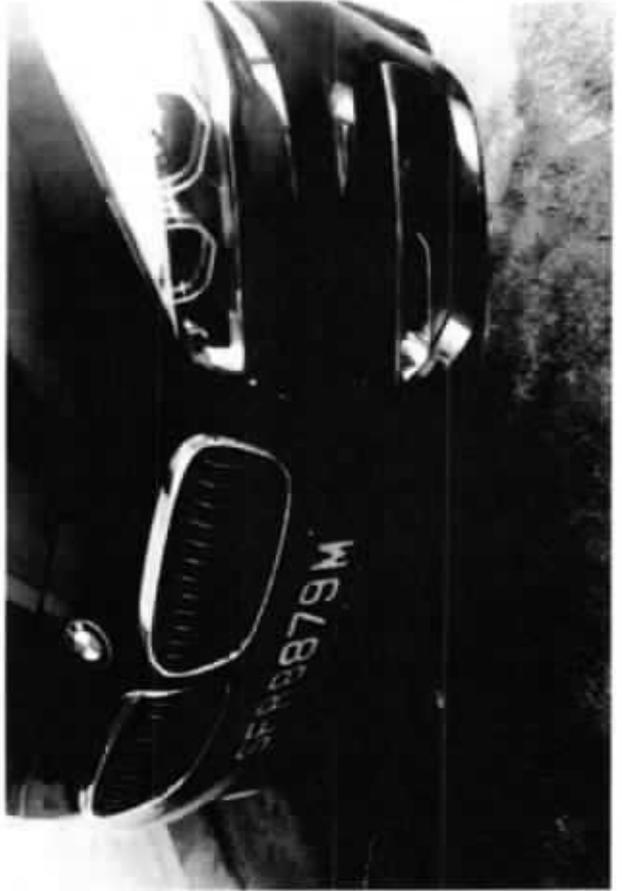
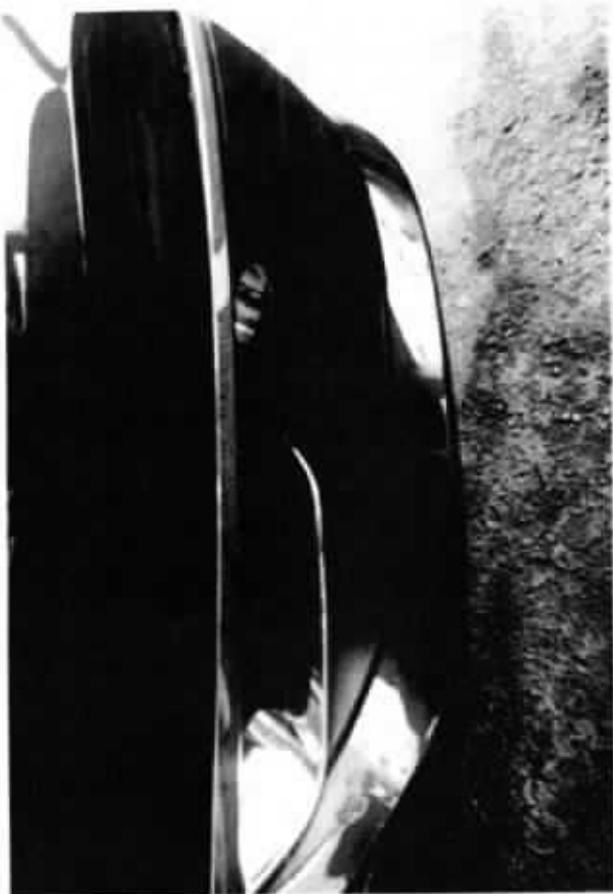
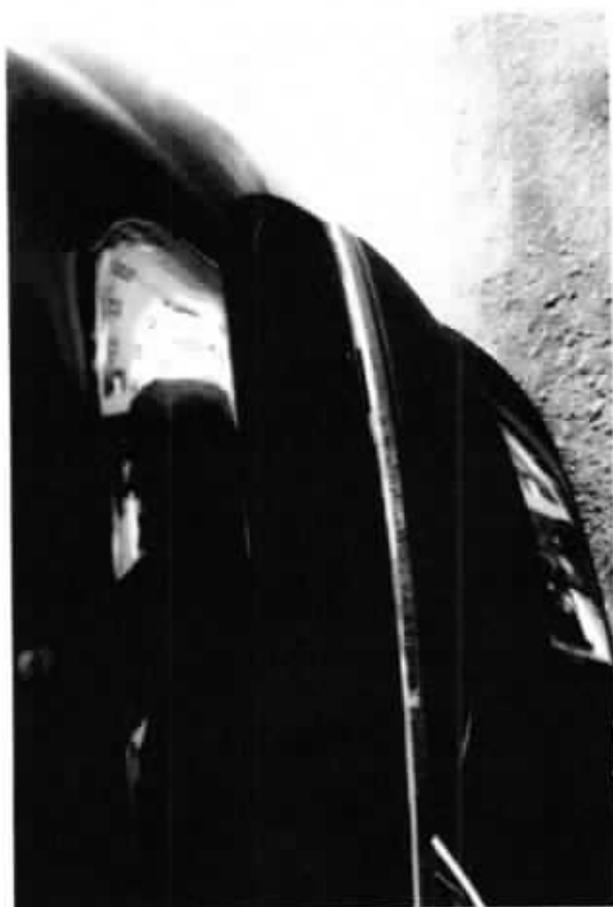
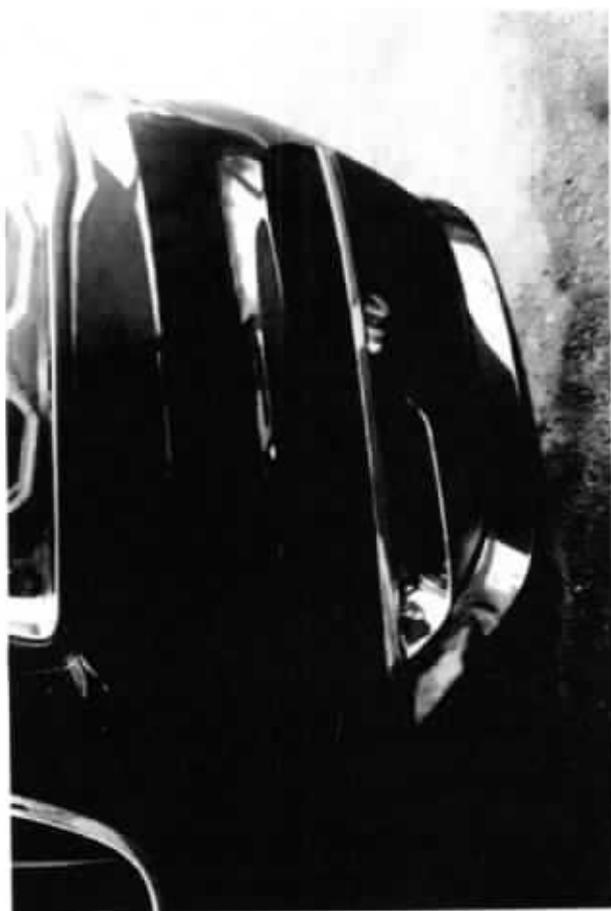
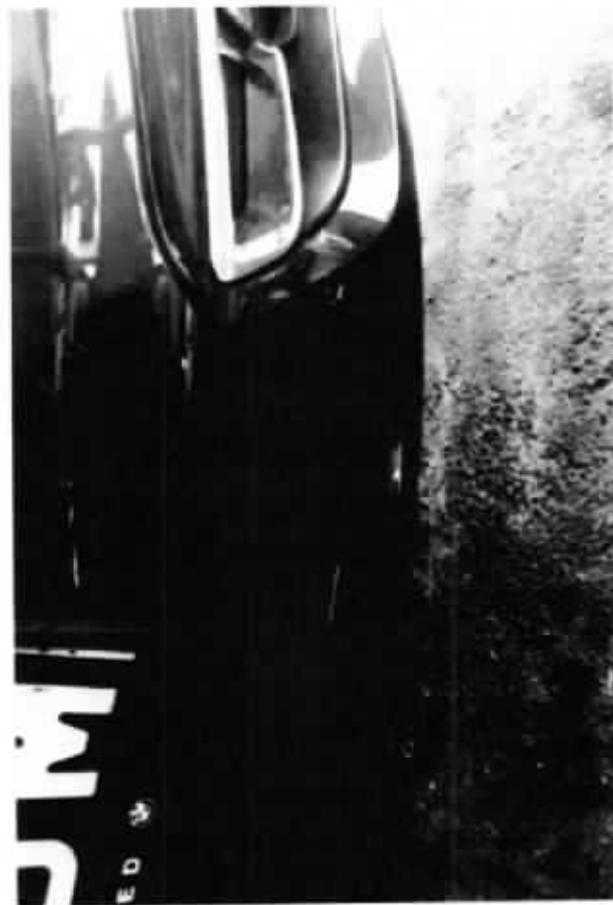
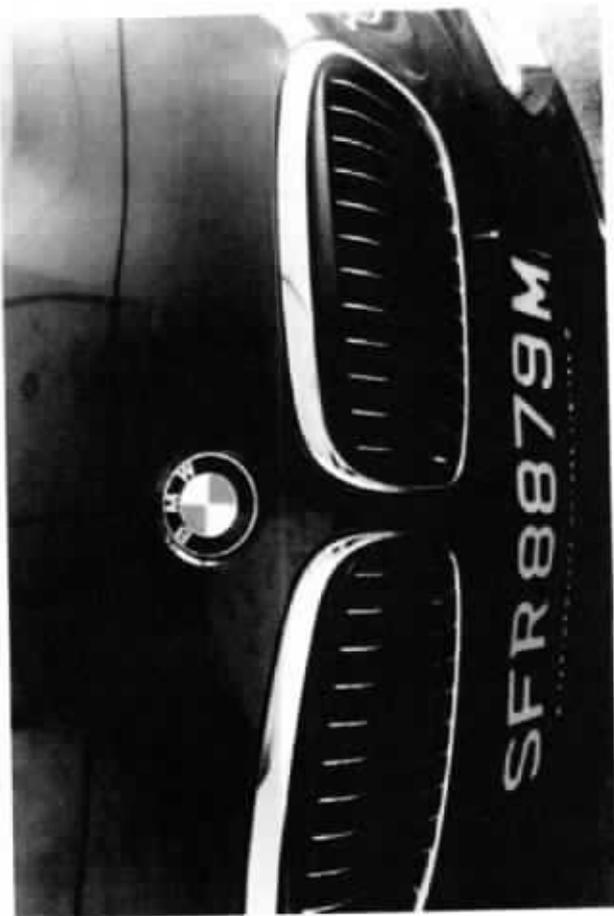
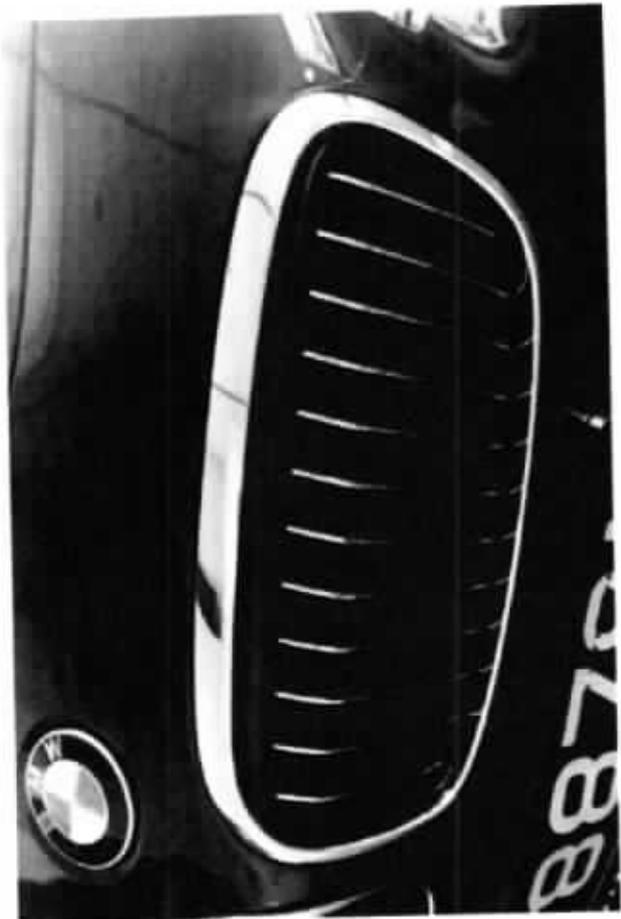
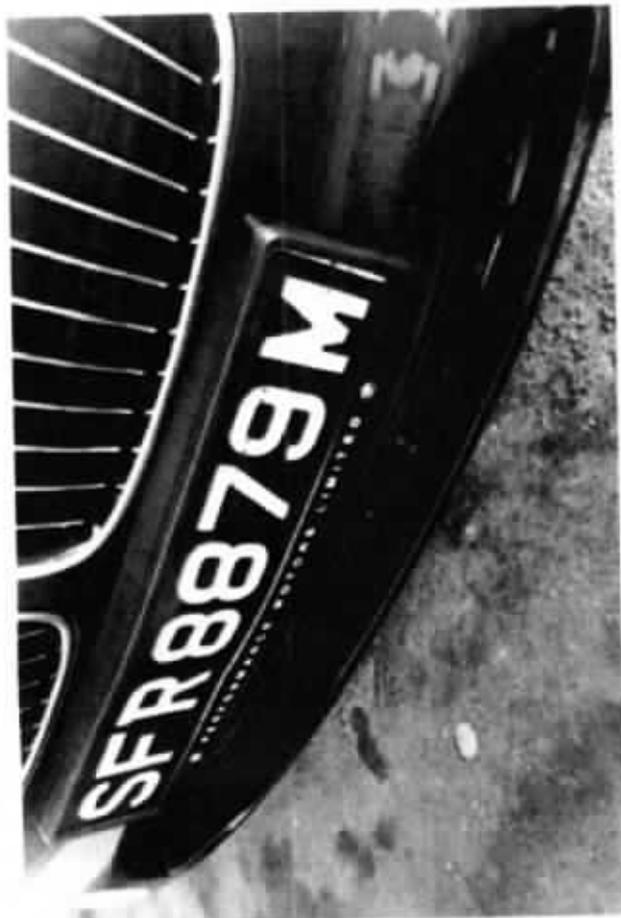
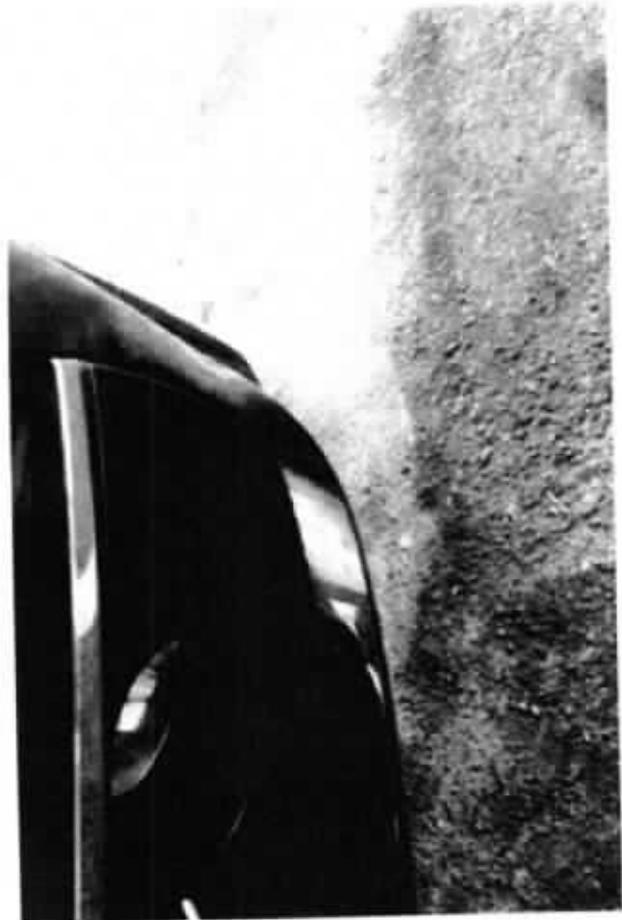
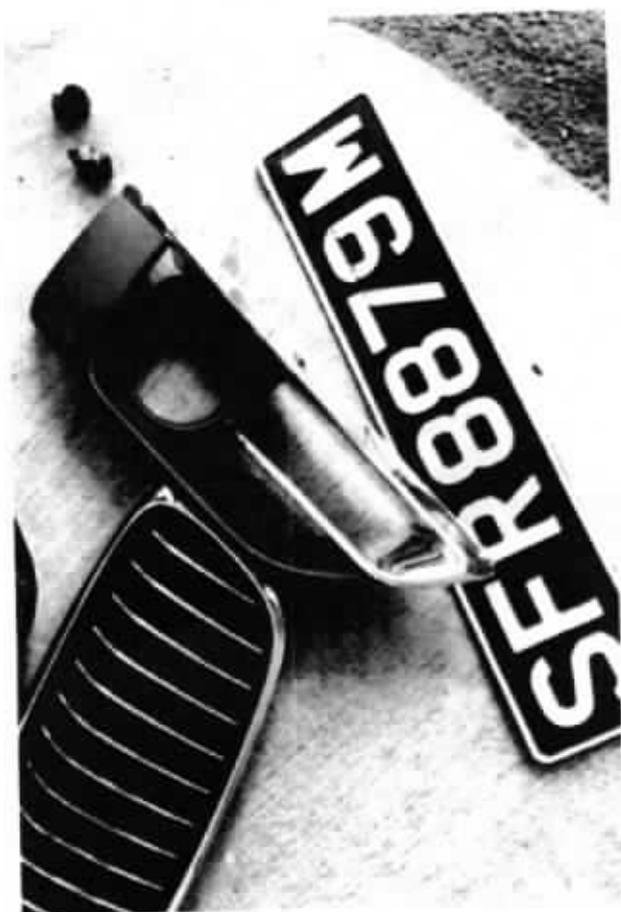
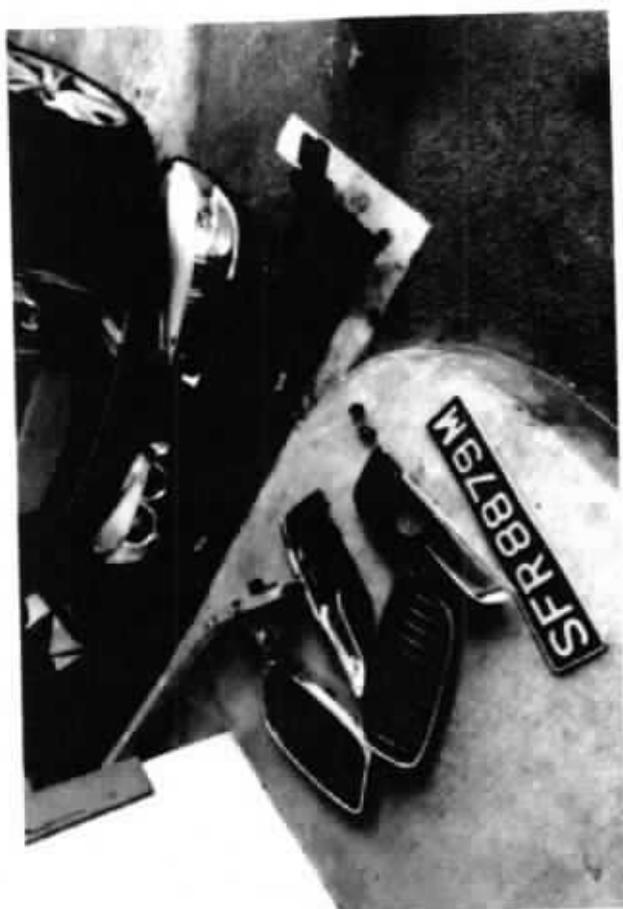
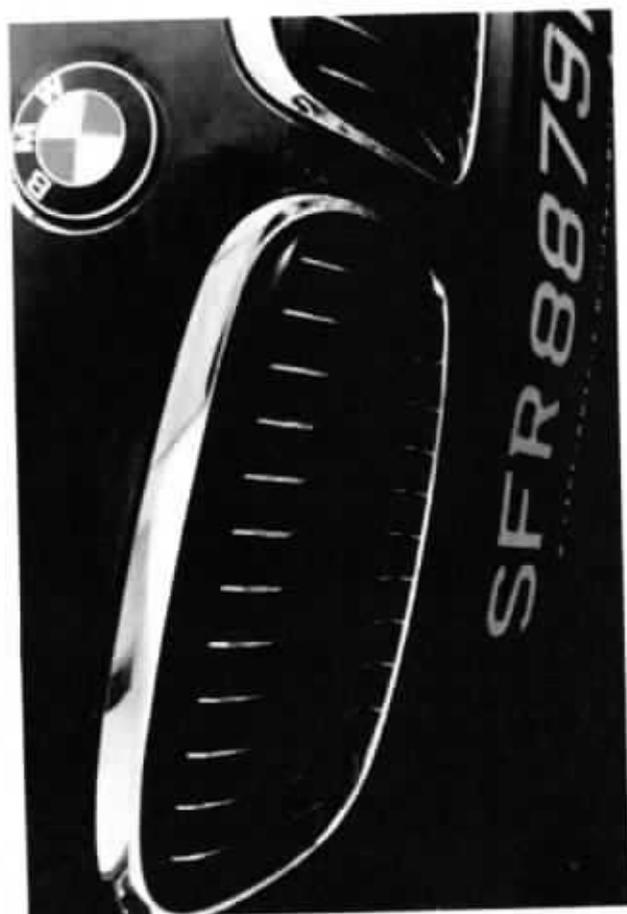
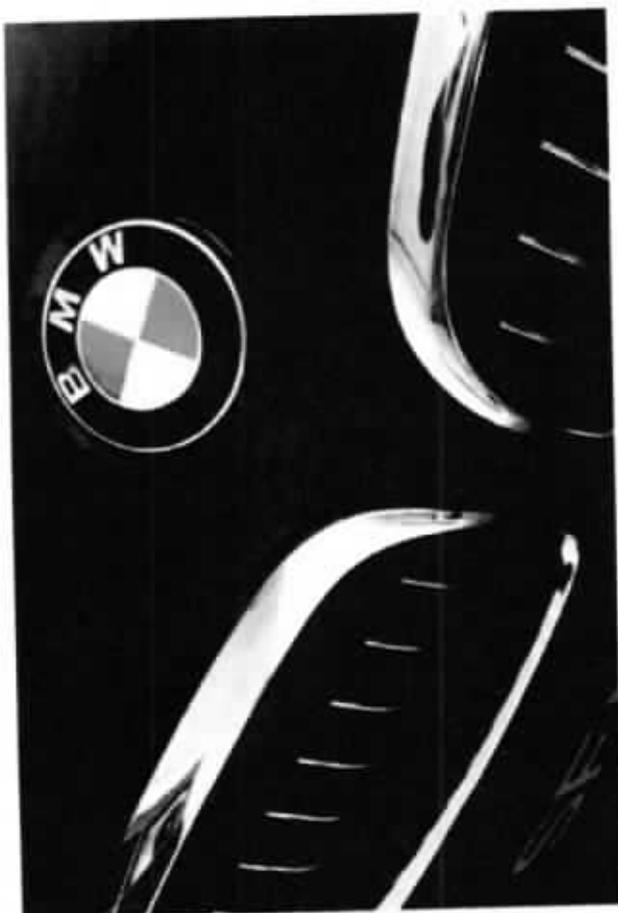
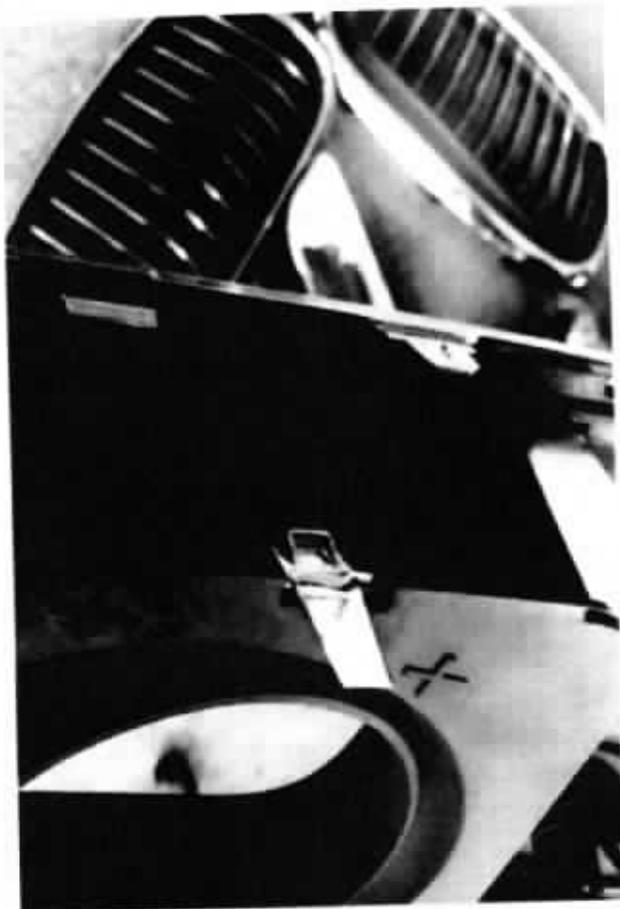
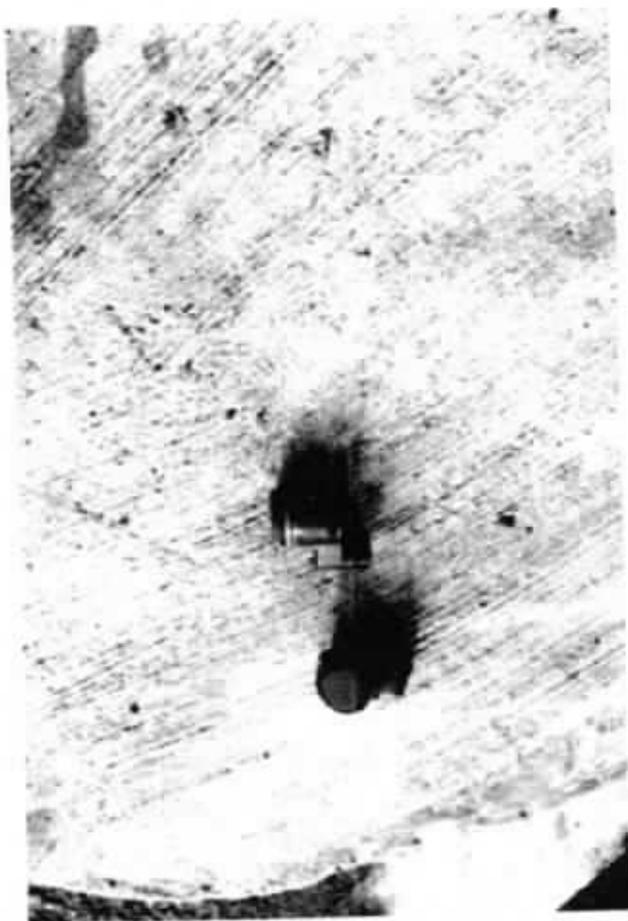
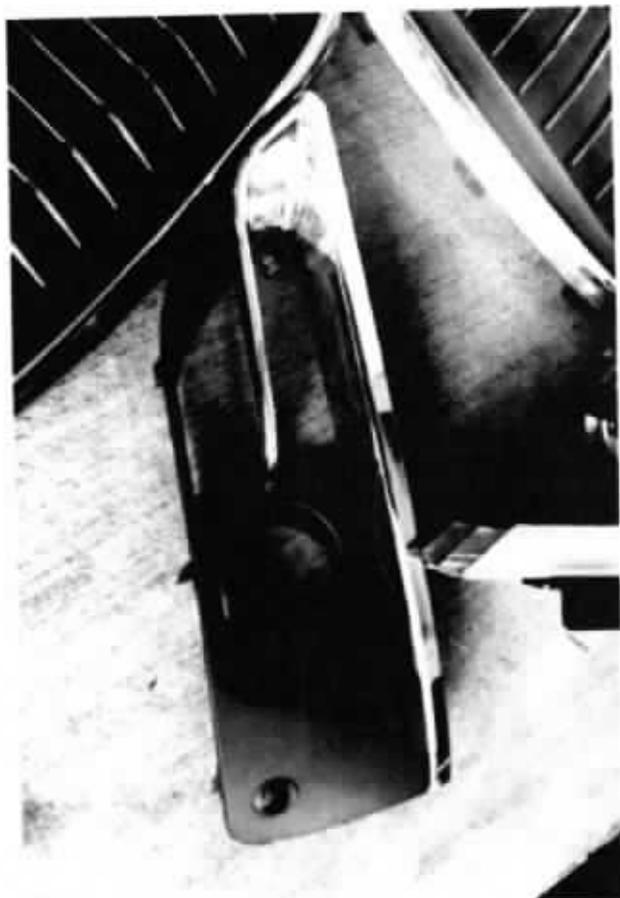
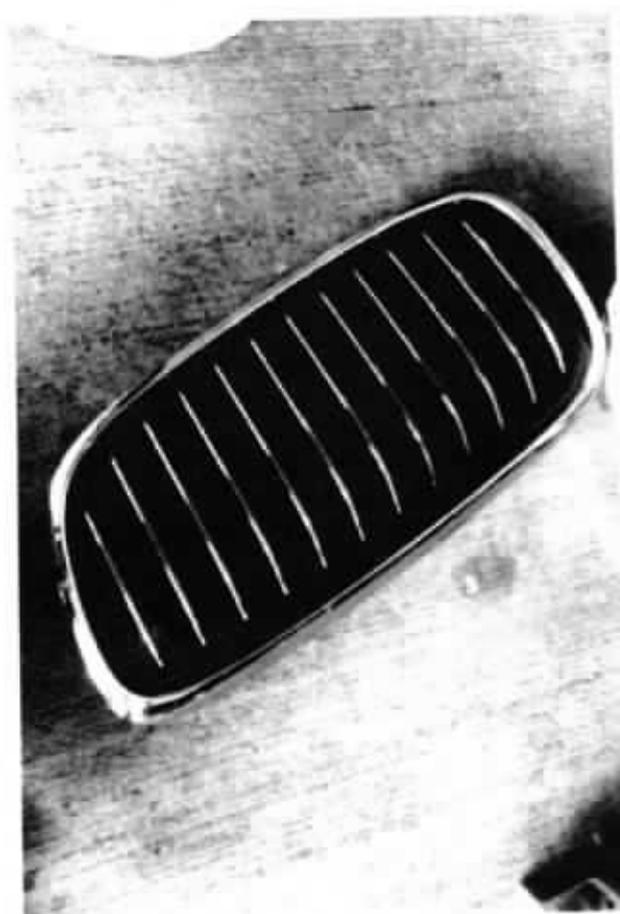
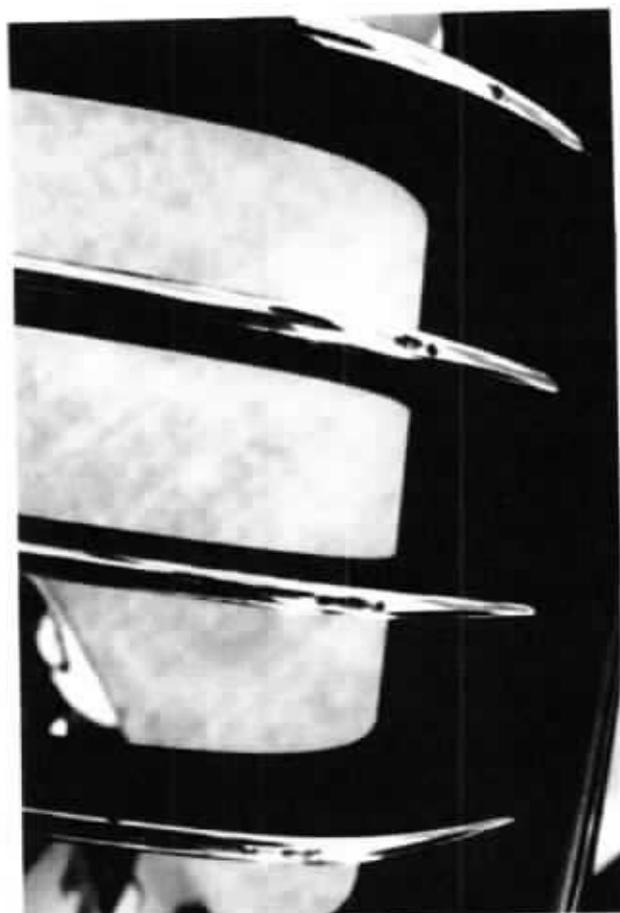
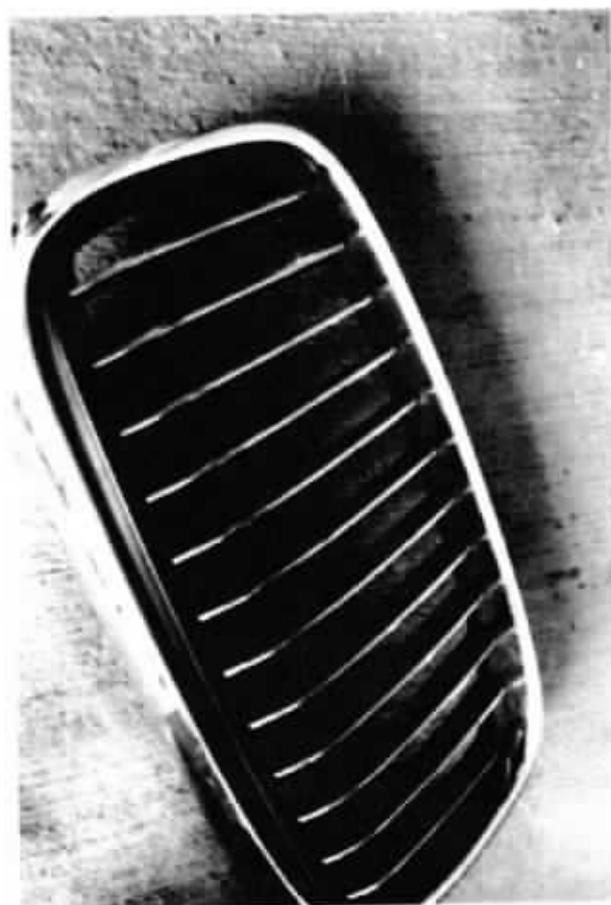
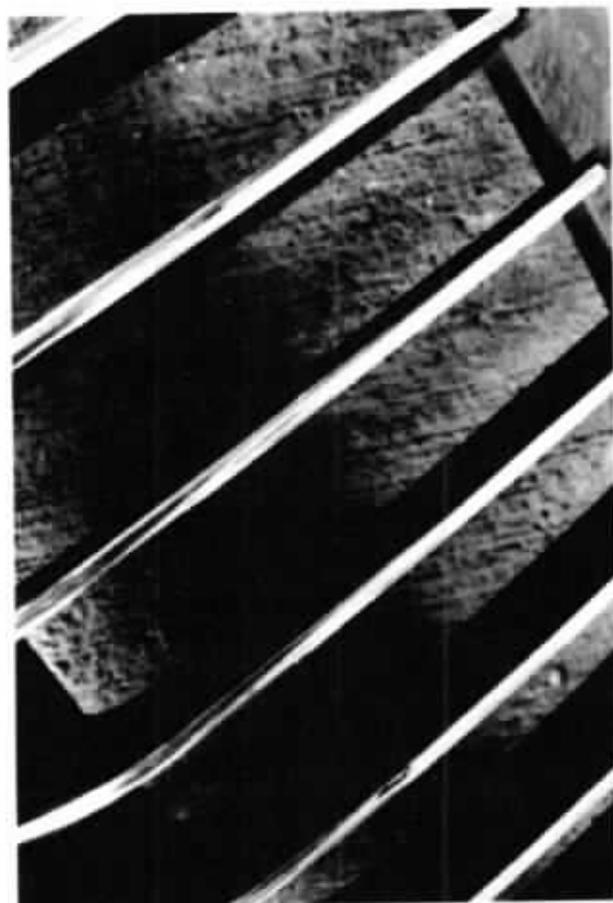
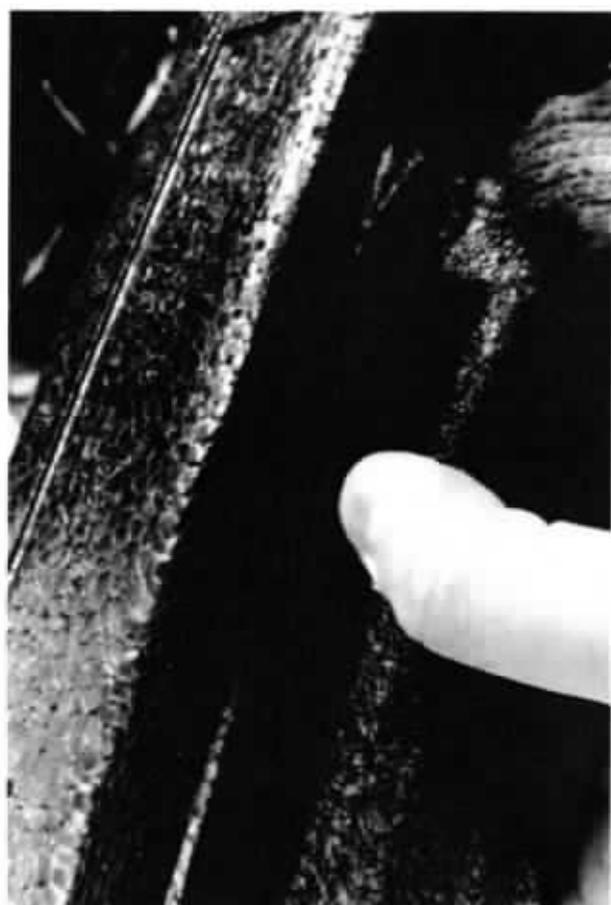
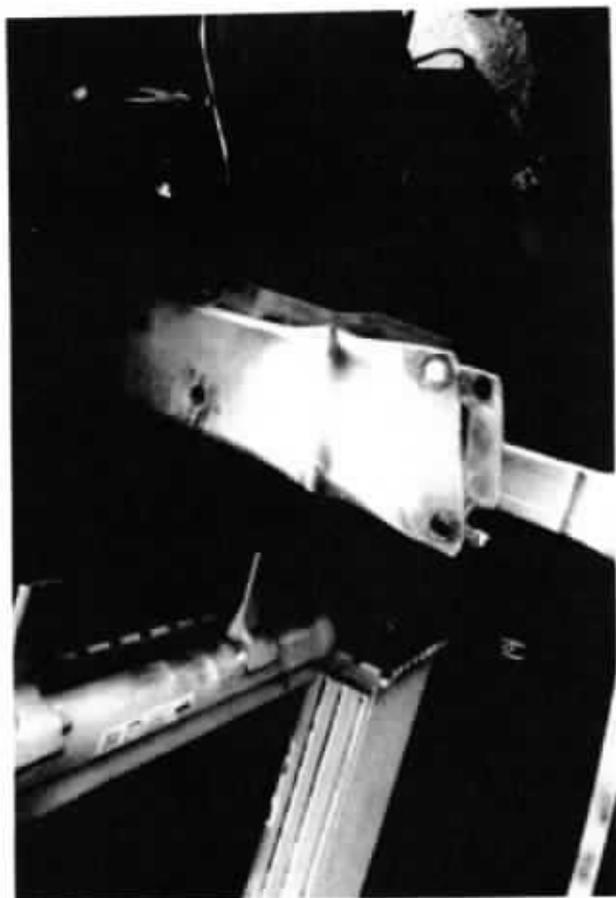
Enclosed Forty ( 40 ) photographs depicting damage to the vehicle.

DESCRIPTION OF PARTS AND NATURE OF REPAIRS	QTY	ASSESSED CONDITION	ORIGINAL QUOTATION		REVISED QUOTATION	
			PC/SET			
<b>SPARE PARTS</b>						
1 FRONT HEADLAMP	2	CRACKED	\$	7,600.00	\$	7,600.00
2 FRONT BUMPER	1	CRACKED	\$	1,930.00	\$	1,930.00
3 FRONT BUMPER RETAINER	2	NECESSARY	\$	250.00	\$	250.00
4 FRONT GRILLE LH	1	GRAZED	\$	280.00	\$	280.00
5 FRONT GRILLE RH	1	GRAZED	\$	280.00	\$	280.00
6 FRONT GRILLE BASE	1	NOT NECESSARY	\$	397.00	\$	-
7 FRONT BUMPER INNER GUIDE	1	CRACKED	\$	515.00	\$	515.00
8 FRONT BUMPER REINFORCEMENT	1	DENTED	\$	629.00	\$	629.00
9 FRONT BUMPER SPONGE	1	CRACKED	\$	158.00	\$	158.00
10 FRONT LH FOG LAMP	1	NOT NECESSARY	\$	340.00	\$	-
11 FRONT LH FOG LAMP COVER	1	CRACKED	\$	290.00	\$	290.00
12 FRONT RH BUMPER REINFORCEMENT BRACKET	1	NOT NECESSARY	\$	175.00	\$	-
13 FRONT LH BUMPER REINFORCEMENT BRACKET	1	DENTED	\$	175.00	\$	175.00
14 FRONT BUMPER LOWER GRILLE	1	NOT NECESSARY	\$	414.00	\$	-

The impact was confined to the front portion of the vehicle.  
The damages appeared to be consistent as per the accident report statement.  
Please refer the attached schedule and photographs for details.

The vehicle sustained damage at the front portion.  
For details, refer to assessment for repairs and photographs attached.

Our assessment of the repair costs to pre-accident condition was **S\$18,500.00** nett at lump sum basis.(Subject to GST if applicable)  
Under normal circumstances, estimated period required for repairs : Five ( 05 ) working days.
