LKK Auto Consultants Pte Ltd

Insured Veh.	GBE 4377L	Veh. Inspected	SLS 324Z
Policy No.	28857437MKC	Coverage (\$)	0.00
Claim No.	559777	Excess (\$)	0.00
Assign From	MERIMEN (CHRISTINA WONG)	Assign Date	31/05/2018

Accident Date	26/05/2018	Inspection Date	31/05/2018
Survey held at	T K MOTOR WORKSHOP BLK 1 KAKI BUKIT AVE 6 #02-56 SINGAPORE 417883

VEHICLE DAMAGE INSPECTION REPORT

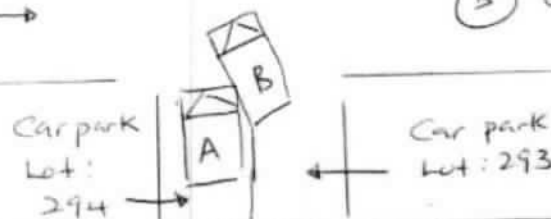
Sketch Plan

Blk 124, Honggang Ave 1 Carpark Lot No: 294.

(A) SLS 324 Z

(B) GBE 4377 L

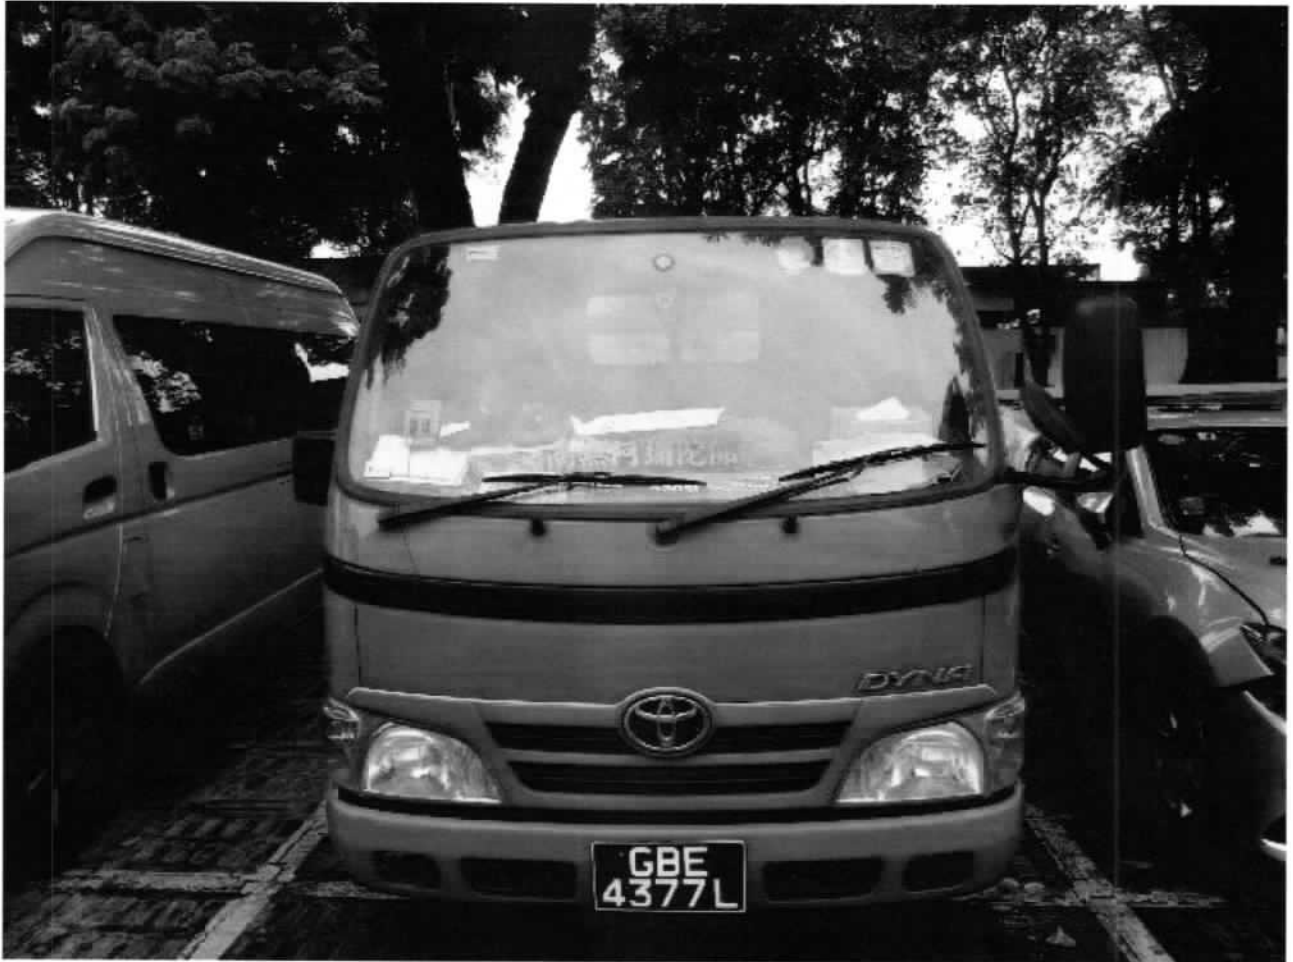
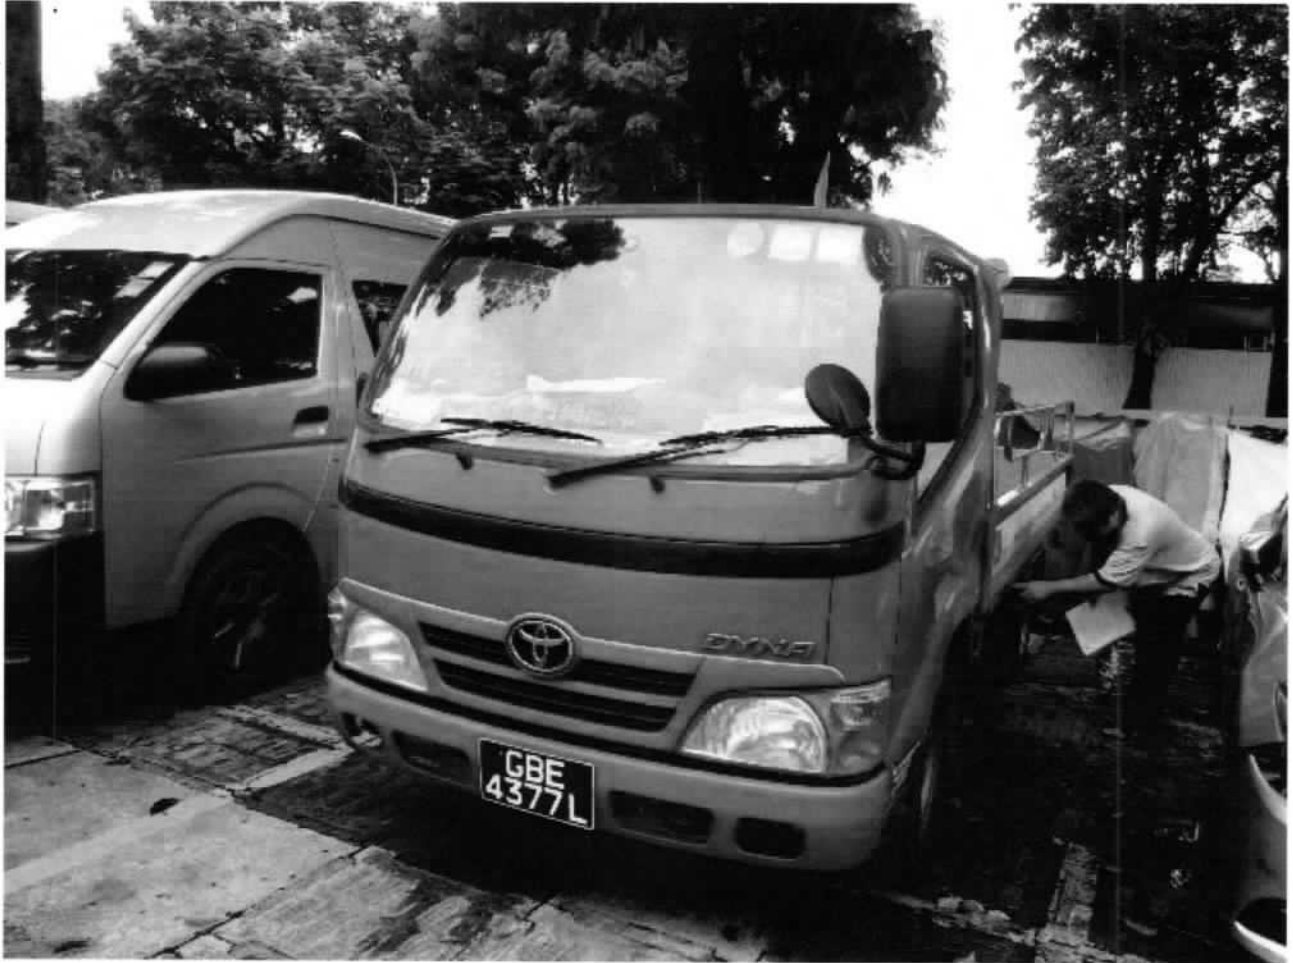
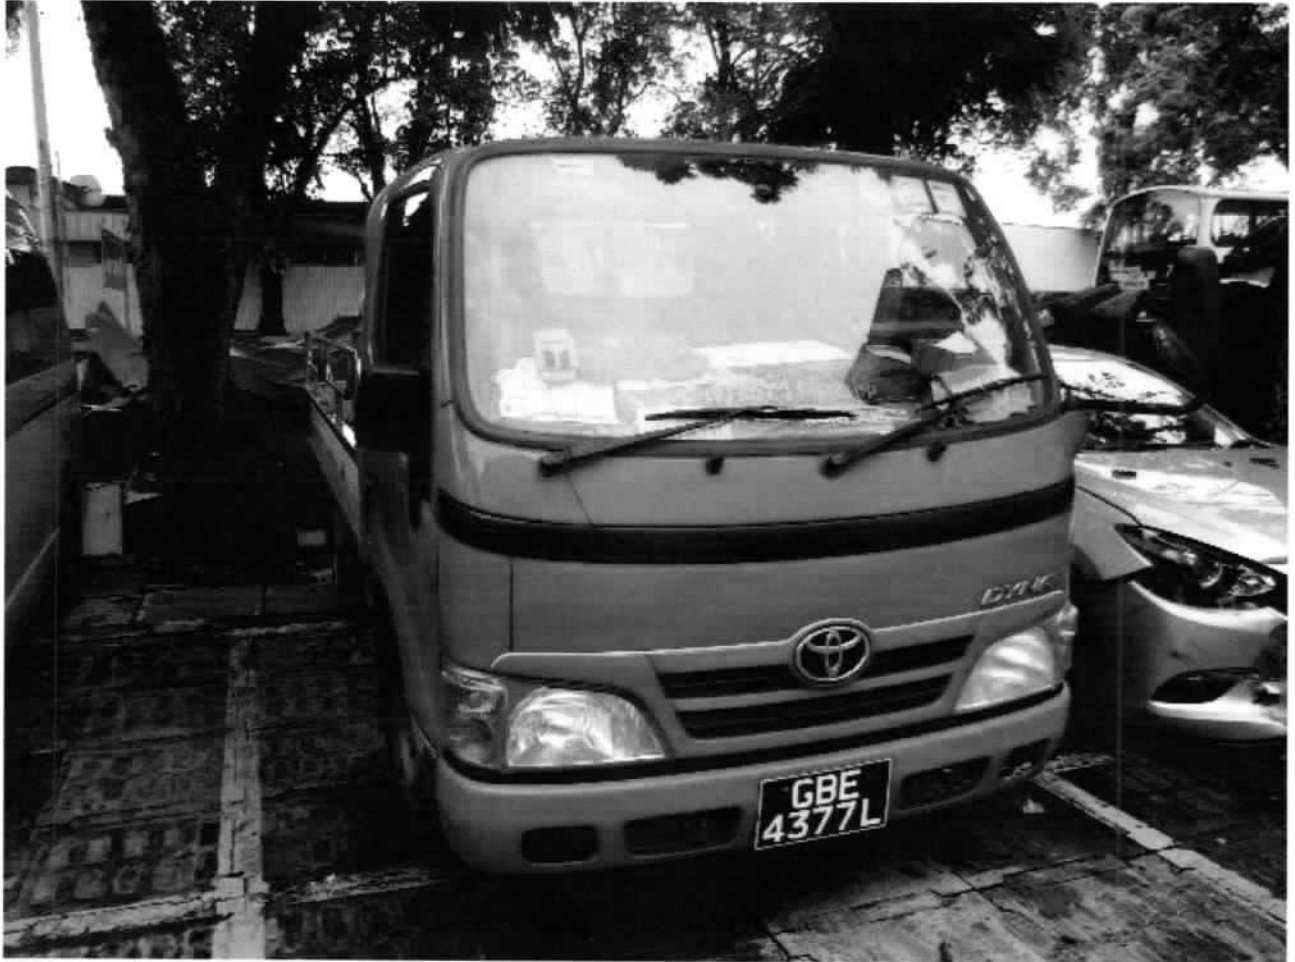
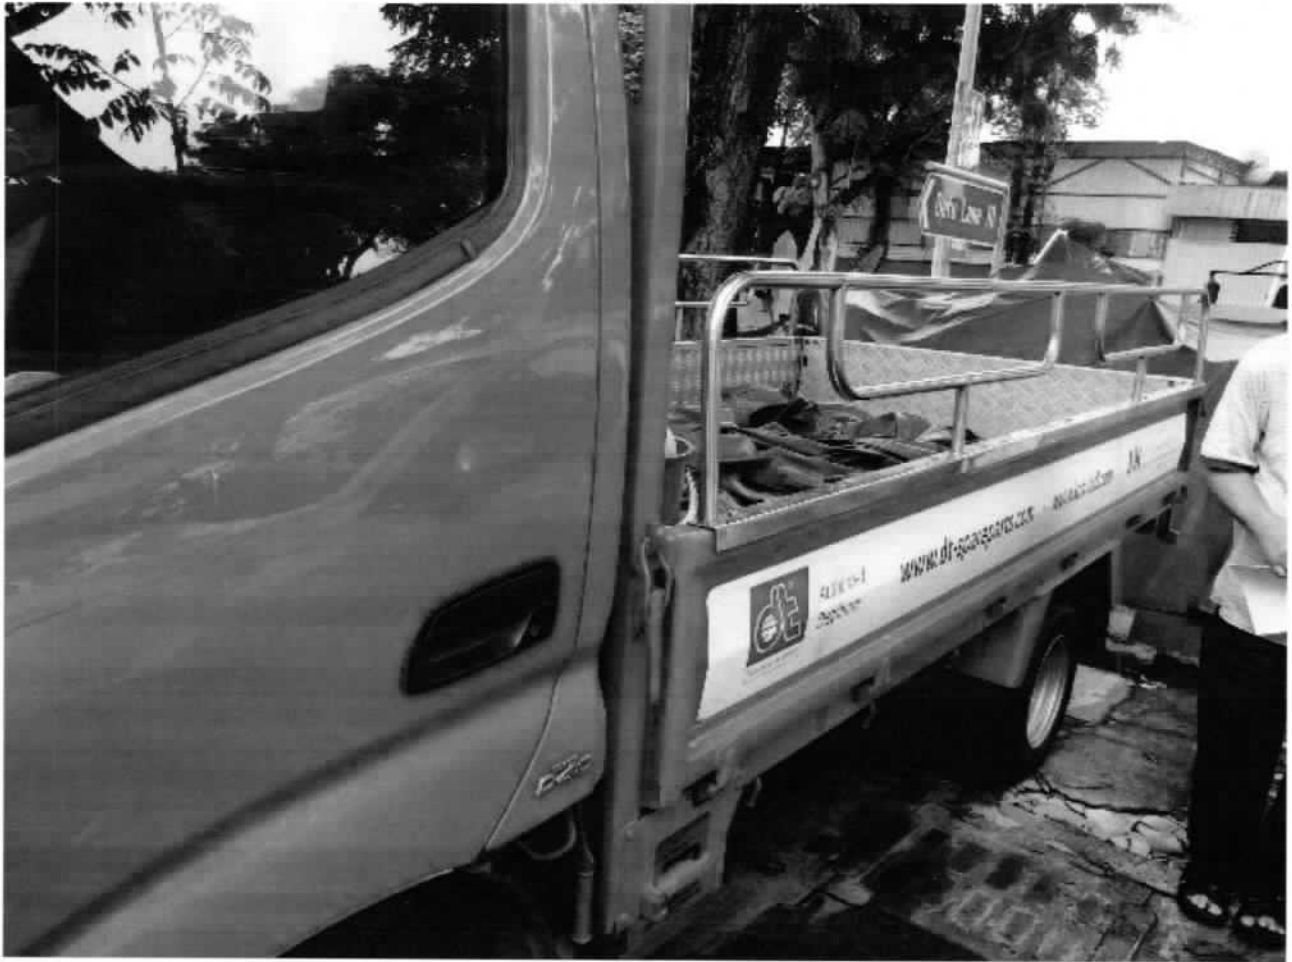
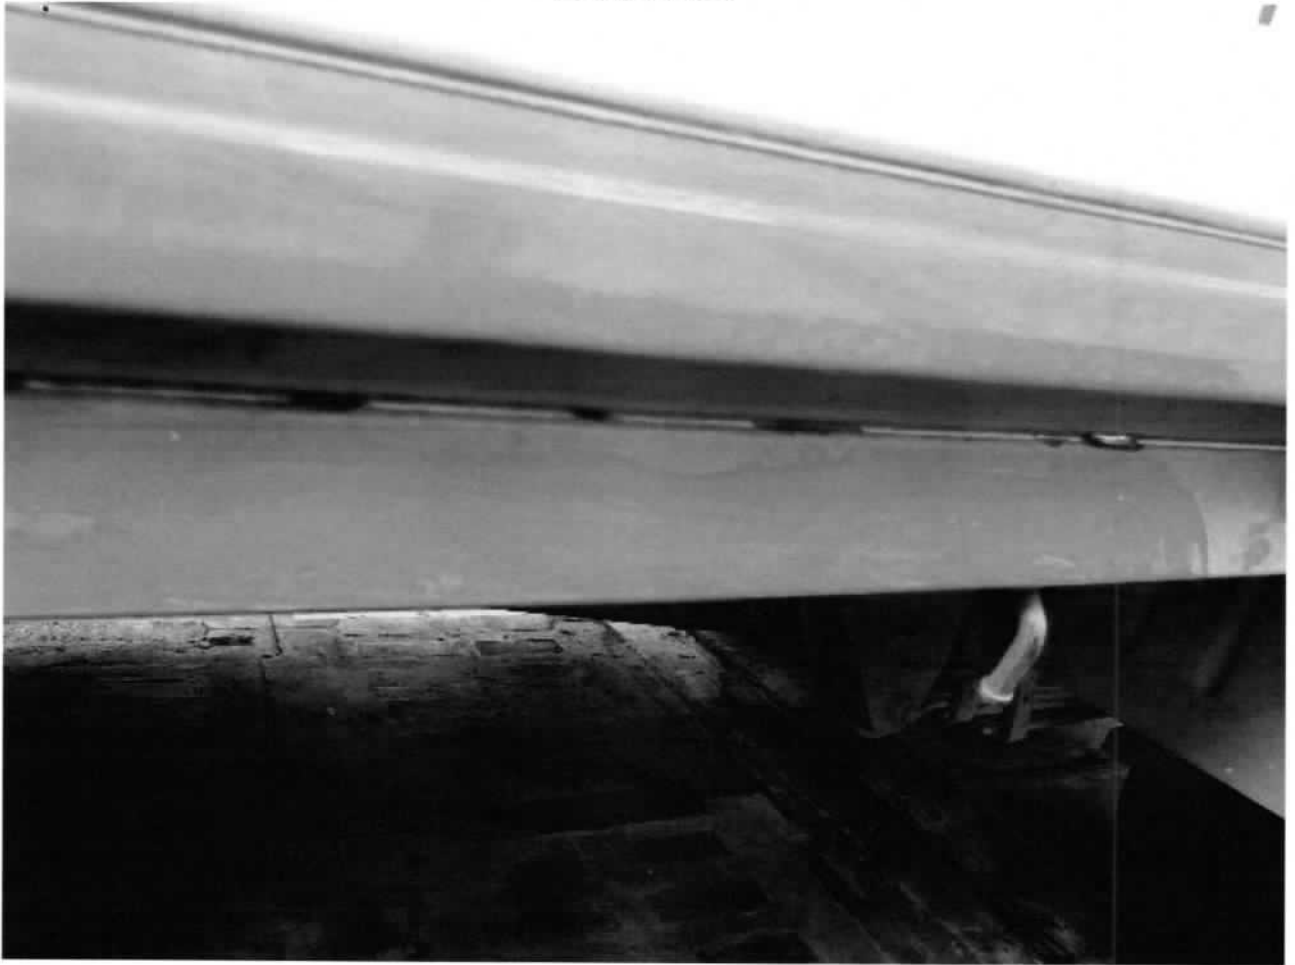
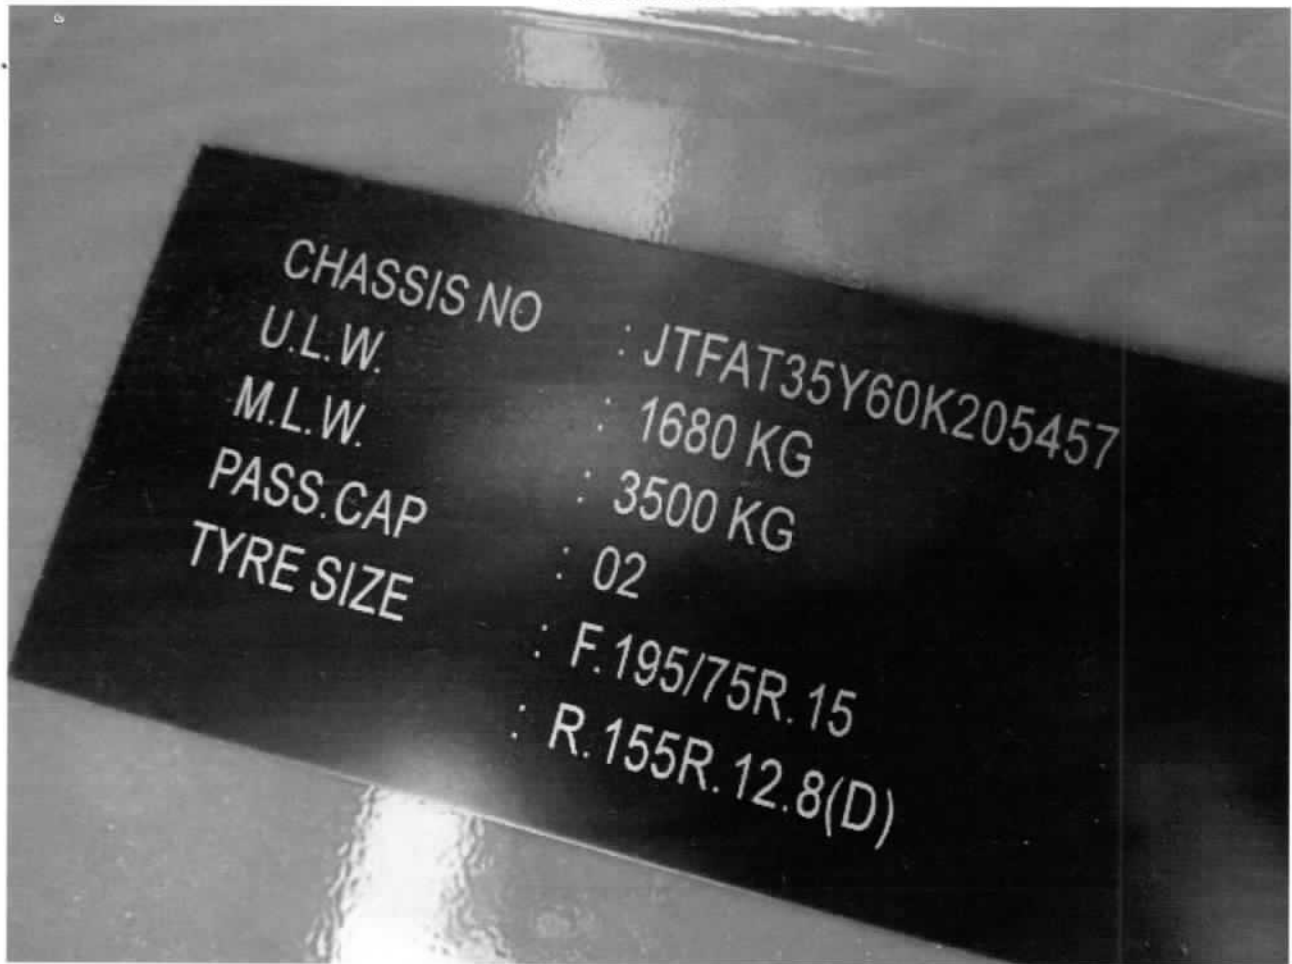
Accident Photo

The U/C / Chassis frame / Body Structure affected due to collision.

The lorry damaged my front right side and my bonnet of my vehicle .
