**ACCIDENT INVOLVING SJG7600S & SLS4646T ON 01 JUNE 2018 ALONG U-TURN OF SENTOSA GATEWAY AT ABOUT 0830 HOURS**

# LKK Auto Consultants Pte Ltd

## 1. Policy Particulars :- (THIRD PARTY CLAIM)

## VEHICLE DAMAGE INSPECTION REPORT

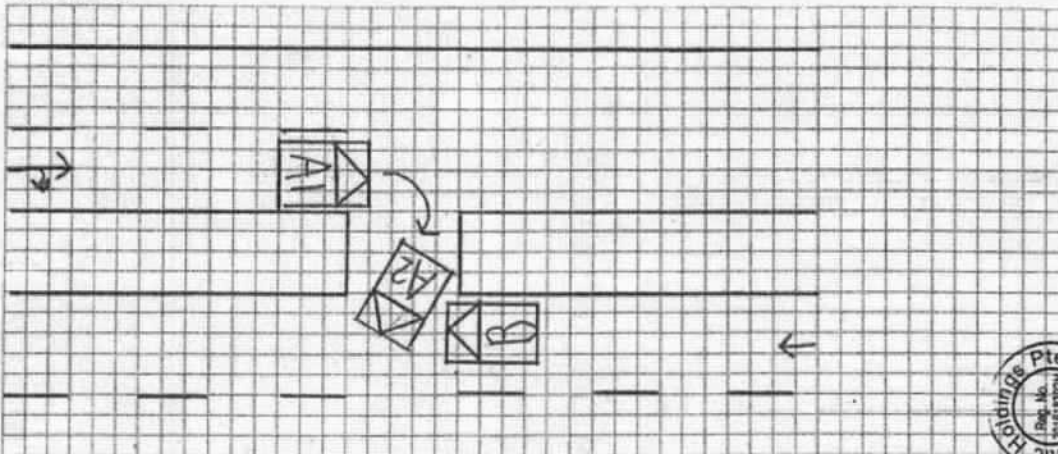
## SKETCH PLAN

WHILST MAKING A U-TURN WITH THE GREEN-ARROW IN MY FAVOUR, SUDDENLY  
 VEH 'B' WHICH EARLIER WAS ON THE OPPOSITE LANE BLATANTLY BEAT THE  
 RED LIGHTS AND COLLIDED ONTO MY LEFT HAND SIDE PORTION.
