SGW 8500S

# LKK Auto Consultants Pte Ltd

Ref : CS/MSG18010267/Atd3

## VEHICLE DAMAGE INSPECTION REPORT

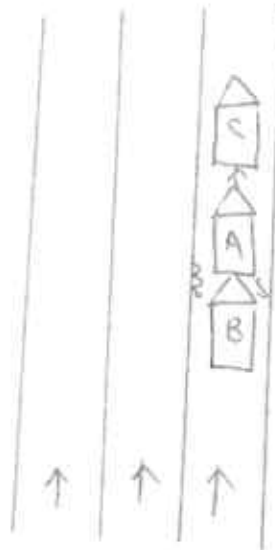
SKETCH PLAN

- A) SGW 85005
- B) SJP 121G
- C) SFS 1089S

AT 1005AM ON 1ST JUNE 2018, MY CAR SGW85005 WAS TRAVELING ON BRADDELL RD RIGHT LANE.

WHEN I STOP MY CAR DUE TO THE CAR STOP, THE CAR BEHIND HIT ME, CAUSING MY CAR TO HIT THE FRONT CAR.

THE CAR BEHIND IS A WHITE HONDA CIVIC SJP121G.
