TP Claims against NTUC Income: Follow-Through Survey

NTUC INCOME INSURANCE CO-OPERATIVE LTD Ref: NS/INC18010959/K1rb

1. Policy Particulars :- THIRD PARTY CLAIM

ADJUSTMENT ON REPAIR COST FOR VEHICLE NO. SHC 8054G

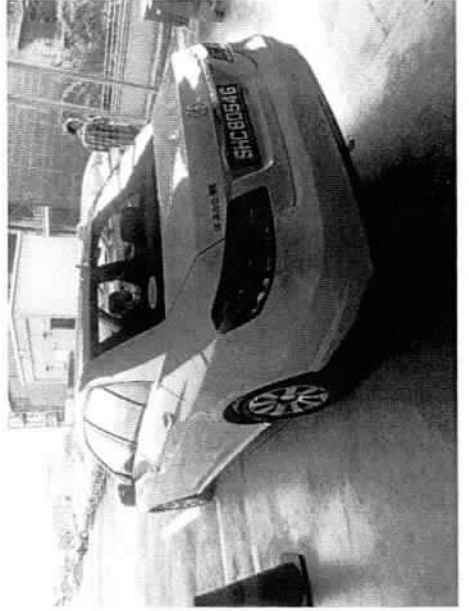
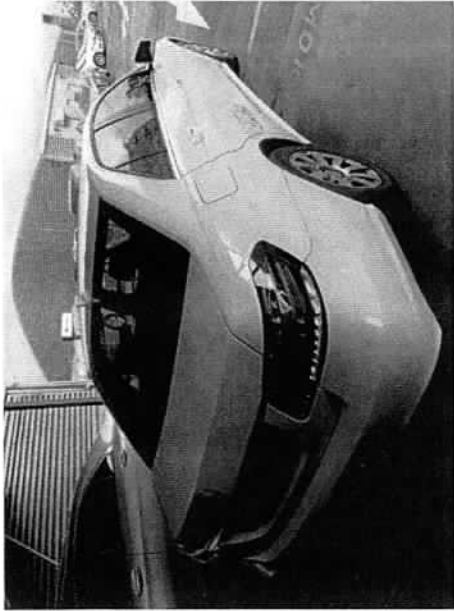
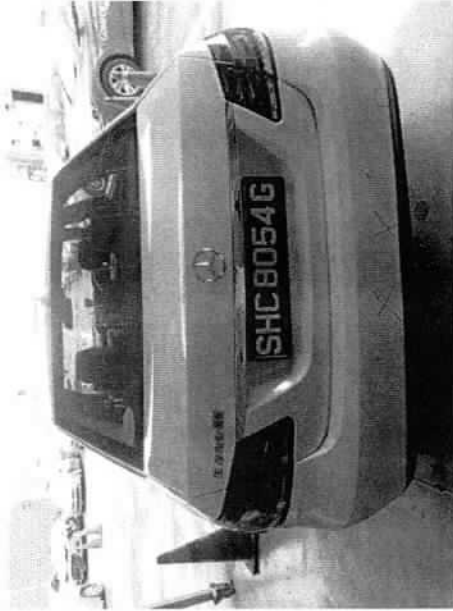
Rear

The U/C / Chassis frame / Body Structure affected due to collision.

4. Description of Damages				
THE VEHICLE SUSTAINED DAMAGES AT THE REAR PORTION. DAMAGES SEE DETAILS.				
5. General Information				
Accident Date	12/06/2018	Inspection Date	14/06/2018	
Survey held at	COMFORTDELGRO ENGINEERING PTE LTD 59 LOYANG DRIVE SINGAPORE 508969			
5a. Remarks				
A)THE INSPECTION WAS CONDUCTED ON A"WITHOUT PREJUDICE" BASIS. B)IN ACCORDANCE TO YOUR INSTRUCTIONS, WE HAVE NOT AUTHORISED REPAIRS.				
5b. Estimate Days of Repair				
ESTIMATED NORMAL PERIOD FOR REPAIR:		2 Working Days

Final Lumpsum Repair cost \$1,500.00

Qty	Description of Parts	Condition	Estimate By Workshop (\$)	Our Adjusted (\$)
<u>REPLACEMENT OF PARTS</u>				
1	REAR BUMPER	DEFORMED	1,510.00	1,510.00
1	REAR BUMPER REINFORCEMENT	SERVICEABLE	1,150.00	-
2	REAR BUMPER BRACKET LOWER (LH/RH) @\$135.00	SERVICEABLE	270.00	-
2	REAR BUMPER BRACKET TOP (LH/RH) @\$125.00	SERVICEABLE	250.00	-
2	REAR BUMPER RETAINER MOUNTING (LH/RH) @\$115.00	SERVICEABLE	230.00	-
1	REAR BUMPER LOWER COVER	CUT	325.00	325.00
LESS 20% DISCOUNT			-747.00	-367.00
			2,988.00	1,468.00
<u>LABOUR</u>				
PANEL BEATING.		NOT NECESSARY	400.00	200.00
SPRAY PAINTING CHARGE.			250.00	200.00
WIRING CHARGE.			50.00	-
			700.00	400.00
GRAND TOTAL			3,688.00	1,868.00
RECOMMENDED COST OF LUMP SUM REPAIRS (TO ITS PRE-ACCIDENT CONDITION) (CONFIRMED)				1,500.00
