Your Ref: Honda Engine
Our Ref : CI/TP18010981/D

18 June 2018

INSPECTION REPORT OF A HONDA ENGINE

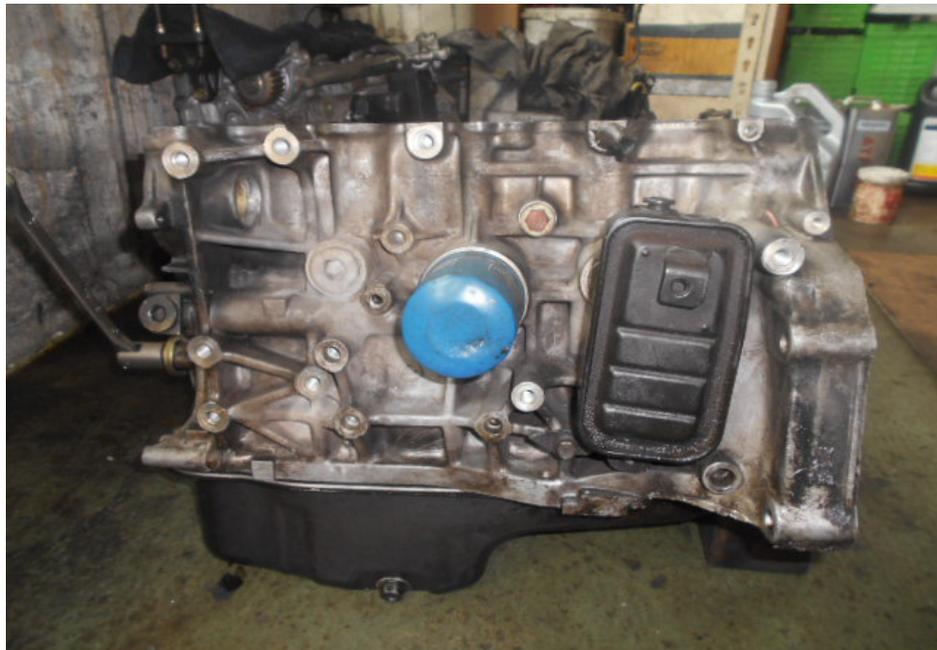
Photo 3 shows a general view of the Honda engine that I had inspected. My visual examination of the engine housing revealed the housing to be of serviceable/satisfactory condition. There was no crack and/or hole observed on the engine housing.

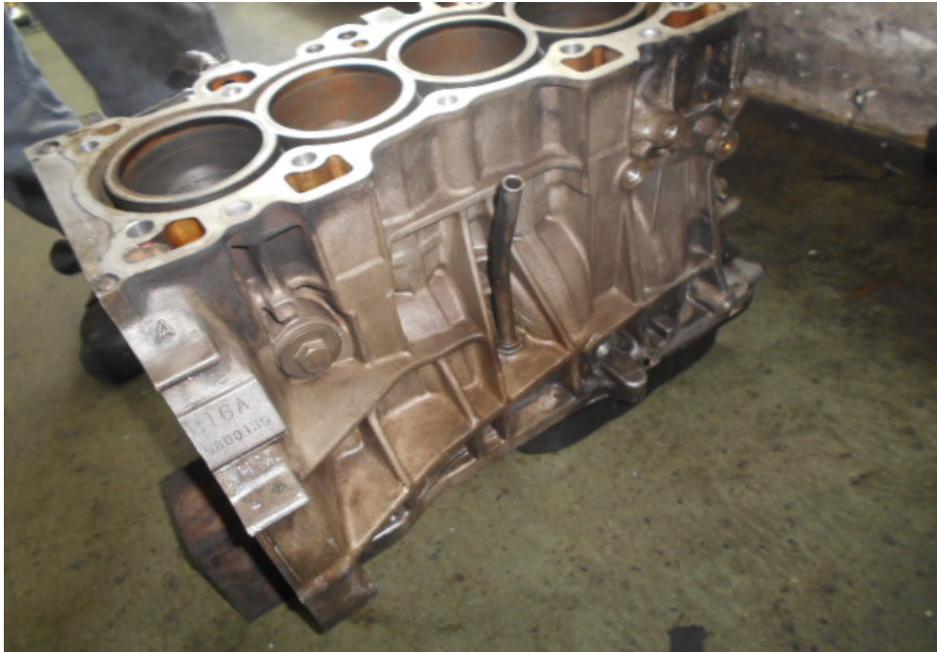
Photo 3 shows a general view of the Honda engine that I had inspected. My visual examination of the engine housing revealed the housing to be of serviceable/satisfactory condition. There was no crack and/or hole observed on the engine housing.

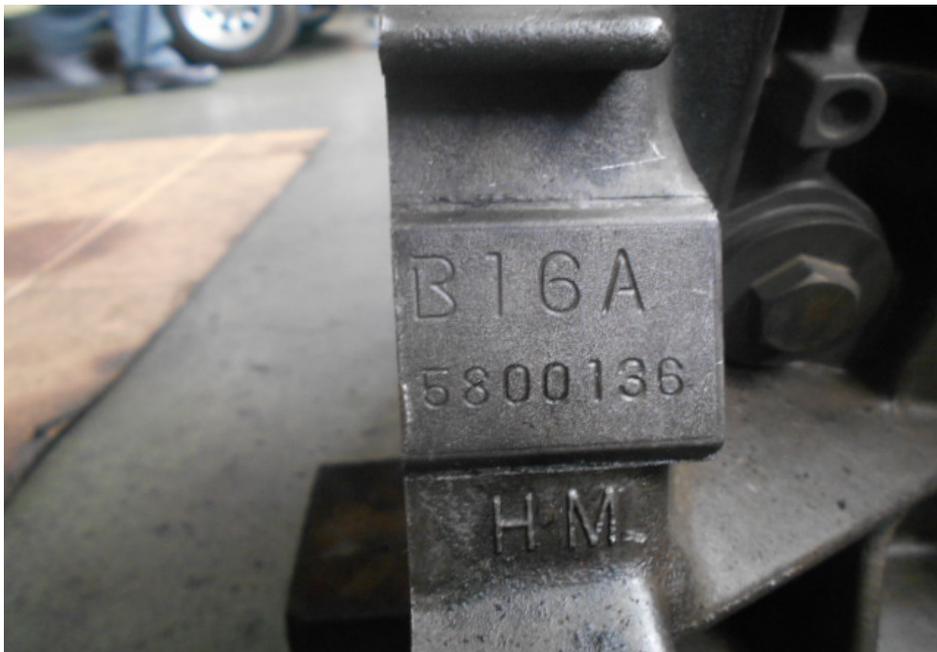
Photo 4 shows the engine number engraved on the housing of the Honda engine that I had inspected. The engine number was B16A5800136.

13. In summary, the Honda engine that I had inspected is a Honda B16A model engine. The engine number engraved on the housing of this Honda engine was B16A5800136.

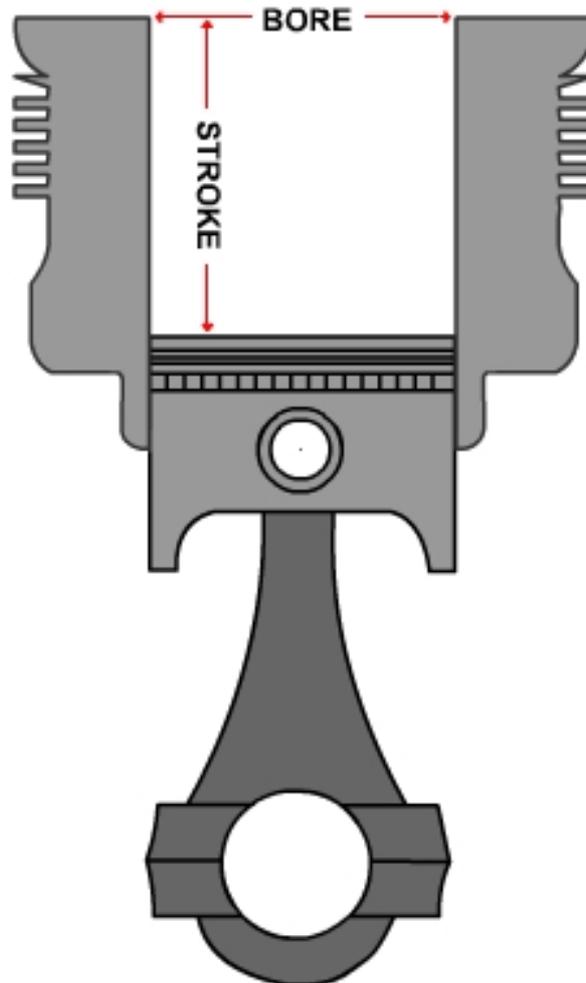
9. The bore of an engine refers to the measurement of the inside diameter of the cylinder while the stroke refers to the distance the piston moves in one direction of upward or downward movement in the cylinder. See diagram below for illustration purposes.

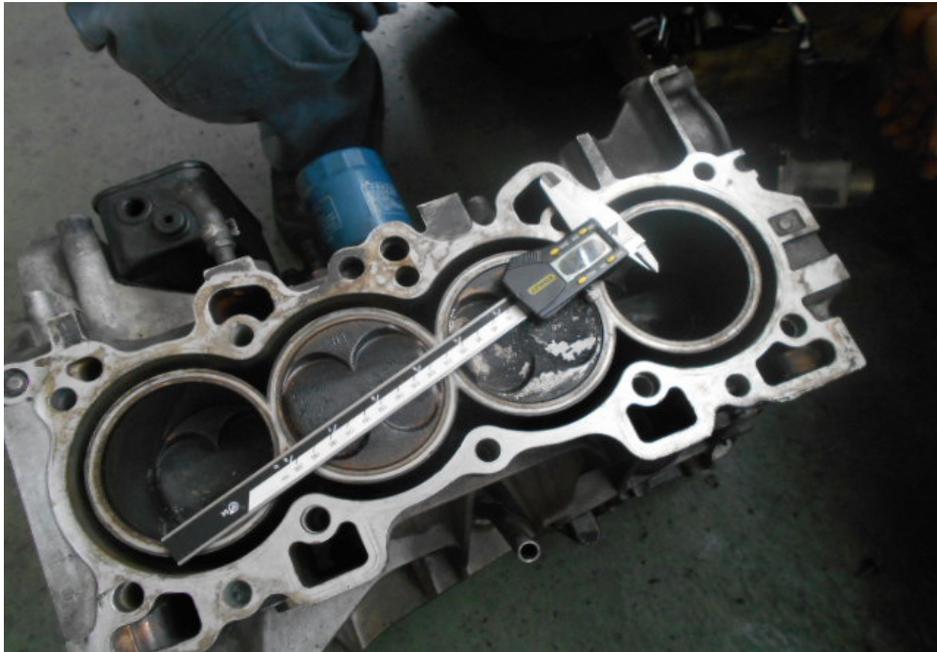
Photo 5 shows the bottom block of the Honda engine and the digital Vernier Caliper that was used to measure the bore and stroke of the Honda engine. The digital Vernier Caliper was calibrated before the start of the measurements.

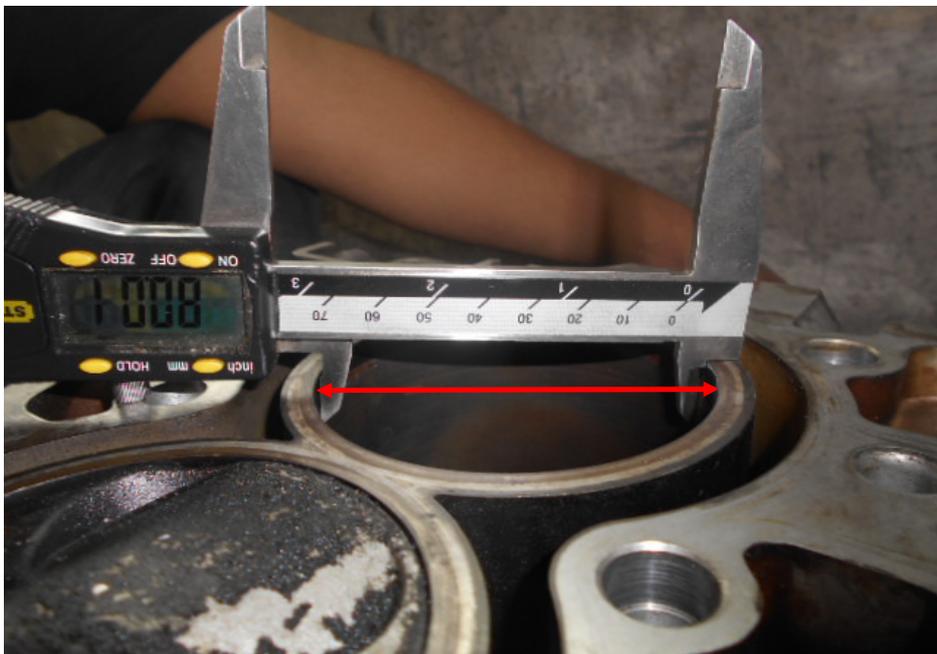
Photo 6 shows measurement being carried out to the bore of cylinder 1 of the Honda engine. The bore measurement of cylinder 1 was recorded to be 80.01mm.

Bore (mm)	Stroke (mm)
Cylinder 1	80.01	77.15
Cylinder 2	80.32	76.74
Cylinder 3	80.19	76.71
Cylinder 4	80.03	77.28

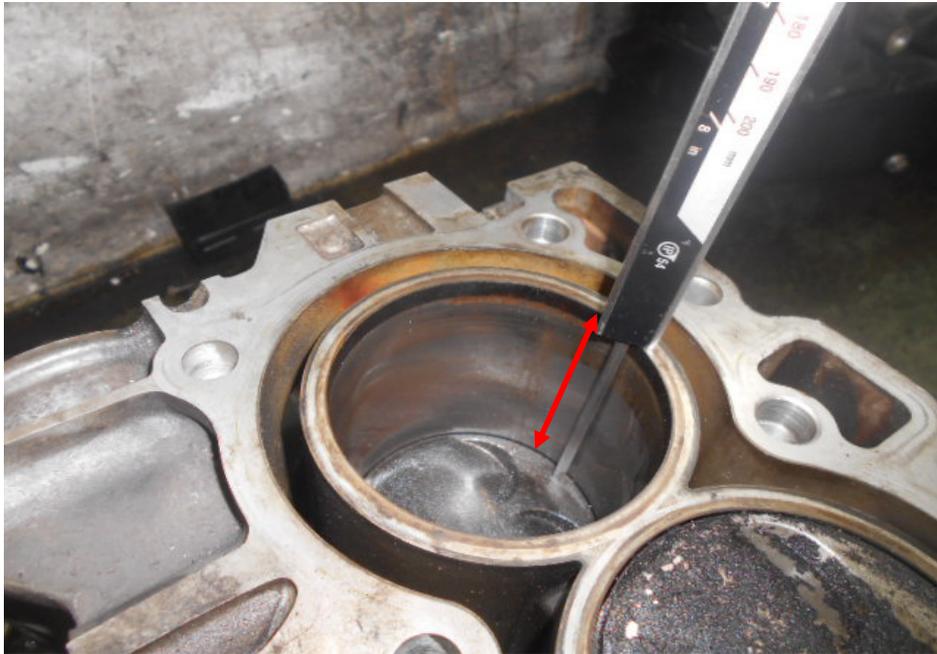
Photo 7 shows measurement being carried out to the stroke of cylinder 1 of the Honda engine. The bore and stroke measurements of the Honda engine were carried out using a digital Vernier Caliper.

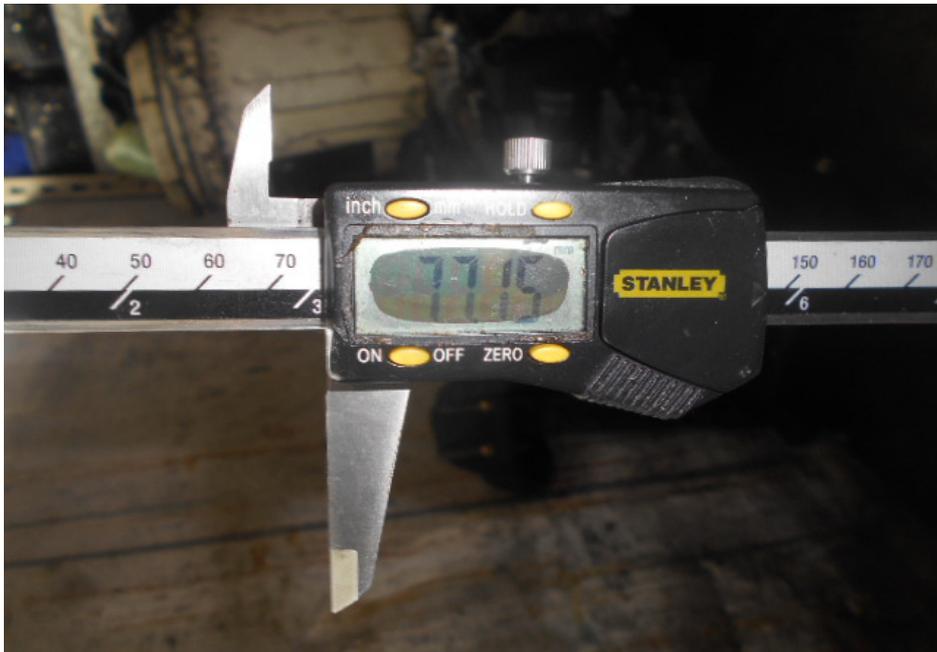
Photo 8 shows the stroke measurement of cylinder 1, which was recorded to be 77.15mm.

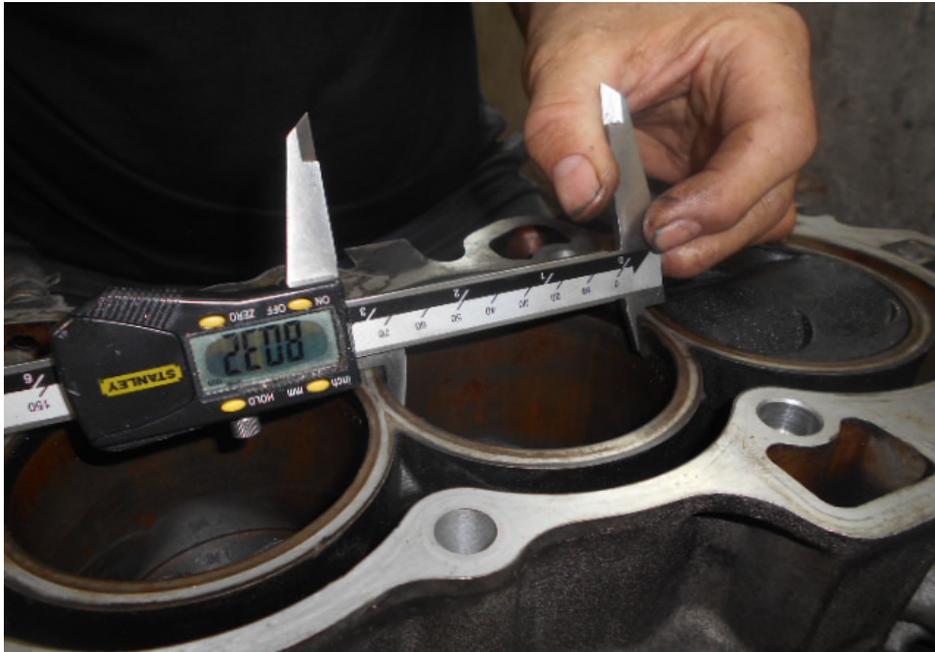
Photo 9 shows measurement being carried out to the bore of cylinder 2 of the Honda engine. The bore measurement of cylinder 2 was recorded to be 80.32mm.

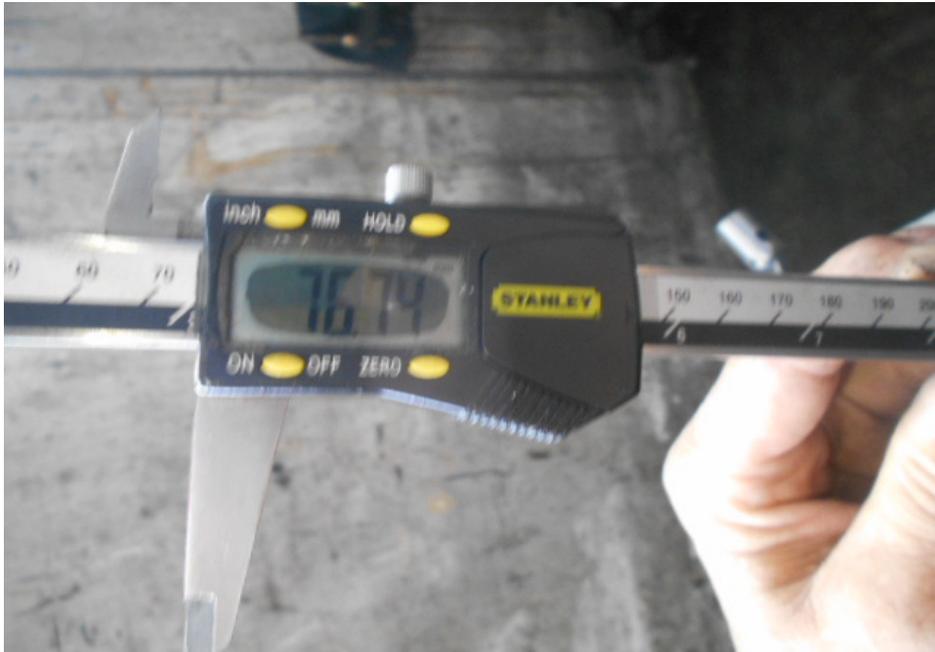
Photo 11 shows the stroke measurement of cylinder 2, which was recorded to be 76.74mm.

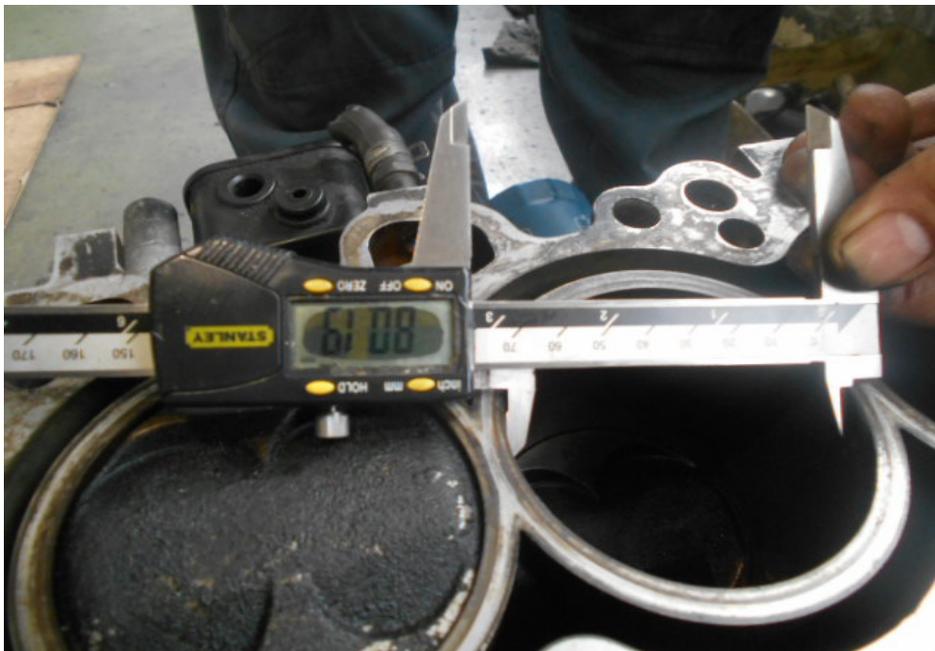
Photo 12 shows measurement being carried out to the bore of cylinder 3 of the Honda engine. The bore and stroke measurements of the Honda engine were carried out using a digital Vernier Caliper. The bore measurement of cylinder 3 was recorded to be 80.19mm.

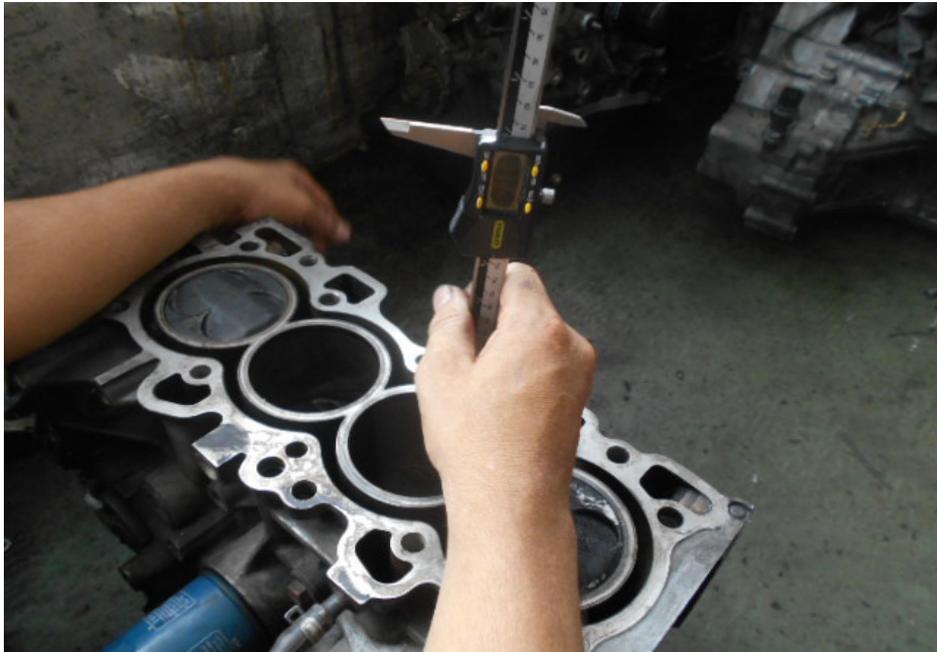
Photo 13 shows measurement of the stroke of cylinder 3 of the Honda engine that I had inspected. The bore and stroke measurements of the Honda engine were carried out using a digital Vernier Caliper that was calibrated before the start of measurements.

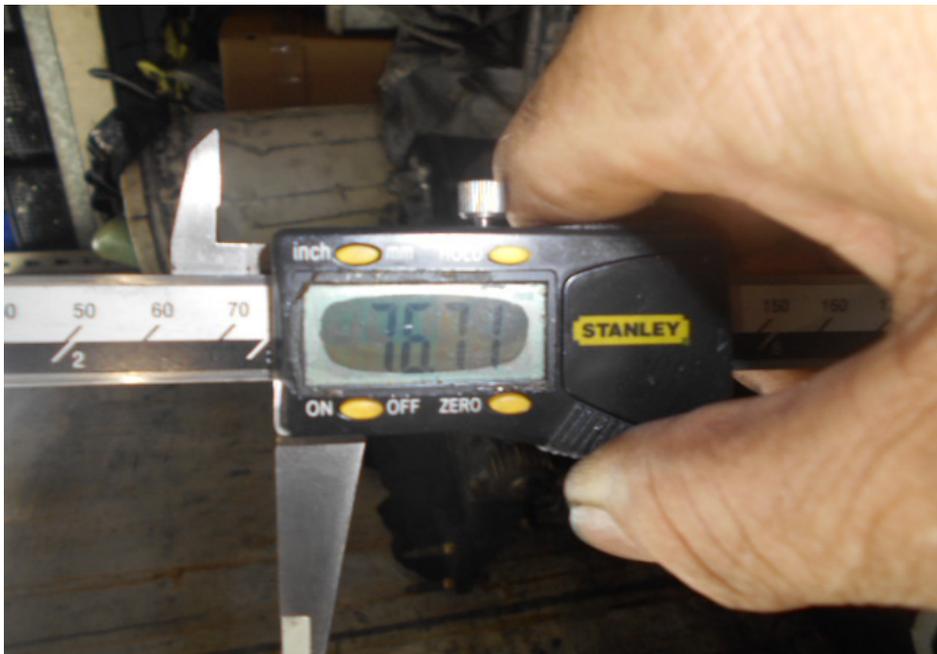
Photo 14 shows the stroke measurement of cylinder 3, which was recorded to be 76.71mm.

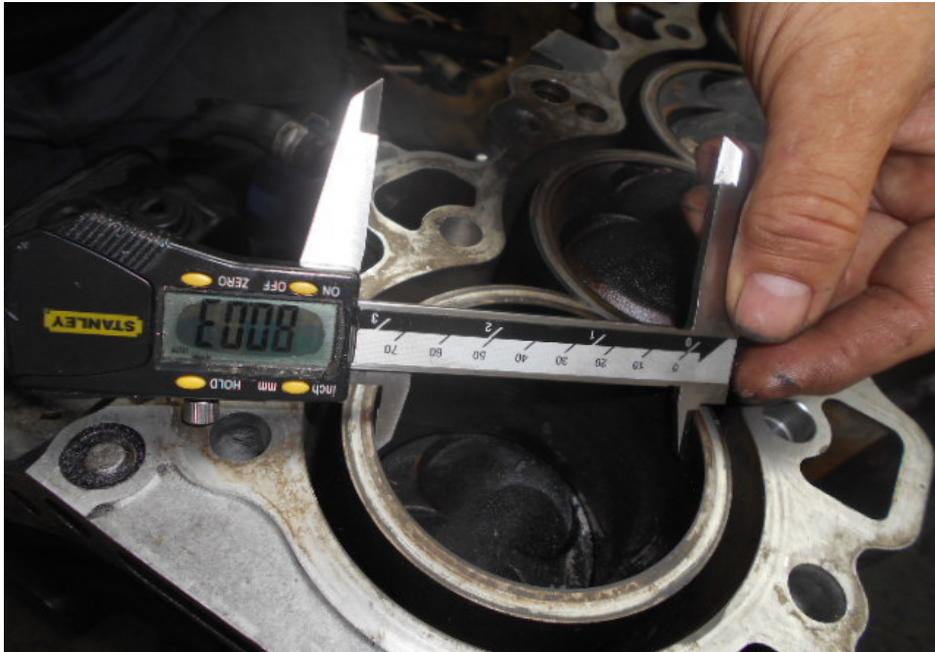
Photo 15 shows measurement being carried out to the bore of cylinder 4 of the Honda engine. The bore and stroke measurements of the Honda engine were carried out using a digital Vernier Caliper. The bore measurement of cylinder 4 was recorded to be 80.03mm.

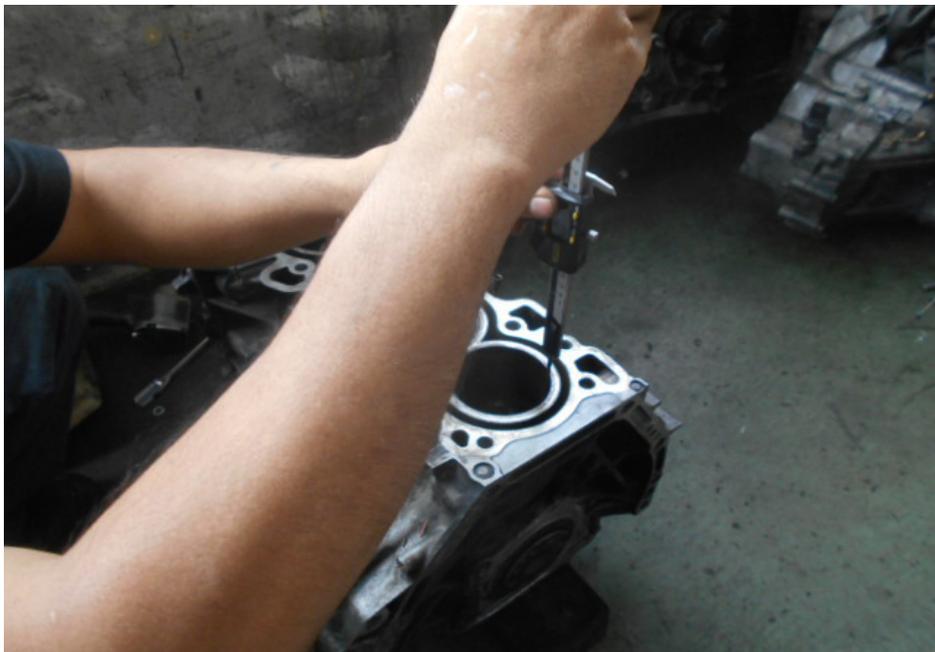
Photo 16 shows measurement being carried out to the stroke of cylinder 4 of the Honda engine. The bore and stroke measurements of the Honda engine were carried out using a digital Vernier Caliper that was calibrated before the start of measurements.

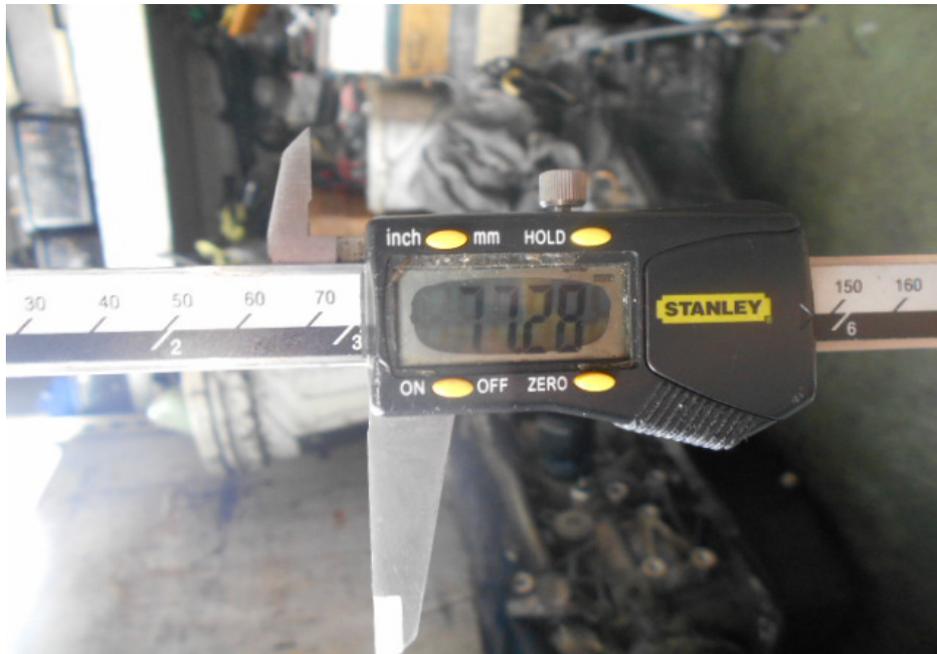
Photo 17 shows the stroke measurement of cylinder 4, which was recorded to be 77.28mm.
