NTUC INCOME INSURANCE CO-OPERATIVE LTD Ref: NS/INC18010996/K1rbn2	
73 BRAS BASAH ROAD #05-01 NTUC TRADE UNION HOUSESINGAPORE 189556	Date: 26-06-2018
	Code: INC4

THE VEHICLE SUSTAINED DAMAGES AT THE FRONT PORTION.
DAMAGES SEE DETAILS.

ADJUSTMENT ON REPAIR COST FOR VEHICLE NO. SHC 3387D

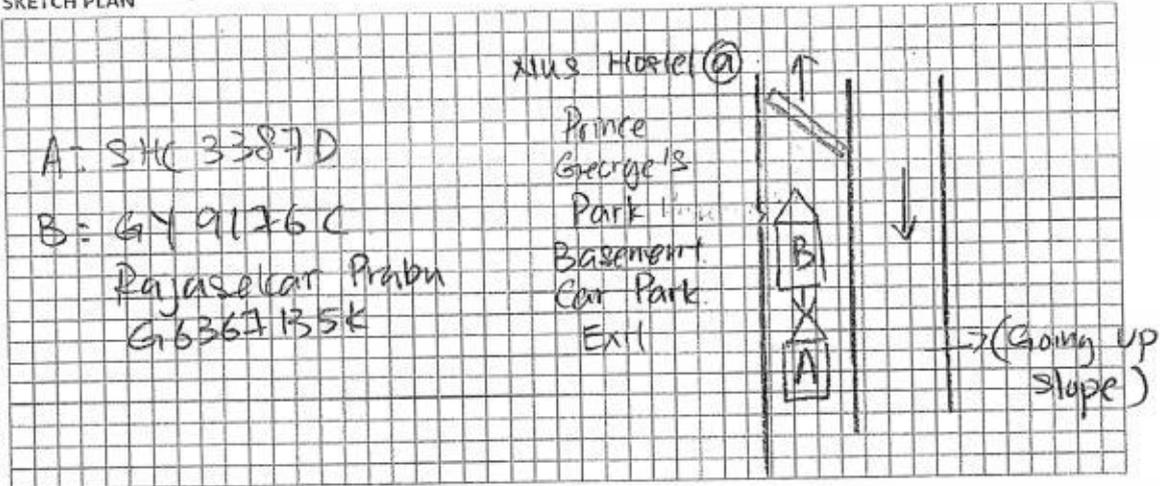
SKETCH PLAN

On 14/6/18 at about 13:15 hrs, my taxi stopped behind of a lorry GY 9176C at Mus Hostel @ Prince George's Park Basement Car Park Exit.

While I waiting for the lorry clear, suddenly the lorry sliding down toward my taxi. I immediately honked at the lorry to alert the driver but no avail. As a result, the lorry sliding backward and collided onto the front portion of my stationary taxi.
