1. Policy Particulars :- THIRD PARTY CLAIM

Manufacturer	HYUNDAI
Model	SONATA
Exact Purpose for which vehicle was being used at time of accident	
Are you claiming under your own insurance policy for repair to your vehicle?	NO
If No, Please state action to be taken	THIRD PARTY
Vehicle Category	TAXI

THE VEHICLE SUSTAINED DAMAGES AT THE O/S FRONT PORTION.
DAMAGES SEE DETAILS.

ADJUSTMENT ON REPAIR COST FOR VEHICLE NO. SHD 4182R

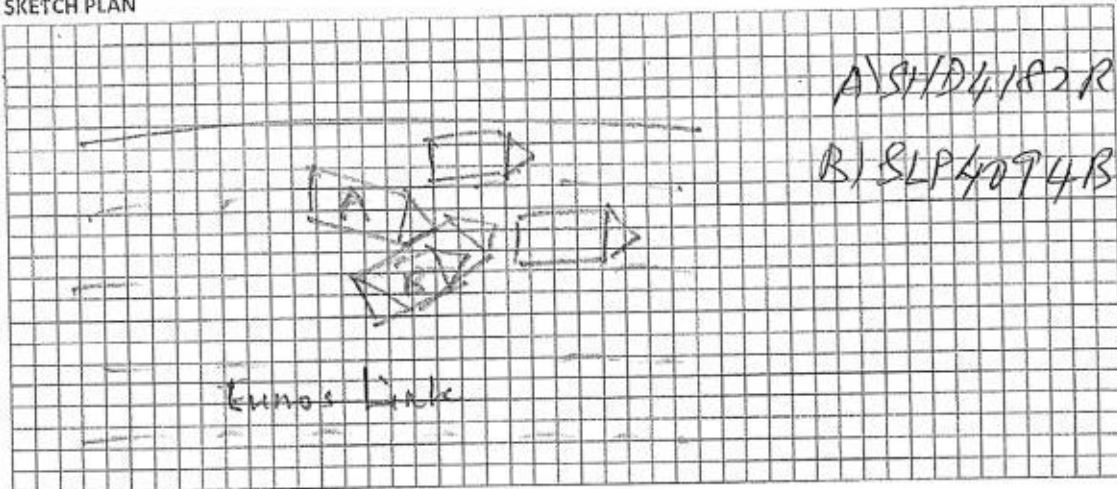
SKETCH PLAN

On 18/6/18 at about 1450hrs while I Veh A was filtering to the right lane noticed Veh B was filtering to the same lane that I was going to. When I saw Veh B approaching I stopped my vehicle and did not move but Veh B moved forward and collided on the right front portion of my stationary vehicle.

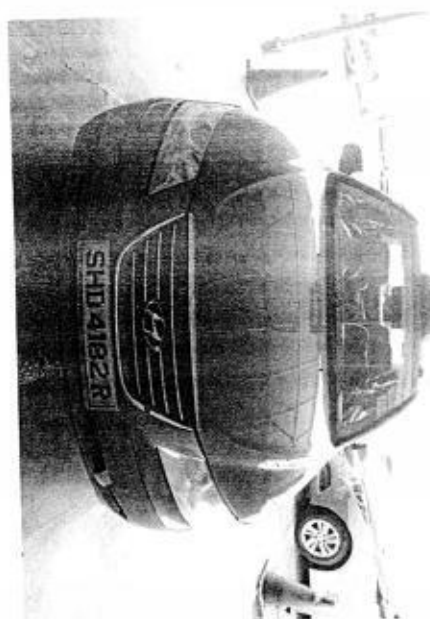
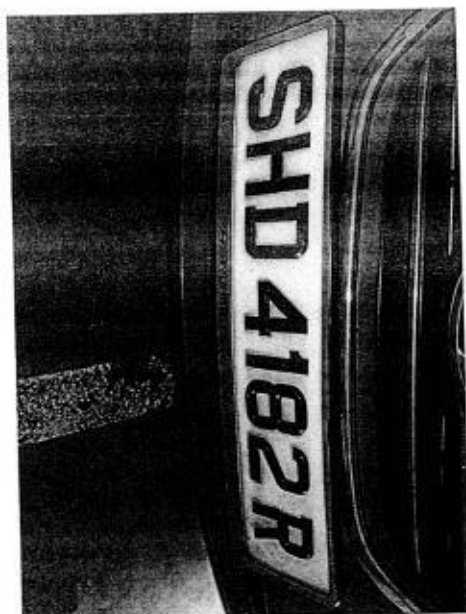
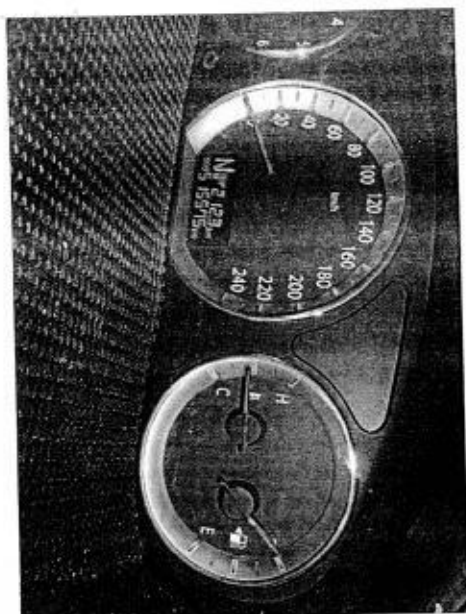
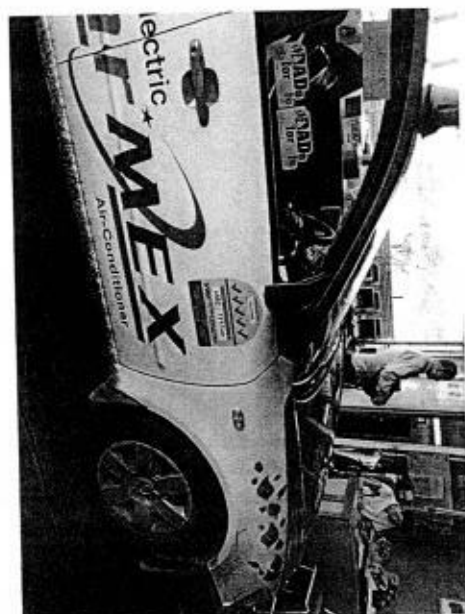
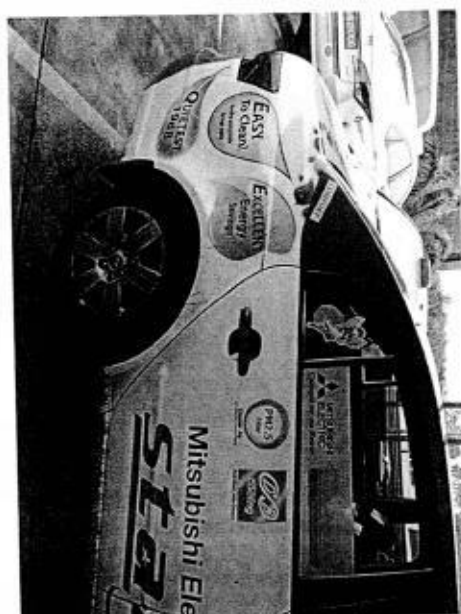
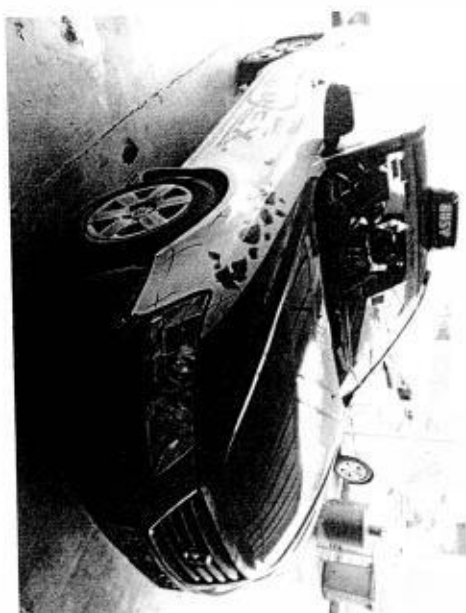
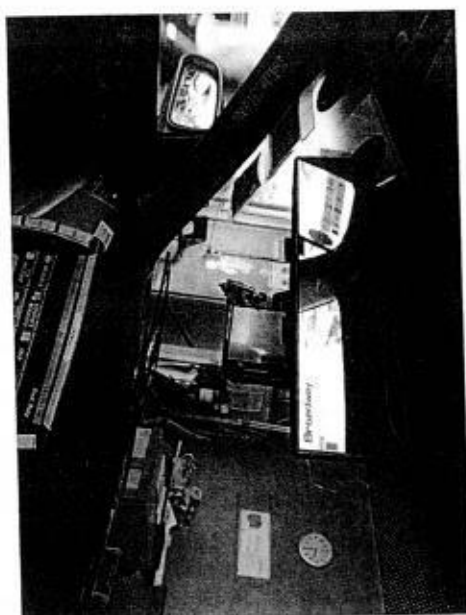
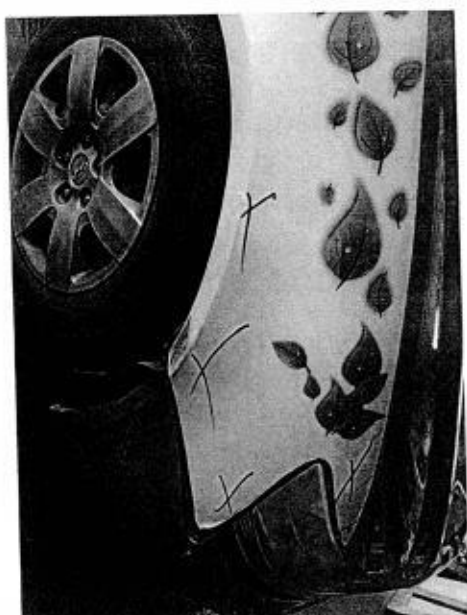
O/S Front

Qty	Description of Parts	Condition	Estimate By Workshop (\$)	Our Adjusted (\$)
REPLACEMENT OF PARTS				
1	FRONT BUMPER	DEFORMED	538.80	538.80
1	FRONT BUMPER TOP BRACKET-RH	SERVICEABLE	22.40	-
1	FRONT BUMPER SIDE BRACKET-RH	SERVICEABLE	14.30	-
1	FRONT BUMPER PROTECTOR-RH	SERVICEABLE	29.20	-
10	FRONT BUMPER CLIPS @\$2.20	NECESSARY	22.00	22.00
1	HEADLAMP-RH	SERVICEABLE	797.90	-
1	FRONT FENDER-RH	TO REPAIR SEE LABOUR	593.00	-
1	FRONT FENDER SHIELD-RH	CRACKED	86.00	86.00
1	FRONT FENDER RETAINER-RH	SERVICEABLE	9.20	-
1	HEADLAMP SUPPORT PANEL	SERVICEABLE	1,023.00	-
	LESS 20% DISCOUNT		-627.16	-129.36
			2,508.64	517.44
SPECIAL NETT ITEMS				
1	ADVERTISEMENT-FRONT FENDER-RH (SN)	NECESSARY	100.00	100.00

100.00	100.00
LABOUR				
	PANEL BEATING.INCLUSIVE OF THE REPAIR OF FRONT FENDER-RH.		500.00	200.00
	SPRAY PAINTING CHARGE.		500.00	400.00
	WIRING CHARGE.	NOT NECESSARY	50.00	-
	TUFF KOTE.	NOT NECESSARY	80.00	-

-		-	-
	-		-	-
	-		-	-
			1,130.00	600.00
GRAND TOTAL			3,738.64	1,217.44
RECOMMENDED COST OF LUMP SUM REPAIRS (TO ITS PRE-ACCIDENT CONDITION) (CONFIRMED)				900.00

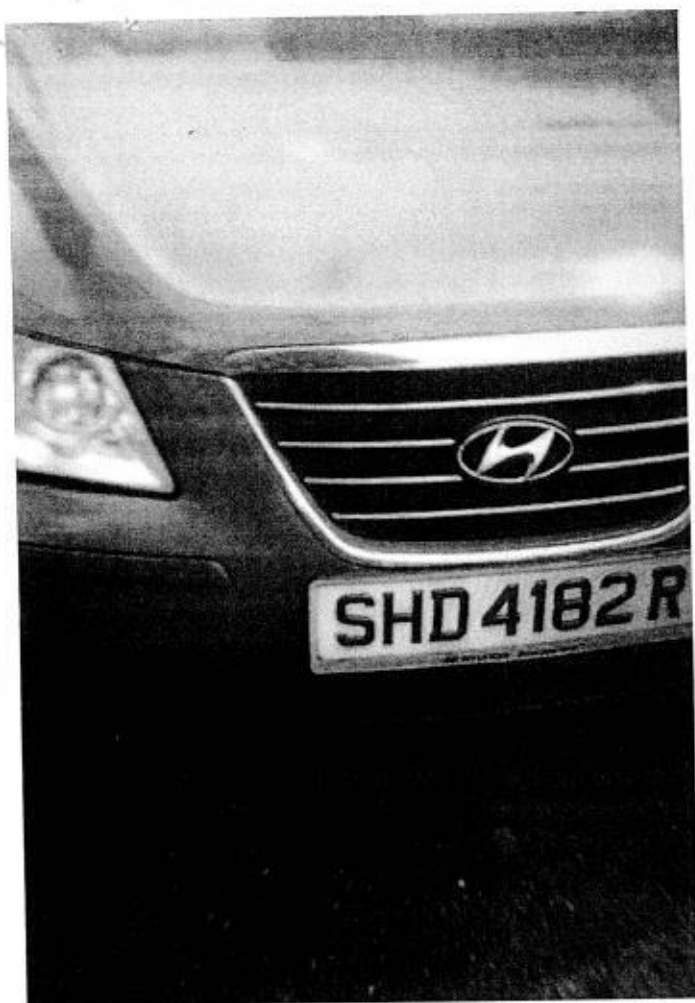
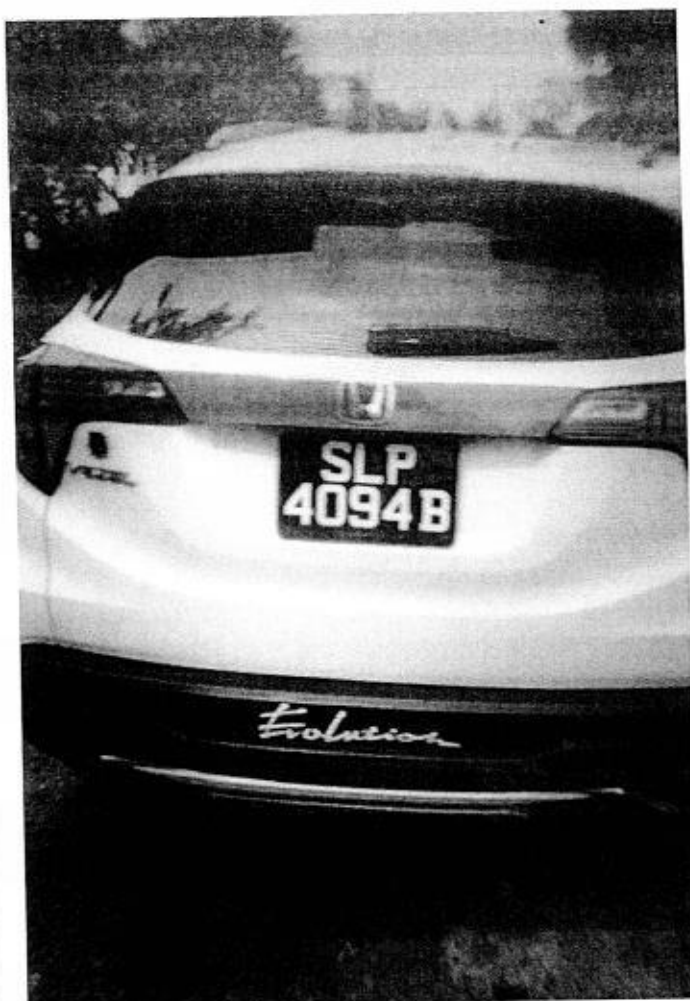
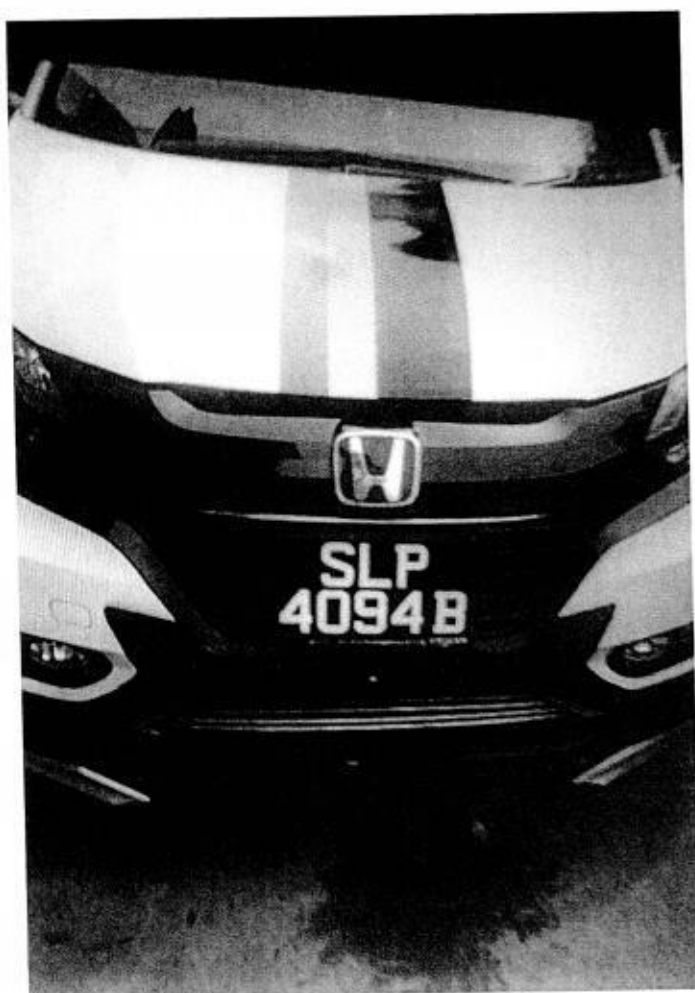
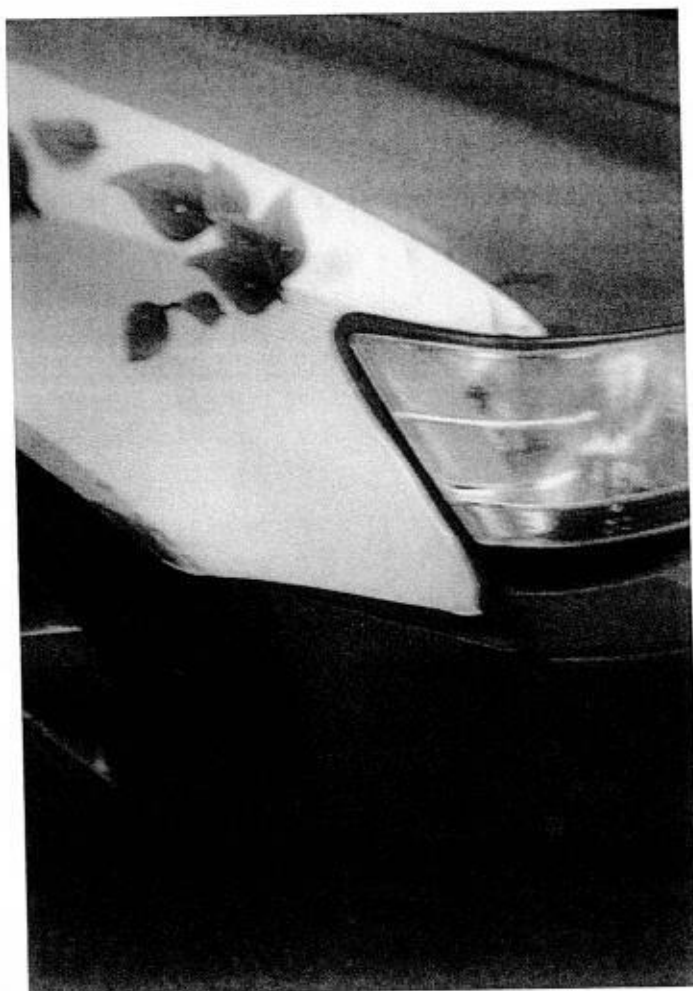
NTUC - taxi Right Front damage
LKIC/Kalini -

1. The repair job shall bill to: NTUC SLP4094B
2. The finalized amount shall be:
 - (a) Spare Parts after List discount
 - (b) Labour Charges
 - Total for Part-By-Part Repair Cost**
 - (c) Lumpsum Repair (if applicable)
Total for Lumpsum repair cost after Less: **Final Lumpsum Repair cost** \$900.00

3. Estimated normal period for repairs: 2 working days.
