NTUC INCOME INSURANCE CO-OPERATIVE LTD Ref: NS/INC18011221/K1vb				
73 BRAS BASAH ROAD #05-01 NTUC TRADE UNION HOUSESINGAPORE 189556			Date: 20-06-2018	 
Code: INC4

1. Policy Particulars :- THIRD PARTY CLAIM				
Insured Veh.	GBE 2572C	Veh. Inspected	SHC 2368R	
Policy No.	5074863750-02	Coverage (\$)	0.00	
Claim No.		Excess (\$)	0.00	
Assign From		Assign Date	20/06/2018

THE VEHICLE SUSTAINED DAMAGES AT THE O/S BODY.
DAMAGES SEE DETAILS.

ADJUSTMENT ON REPAIR COST FOR VEHICLE NO. SHC 2368R

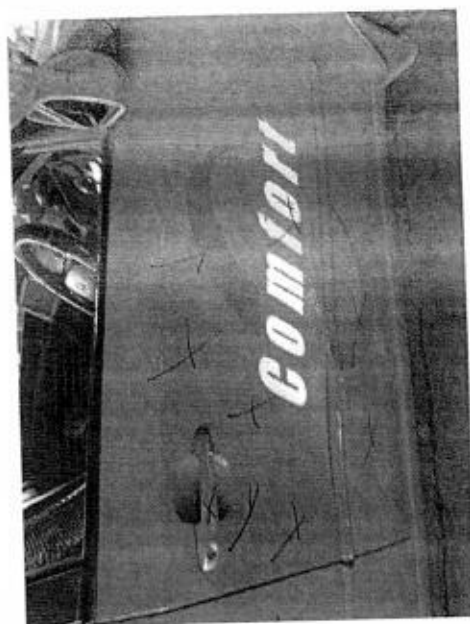
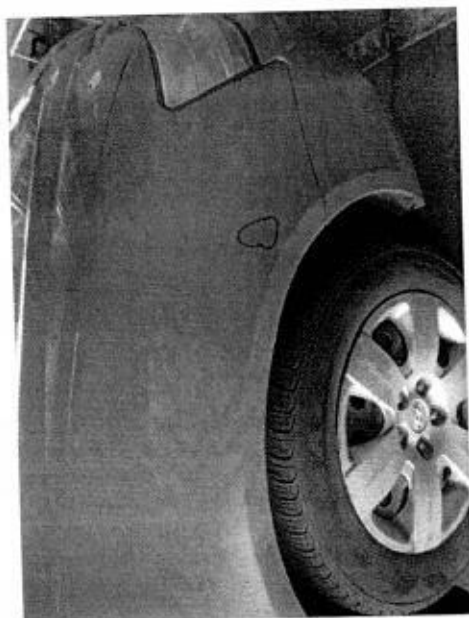
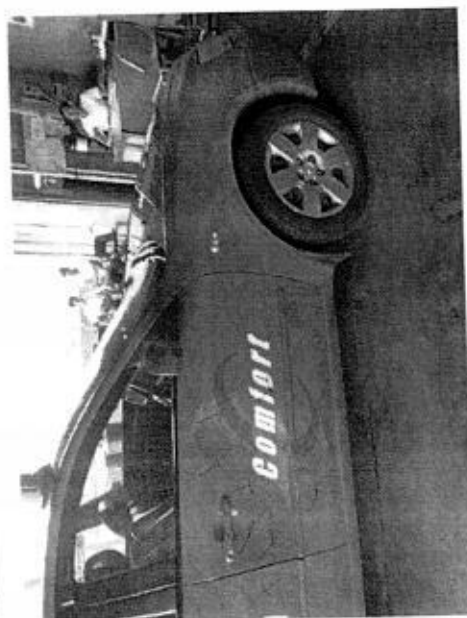
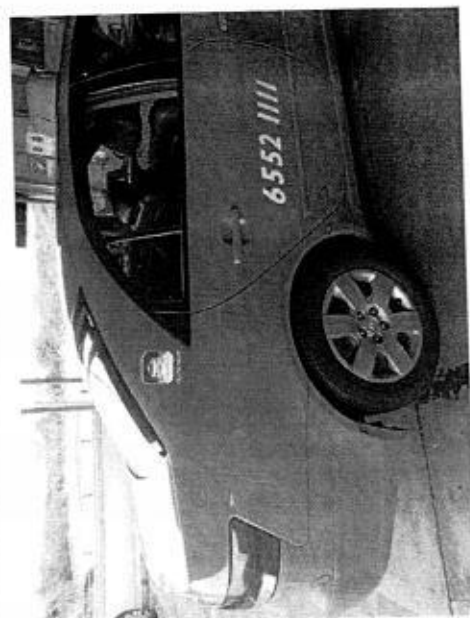
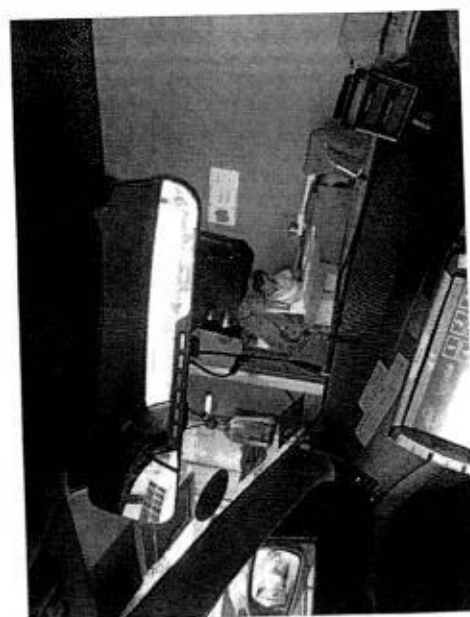
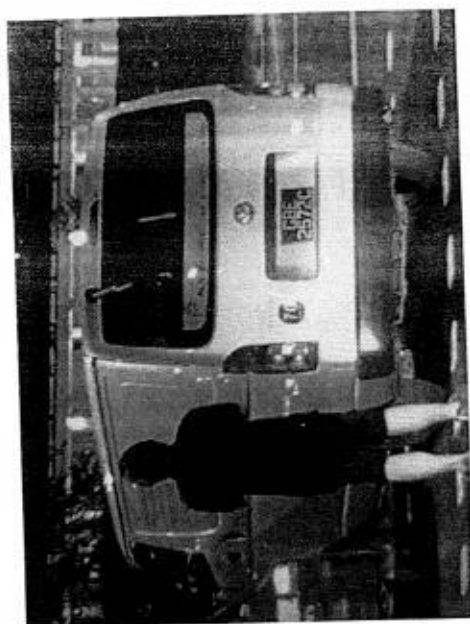
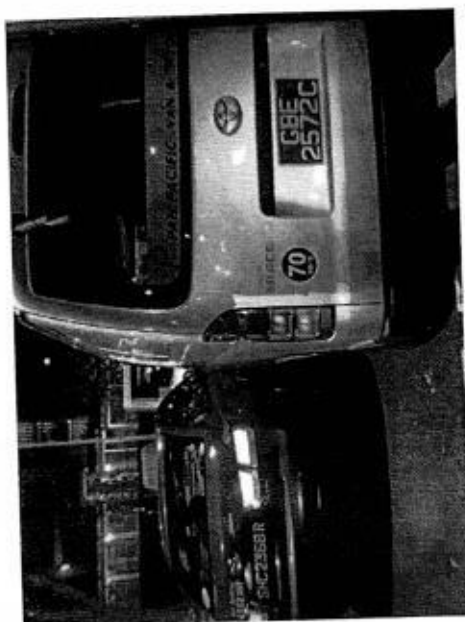
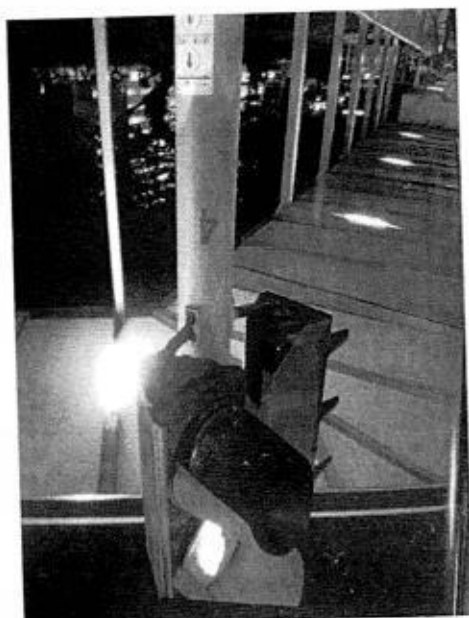
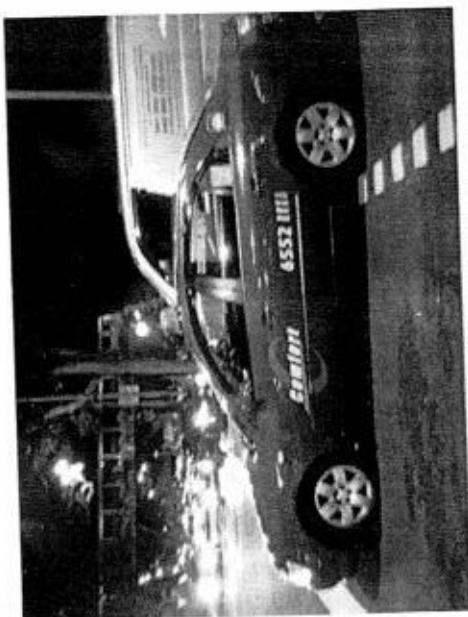
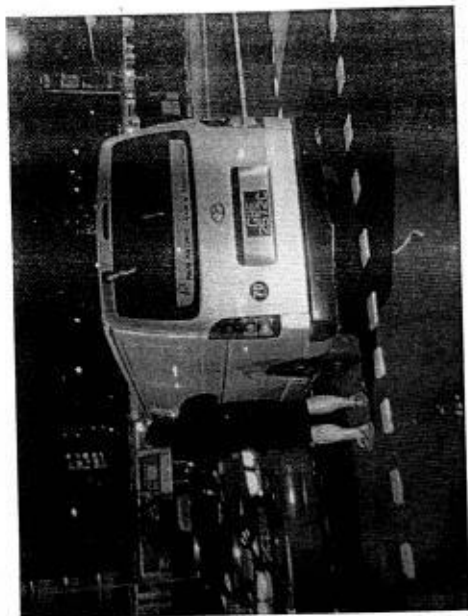
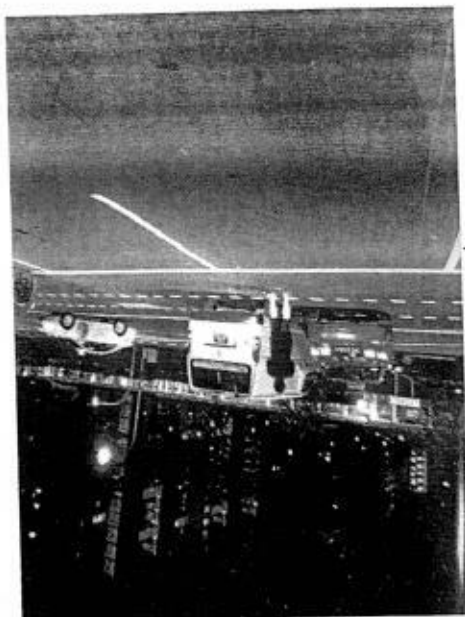
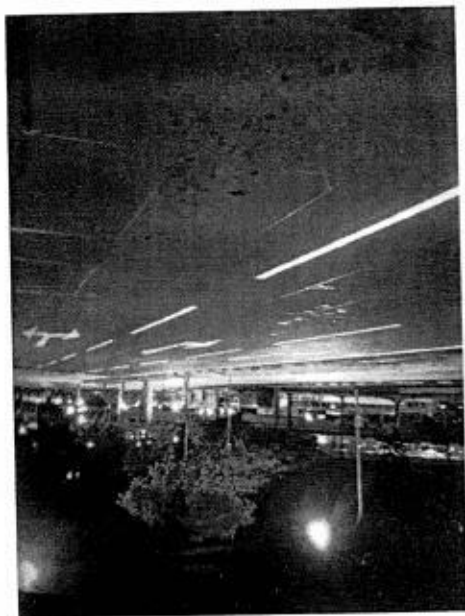
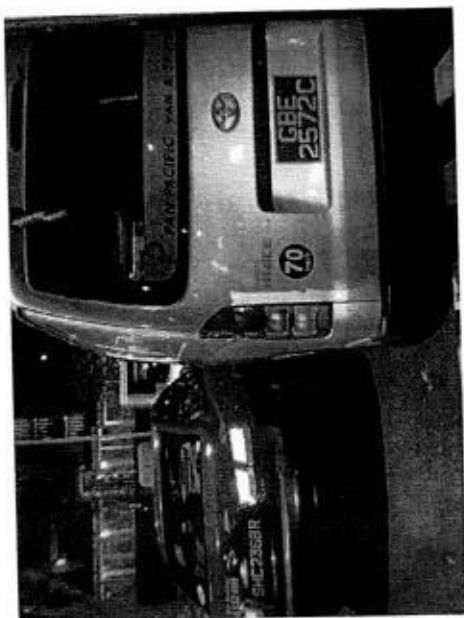
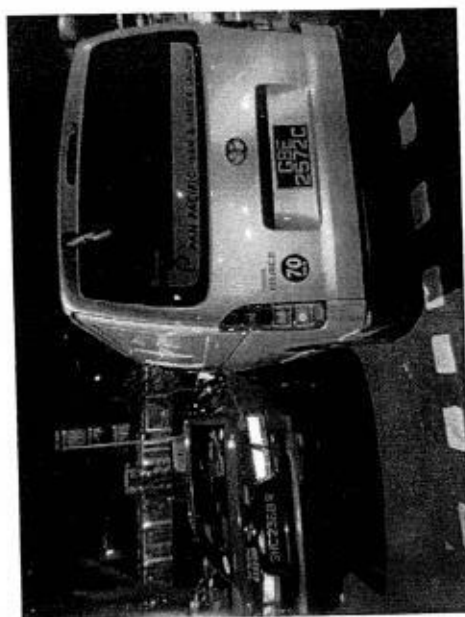
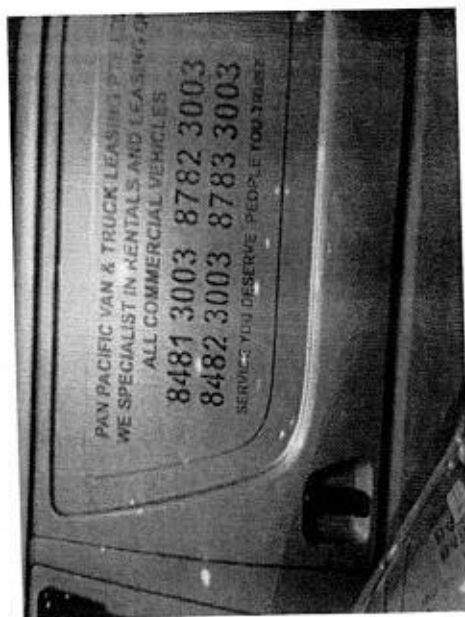
The U/C / Chassis frame / Body Structure affected due to collision.

Qty	Description of Parts	Condition	Estimate By Workshop (\$)	Our Adjusted (\$)
<u>REPLACEMENT OF PARTS</u>				
1	FRONT DOOR (RH)	DENTED	1,345.00	1,345.00
1	FRONT DOOR OUTER HANDLE (RH)	TO REPAIR SEE LABOUR	37.00	-
1	FRONT DOOR PROTECTOR (RH)	CRACKED	74.90	74.90
1	REAR DOOR (RH)(NPA)	TO REPAIR SEE LABOUR	-	-
LESS 20% DISCOUNT			-291.38	-283.98
			1,165.52	1,135.92
<u>SPECIAL NETT ITEMS</u>				
1	FRONT DOOR COMFORT LOGO (RH)(SN)	NECESSARY	75.00	75.00
1	REAR DOOR TEL NO STICKER (RH)(SN)	NECESSARY	10.00	10.00

85.00	85.00
<u>LABOUR</u>				
PANEL BEATING.INCLUSIVE OF THE REPAIR OF FRONT DOOR OUTER HANDLE (RH) AND REAR DOOR (RH).			350.00	200.00
SPRAY PAINTING CHARGE-DOORS X2/MIRROR.			600.00	450.00
WIRING CHARGE.			50.00	-
TUFF KOTE.			50.00	20.00
TRANSFER OF DOOR.			120.00	50.00
			1,170.00	720.00
GRAND TOTAL			2,420.52	1,940.92
RECOMMENDED COST OF LUMP SUM REPAIRS (TO ITS PRE-ACCIDENT CONDITION) (CONFIRMED)				1,550.00
