From: GERALD POH WEE BIN <geraldpoh@lonpac.com>
Sent: Monday, 16 July, 2018 3:40 PM
To: Annie Yew
Cc: MT_Claim_SG; Vic (LKKAUTO)
Subject: FW: ACCIDENT INVOLVING SFA3311G & SHA2506U ALONG MT ELIZABETH LINK ON 21.6.2018 LKK REF CC4/LPC18011384/K1ha3
Attachments: 03072018114519.pdf; 16072018145634.pdf

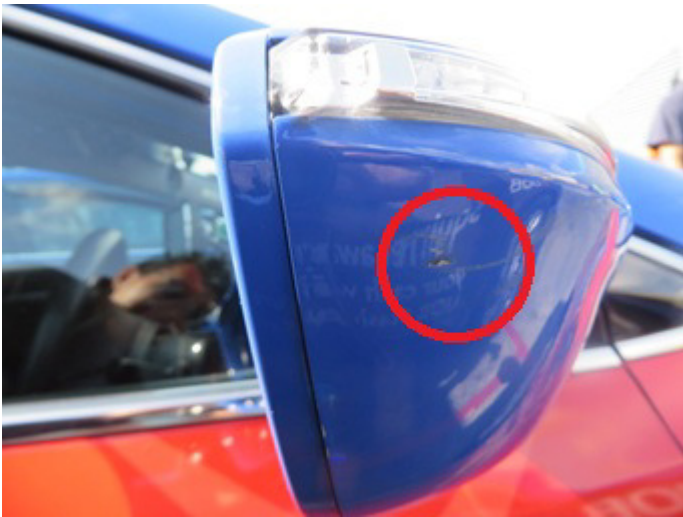
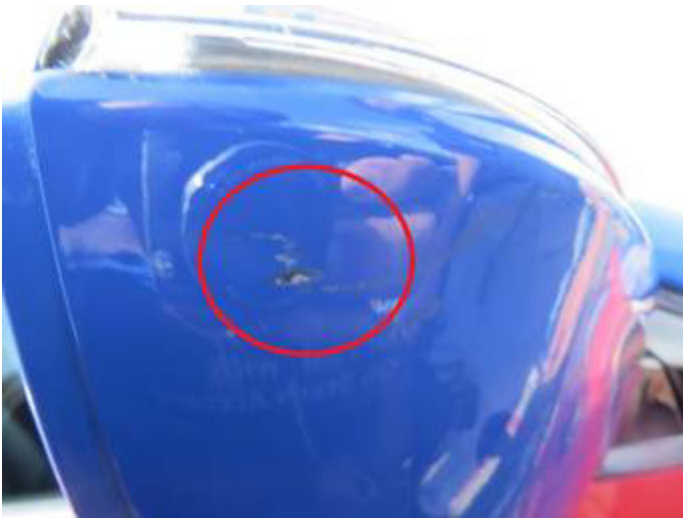
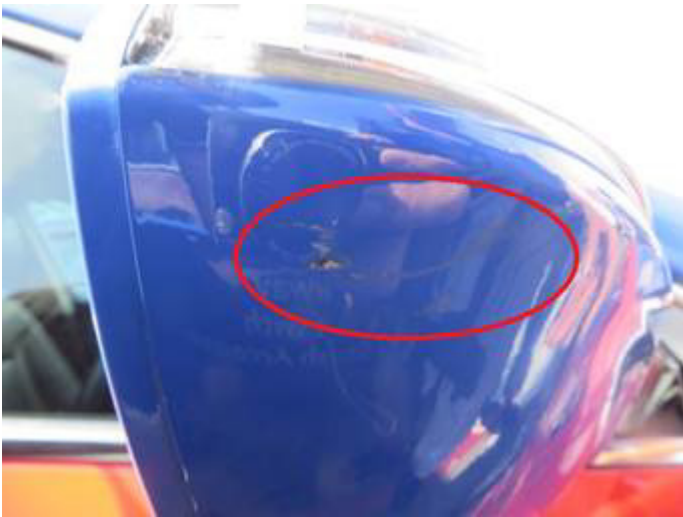
Our surveyor after inspection and further review of the damages to TP taxi, is in the view that the damages sustained to the TP vehicle is consistent to the nature of the accident.

Below inspection photos show the damages observed to the TP RH side mirror. A paint chip off with grazing nature damages were observed (circled).

The estimate of \$1,234.40 submitted by the workshop had been adjusted to \$100.00 which is recommended by our surveyor for labour only.
