1. Policy Particulars :- THIRD PARTY CLAIM			
Insured Veh.	SLL 1445M	Veh. Inspected	SHC 1323B
Policy No.	5088015806-01	Coverage (\$)	0.00
Claim No.		Excess (\$)	0.00
Assign From		Assign Date	25/06/2018

NTUC INCOME INSURANCE CO-OPERATIVE LTD Ref: NS/INC18011580/K1sbn2	
73 BRAS BASAH ROAD #05-01 NTUC TRADE UNION HOUSESINGAPORE 189556	Date: 03-07-2018
	Code: INC4

THE VEHICLE SUSTAINED DAMAGES AT THE REAR PORTION.
DAMAGES SEE DETAILS.

ADJUSTMENT ON REPAIR COST FOR VEHICLE NO. SHC 1323B

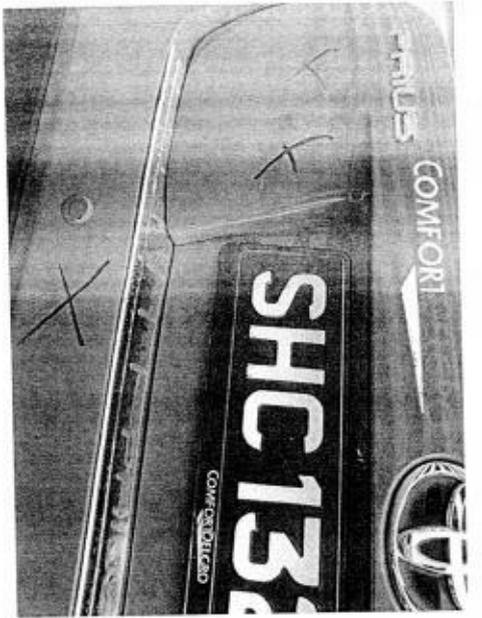
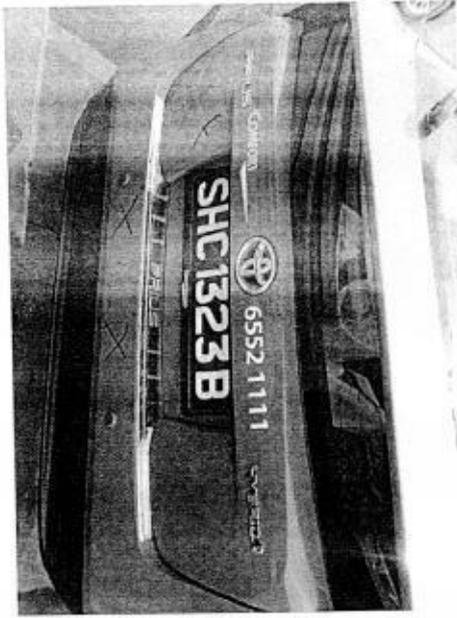
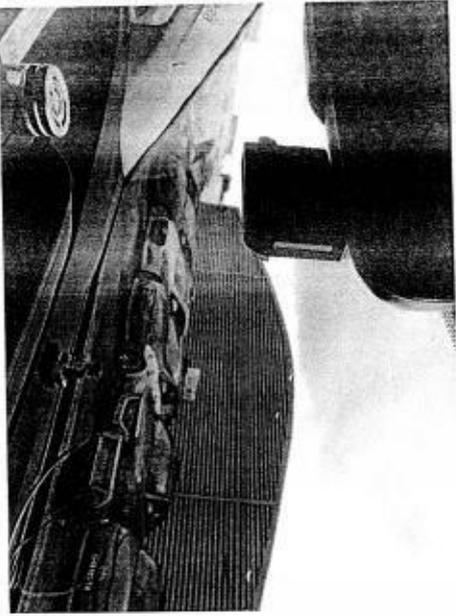
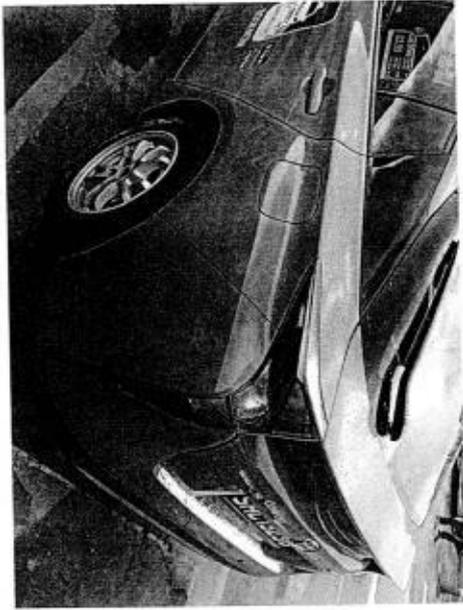
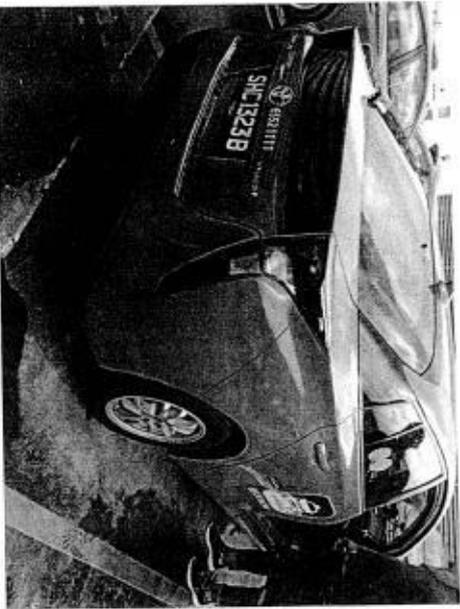
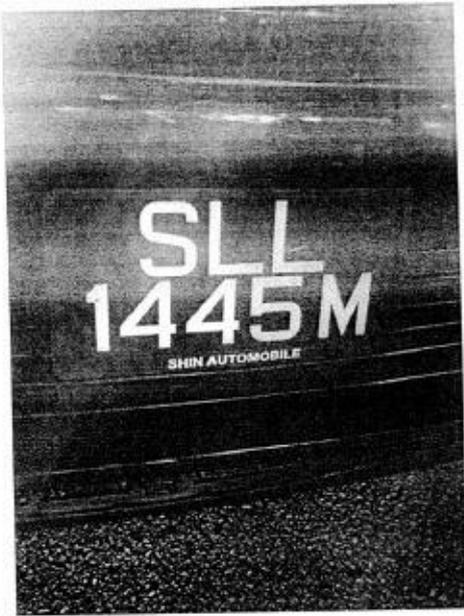
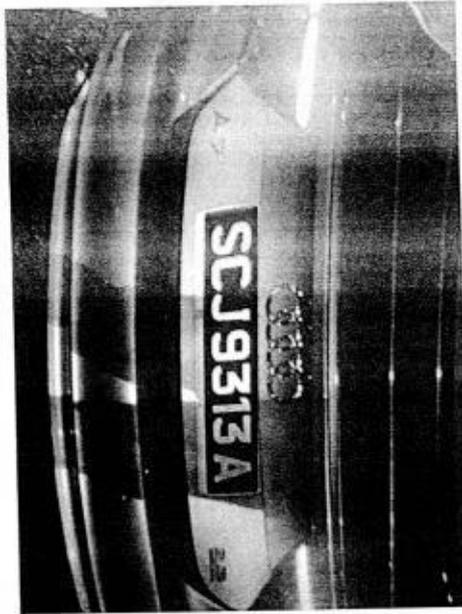
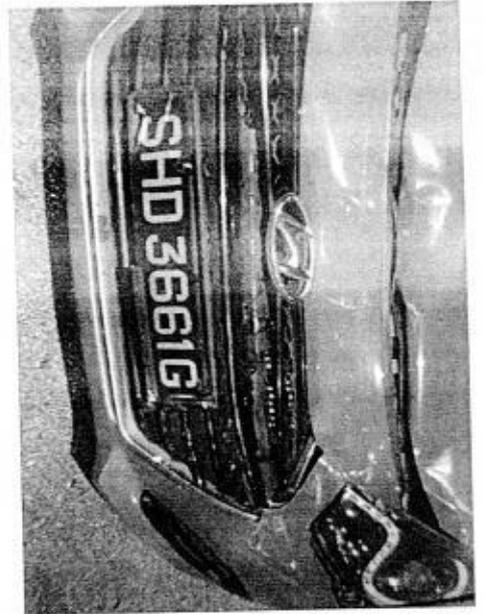
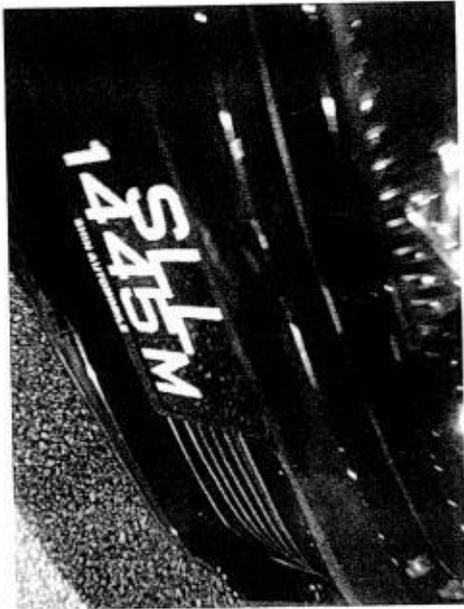
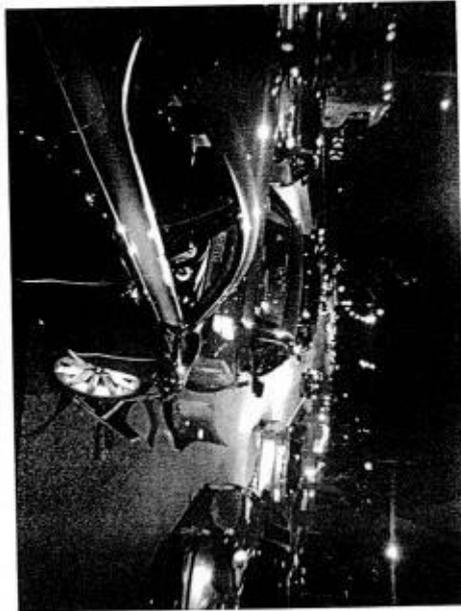
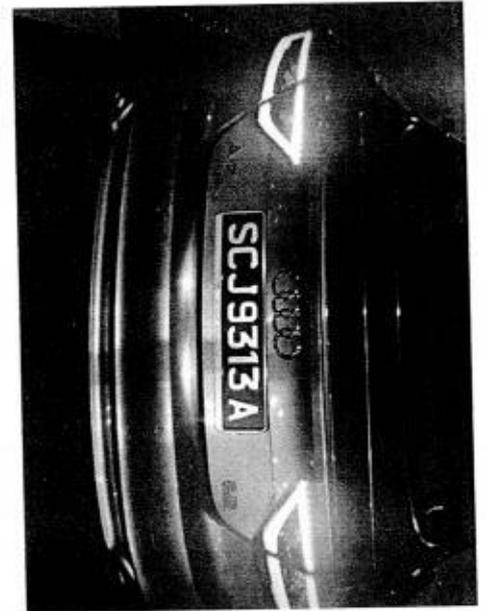
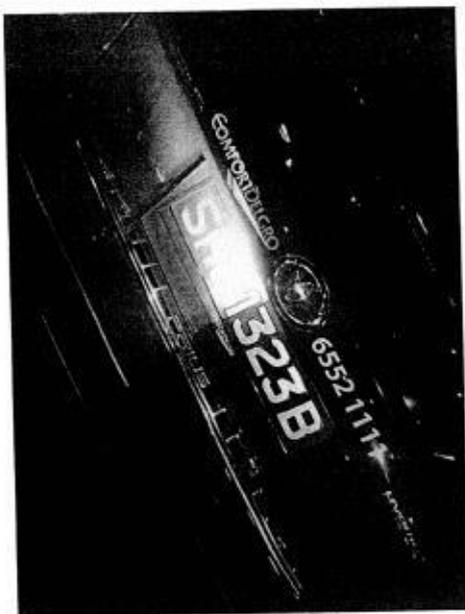
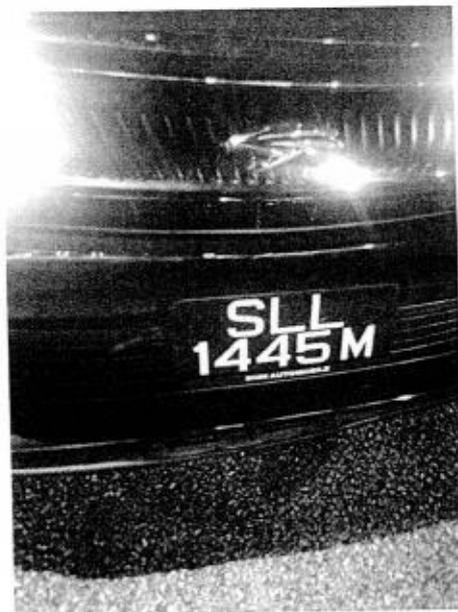
Qty	Description of Parts	Condition	Estimate By Workshop (\$)	Our Adjusted (\$)
REPLACEMENT OF PARTS				
1	REAR BUMPER	TO REPAIR SEE LABOUR	458.60	-
1	REAR BUMPER RE-INFORCEMENT	SERVICEABLE	318.80	-
1	REAR BUMPER UNDER COVER	CUT	552.60	552.60
1	REAR BUMPER SIDE RETAINER	SERVICEABLE	112.70	-
1	REAR BUMPER SPONGE	NOT NECESSARY	143.40	-
10	REAR BUMPER CLIPS	NOT NECESSARY	22.00	-
1	REAR TAILGATE OUTER GARNISH (NPA)	TO REPAIR SEE LABOUR	-	-
1	BOOTLID "PRIUS" EMBLEM	NECESSARY	52.30	52.30
1	BOOTLID "HYBRID" EMBLEM	NECESSARY	52.30	52.30
	LESS 25% DISCOUNT		-428.17	-164.30
			1,284.53	492.90
NETT ITEMS				
1	REAR BUMPER REVERSE SENSOR (N)	SHORTED	135.70	135.70
	LESS 10% DISCOUNT		-	-13.57

135.70	122.13
SPECIAL NETT ITEMS				
1	REAR BUMPER METAL PLATE (SN)	SERVICEABLE	50.00	-
1	BOOTLID COMFORT STICKER (SN)	NECESSARY	30.00	30.00
			80.00	30.00
LABOUR				
	PANEL BEATING.INCLUSIVE OF THE REPAIR OF REAR BUMPER AND REAR TAILGATE OUTER GARNISH.		350.00	200.00
	SPRAY PAINTING CHARGE.		500.00	400.00
	WIRING CHARGE.	NOT NECESSARY	50.00	-
	REMOVE/REFIX REVERSE SENSOR.	NOT NECESSARY	120.00	-
			1,020.00	600.00
GRAND TOTAL			2,520.23	1,245.03

RECOMMENDED COST OF REPAIRS (CONFIRMED)			1,245.03
---	--	--	----------
