To Inspect Vehicle No: PA 7302M Insured: PC 6823Y

**ACCIDENT REPAIR ESTIMATES**

Type of Claim : TP Vehicle No. : PA7302M  
 Make & Model : KING LONG XMQ6119K  
 Year of Manufacture : 2007  
 Chassis No. : LKLR1GSE17B103129  
 Ins Company : NTUC VS CHINA Engine No. : \_\_\_\_\_  
 Excess : \_\_\_\_\_ Policy No. : \_\_\_\_\_  
 Date of Accident : 6/21/2018 Time of Accident : 0730

### VEHICLE DAMAGE INSPECTION REPORT

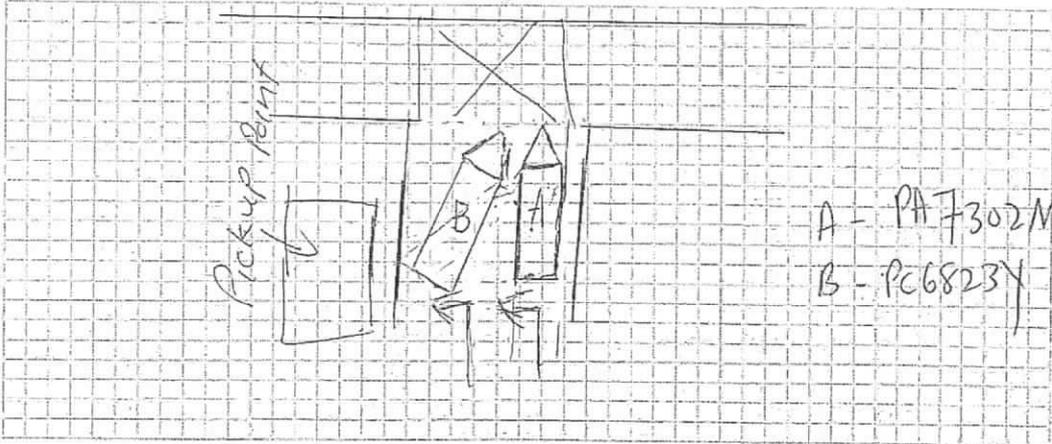
SKETCH PLAN

A - PA7302M  
B - PC6823Y

I was driving towards to Woodlands Square to turn left, Before turning I stopped my vehicle at yellow box. A Bus PC6823Y suddenly <sup>turn right and</sup> hit my left side and damage my windscreen and side mirror.
