NS/INC18011762 / KIRBN2**ASSIGNMENT**

Insured: FBG 3169SPolicy No. 5054737160-05 01062018-310519Claims No. MT/1000516-002

Veh No: SHA 4414M Yr Regn: 30 Apr 2011

ADJUSTMENT ON REPAIR COST FOR VEHICLE NO. SHA 4414M

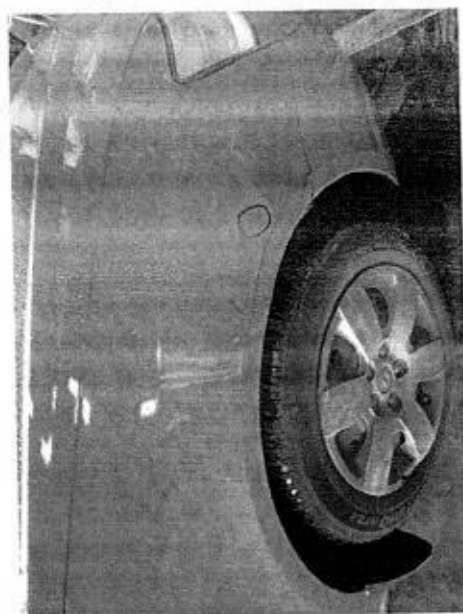
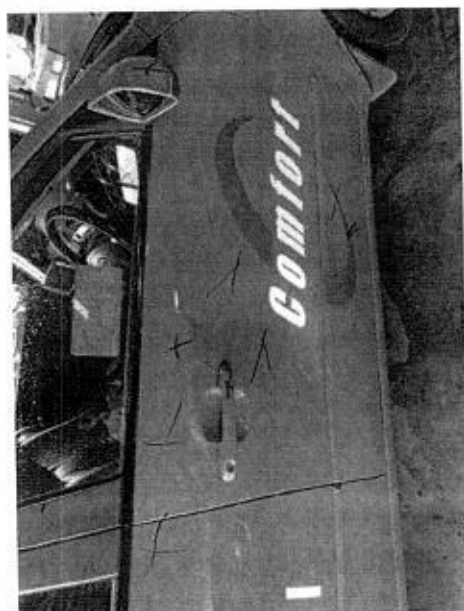
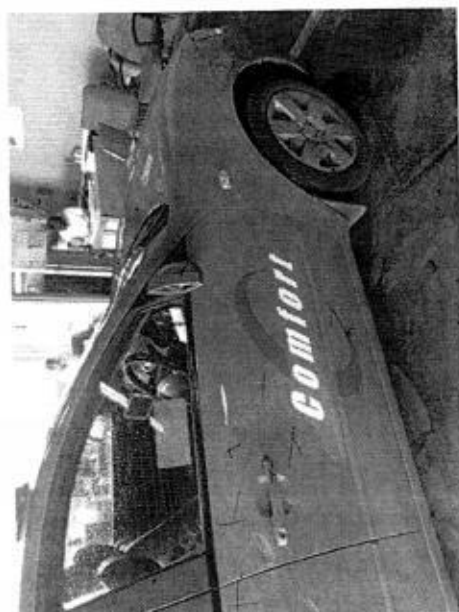
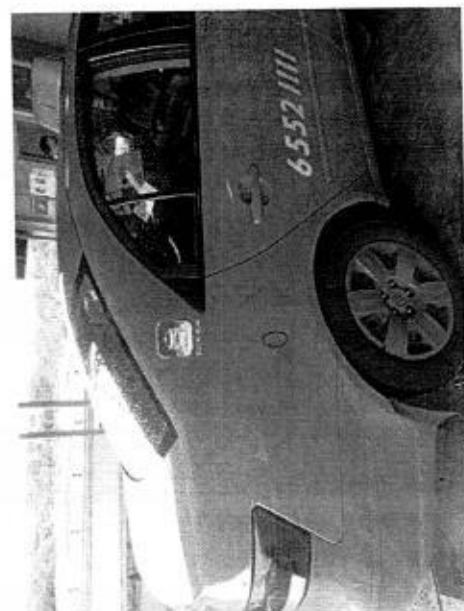
The U/C / Chassis frame / Body Structure affected due to collision.

4. Description of Damages				
THE VEHICLE SUSTAINED DAMAGES AT THE O/S BODY. DAMAGES SEE DETAILS.				
5. General Information				
Accident Date	27/06/2018	Inspection Date	27/06/2018	
Survey held at	COMFORTDELGRO ENGINEERING PTE LTD 59 LOYANG DRIVE SINGAPORE 508969			
5a. Remarks				
A)THE INSPECTION WAS CONDUCTED ON A"WITHOUT PREJUDICE" BASIS. B)IN ACCORDANCE TO YOUR INSTRUCTIONS, WE HAVE NOT AUTHORISED REPAIRS.				
5b. Estimate Days of Repair				
ESTIMATED NORMAL PERIOD FOR REPAIR:		2 Working Days

Qty	Description of Parts	Condition	Estimate By Workshop (\$)	Our Adjusted (\$)
<u>REPLACEMENT OF PARTS</u>				
1	FRONT DOOR (RH)	DENTED	1,344.50	1,344.50
1	FRONT DOOR OUTER HANDLE (RH)	TO REPAIR SEE LABOUR	37.00	-
1	FRONT DOOR MIRROR (RH)	TO REPAIR SEE LABOUR	545.50	-
1	FRONT DOOR PROTECTOR (RH)	TO REPAIR SEE LABOUR	74.90	-
1	REAR DOOR (RH)(NPA)	TO REPAIR SEE LABOUR	-	-
	LESS 20% DISCOUNT		-400.38	-268.90
			1,601.52	1,075.60
<u>SPECIAL NETT ITEMS</u>				
1	FRONT DOOR COLOURED COMFORT LOGO (RH)(SN)	NECESSARY	75.00	75.00
1	REAR DOOR COMFORT LOGO (RH)(SN)	NECESSARY	10.00	10.00

85.00	85.00
<u>LABOUR</u>				
	PANEL BEATING.INCLUSIVE OF THE REPAIR OF FRONT DOOR OUTER HANDLE (RH),FRONT DOOR MIRROR (RH),FRONT DOOR PROTECTOR (RH) AND REAR DOOR (RH).		350.00	200.00
	SPRAY PAINTING CHARGE.		600.00	450.00
	WIRING CHARGE.	NOT NECESSARY	50.00	-
	TUFF KOTE.		50.00	20.00
	TRANSFER OF DOOR.		120.00	50.00

-		-	-
	-		-	-
	-		-	-
			1,170.00	720.00
GRAND TOTAL			2,856.52	1,880.60
RECOMMENDED COST OF LUMP SUM REPAIRS (TO ITS PRE-ACCIDENT CONDITION) (CONFIRMED)				1,450.00
