## Pre-Repair Survey (PRS) Acknowledgement

| Affiliated to Federation Internationale Des Experts En Automobile | | | | |
|---|---|---|---|---|
| THE VEHICLE SUSTAINED DAMAGES AT THE FRONT PORTION.<br>DAMAGES SEE DETAILS. | | | | |

## ADJUSTMENT ON REPAIR COST FOR VEHICLE NO. SLM 80H

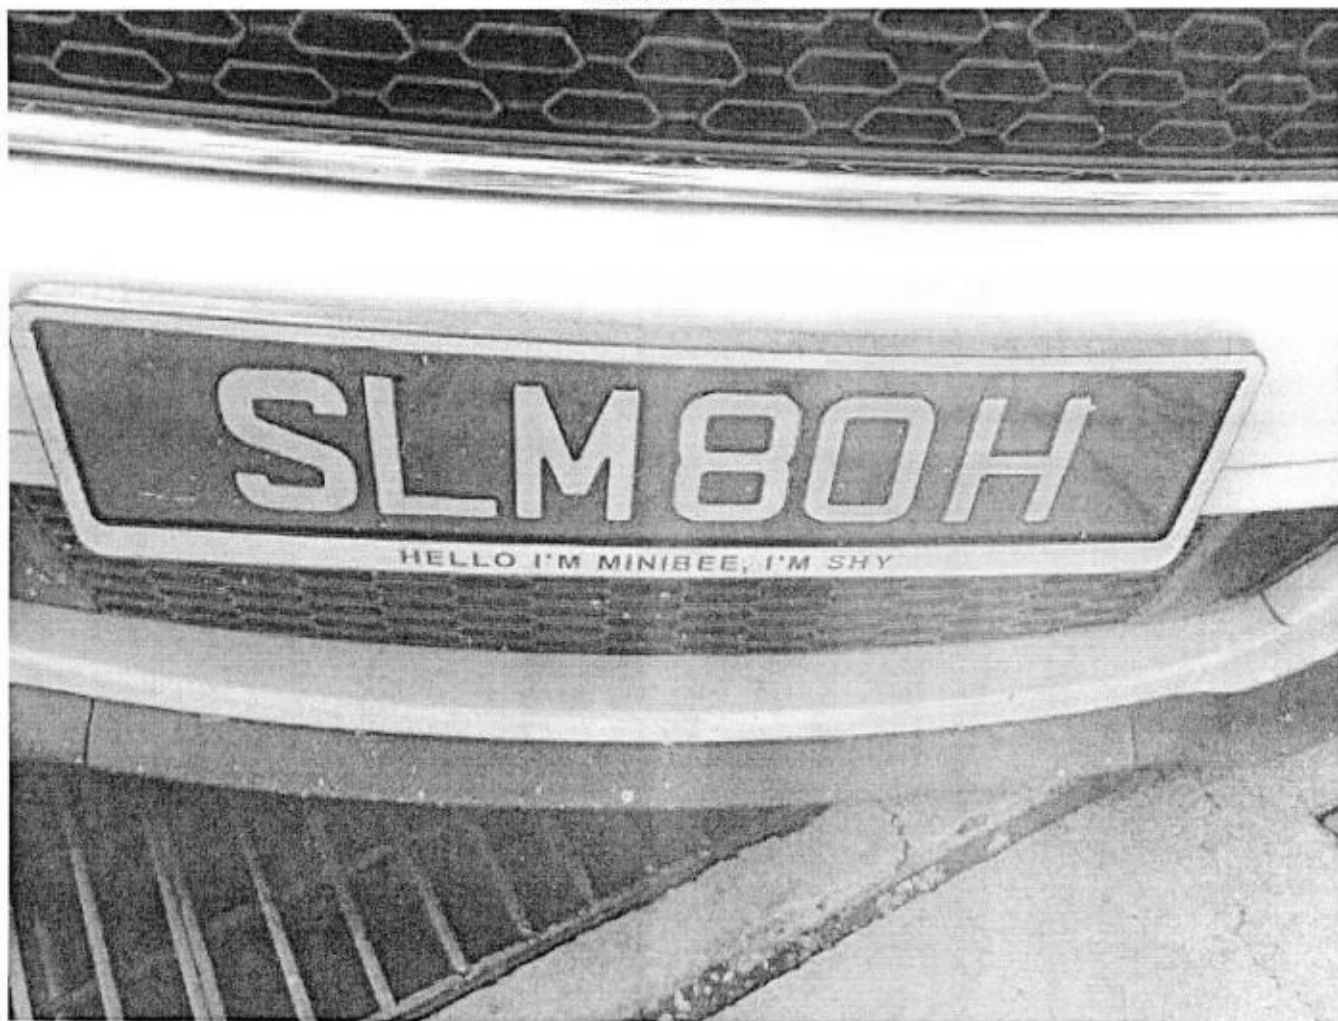
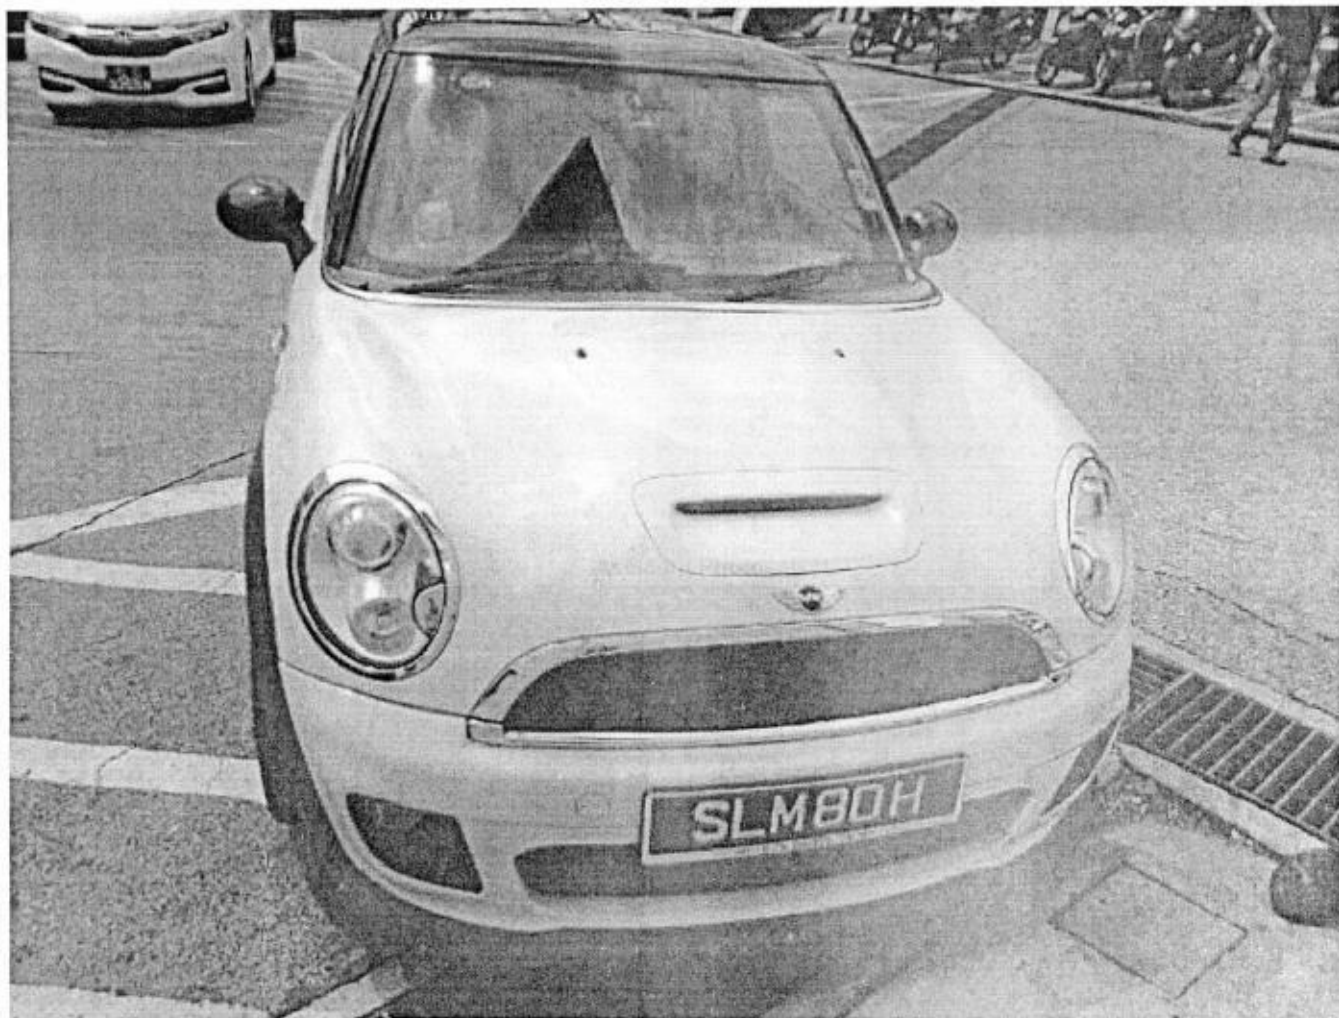
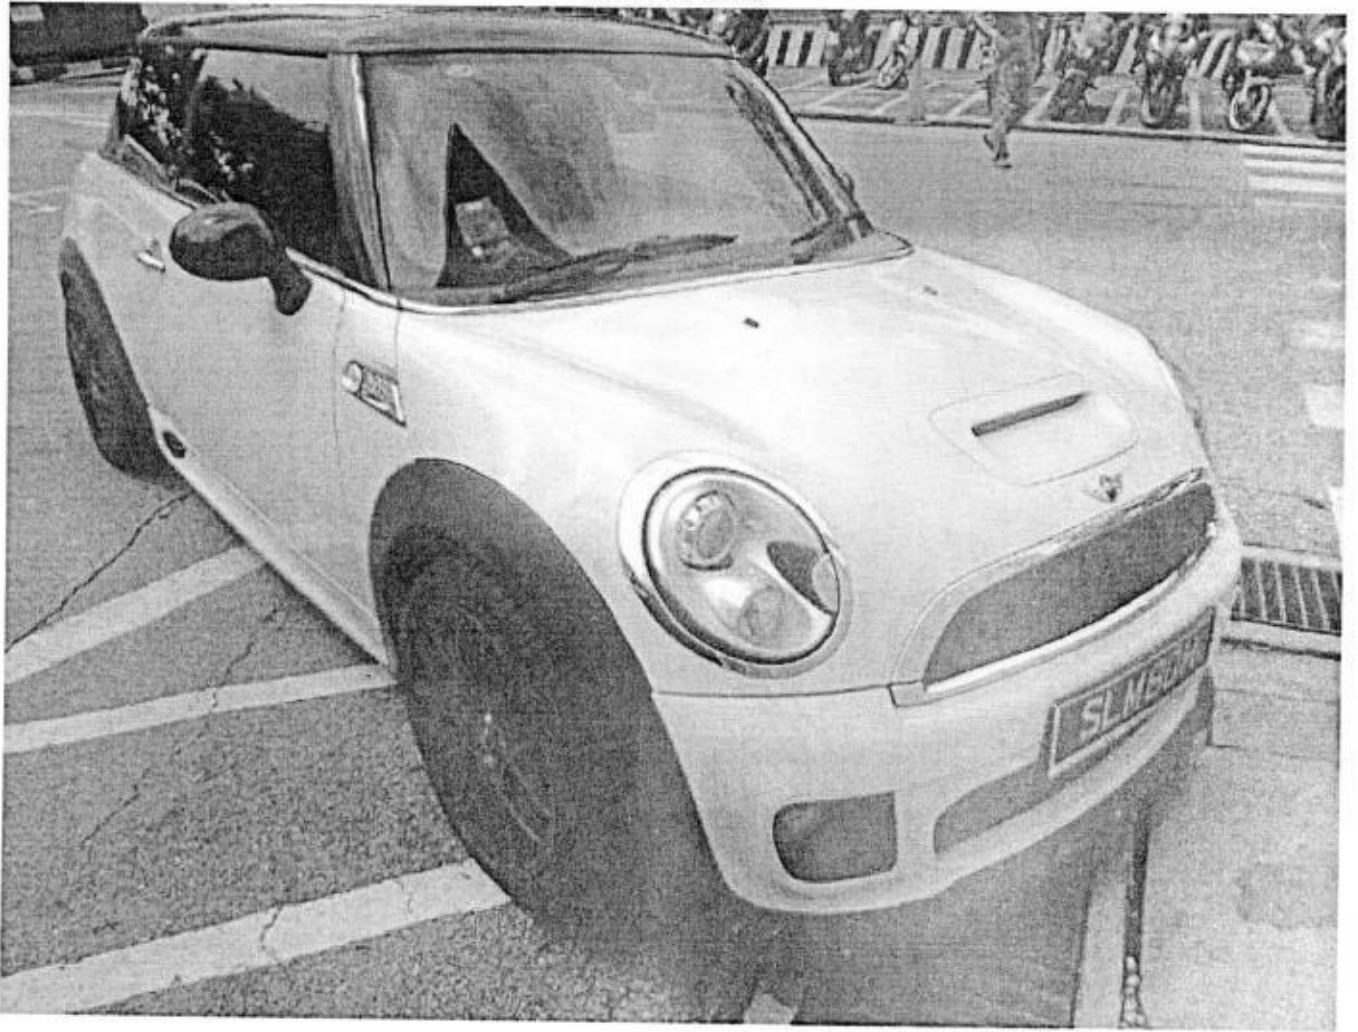
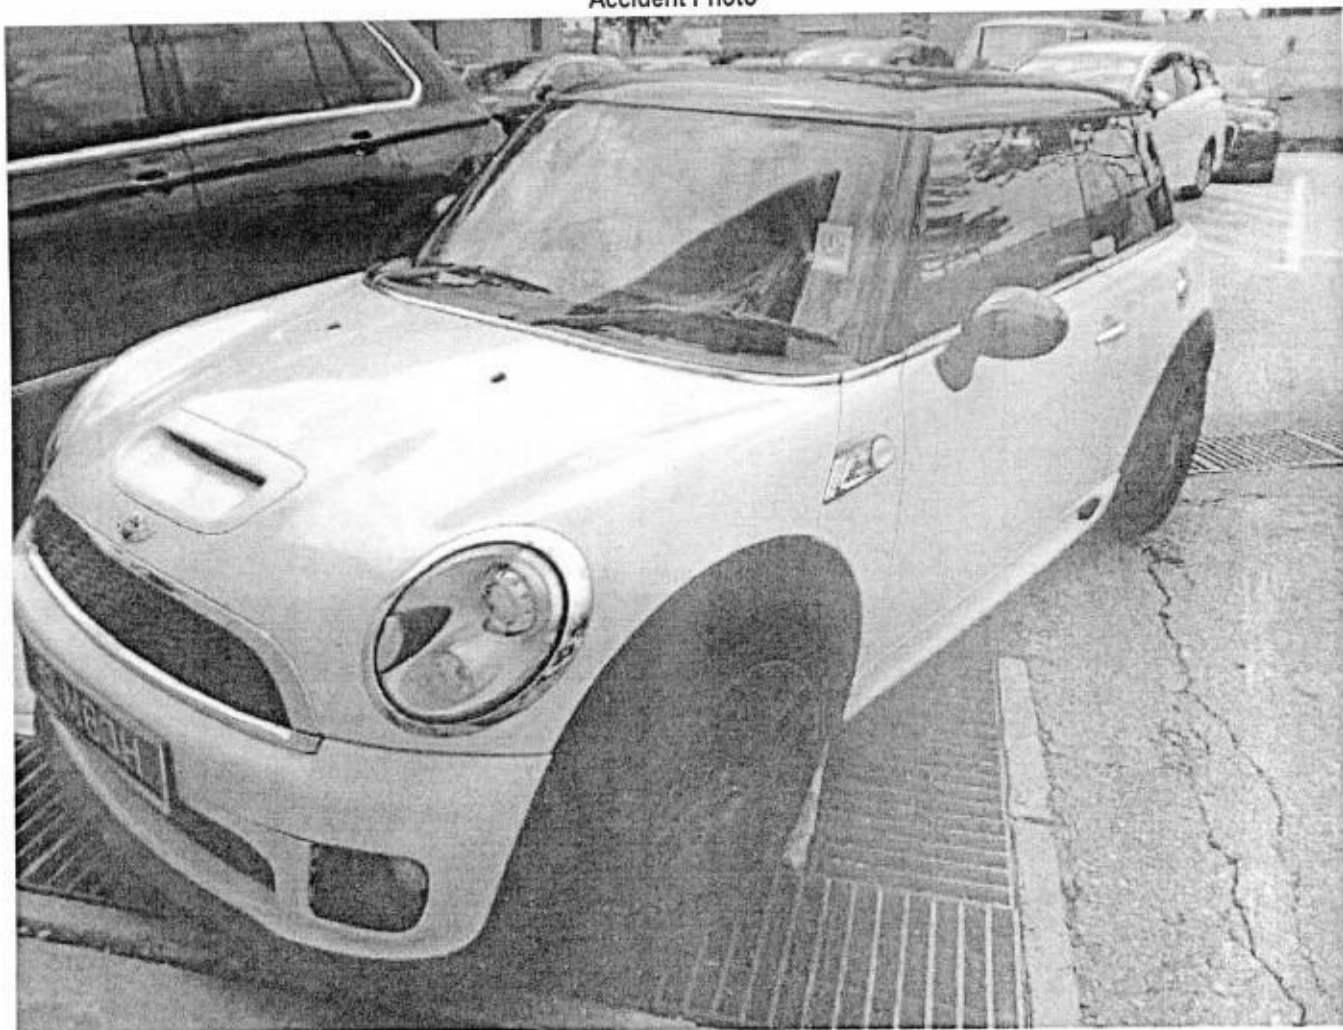
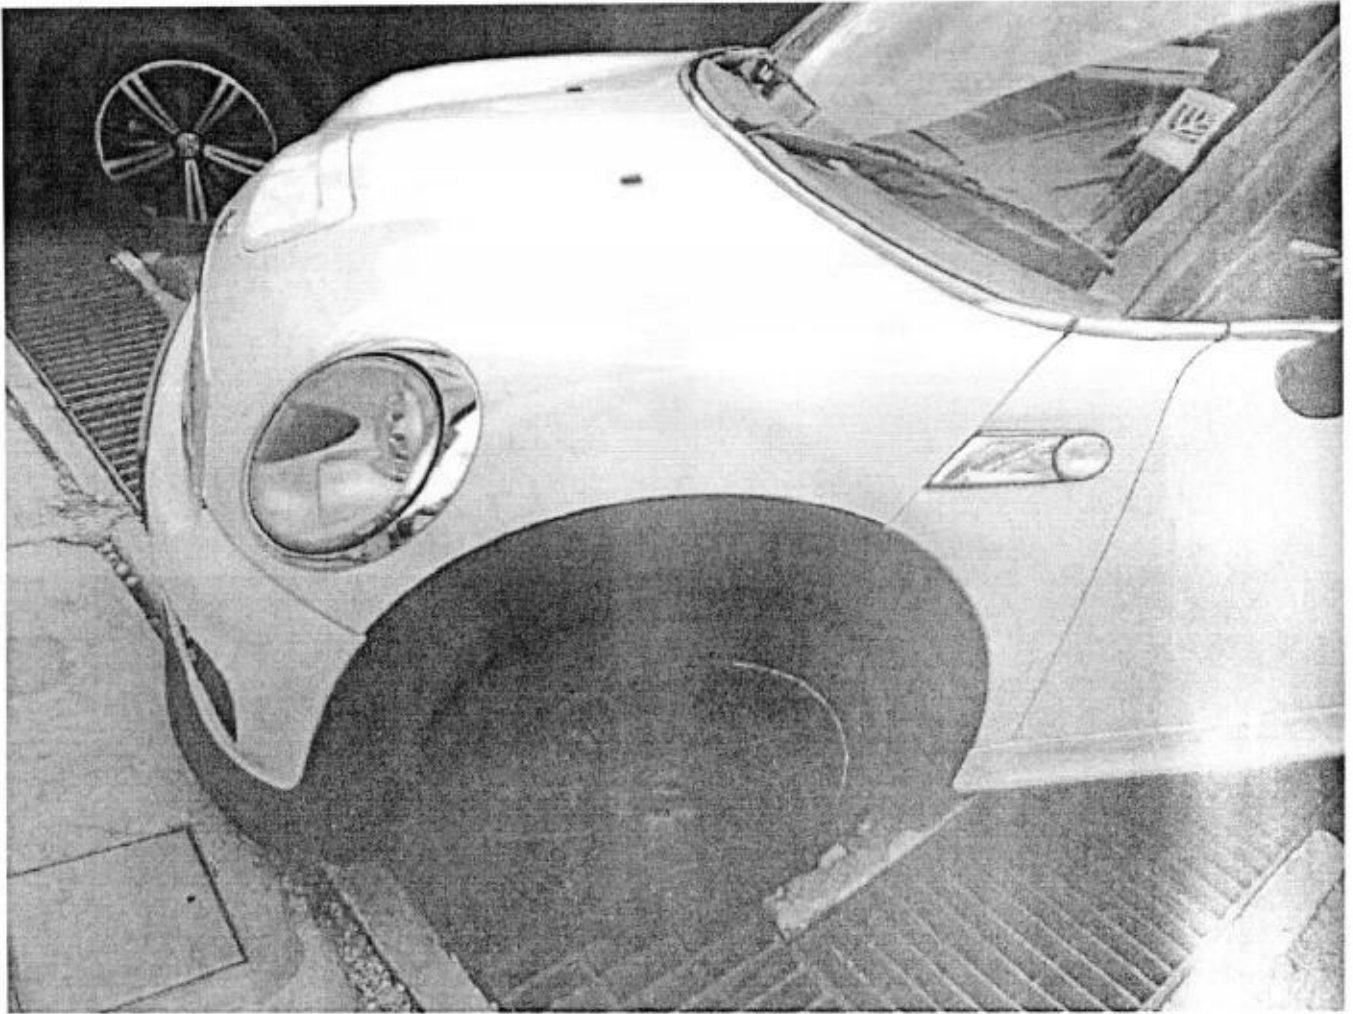
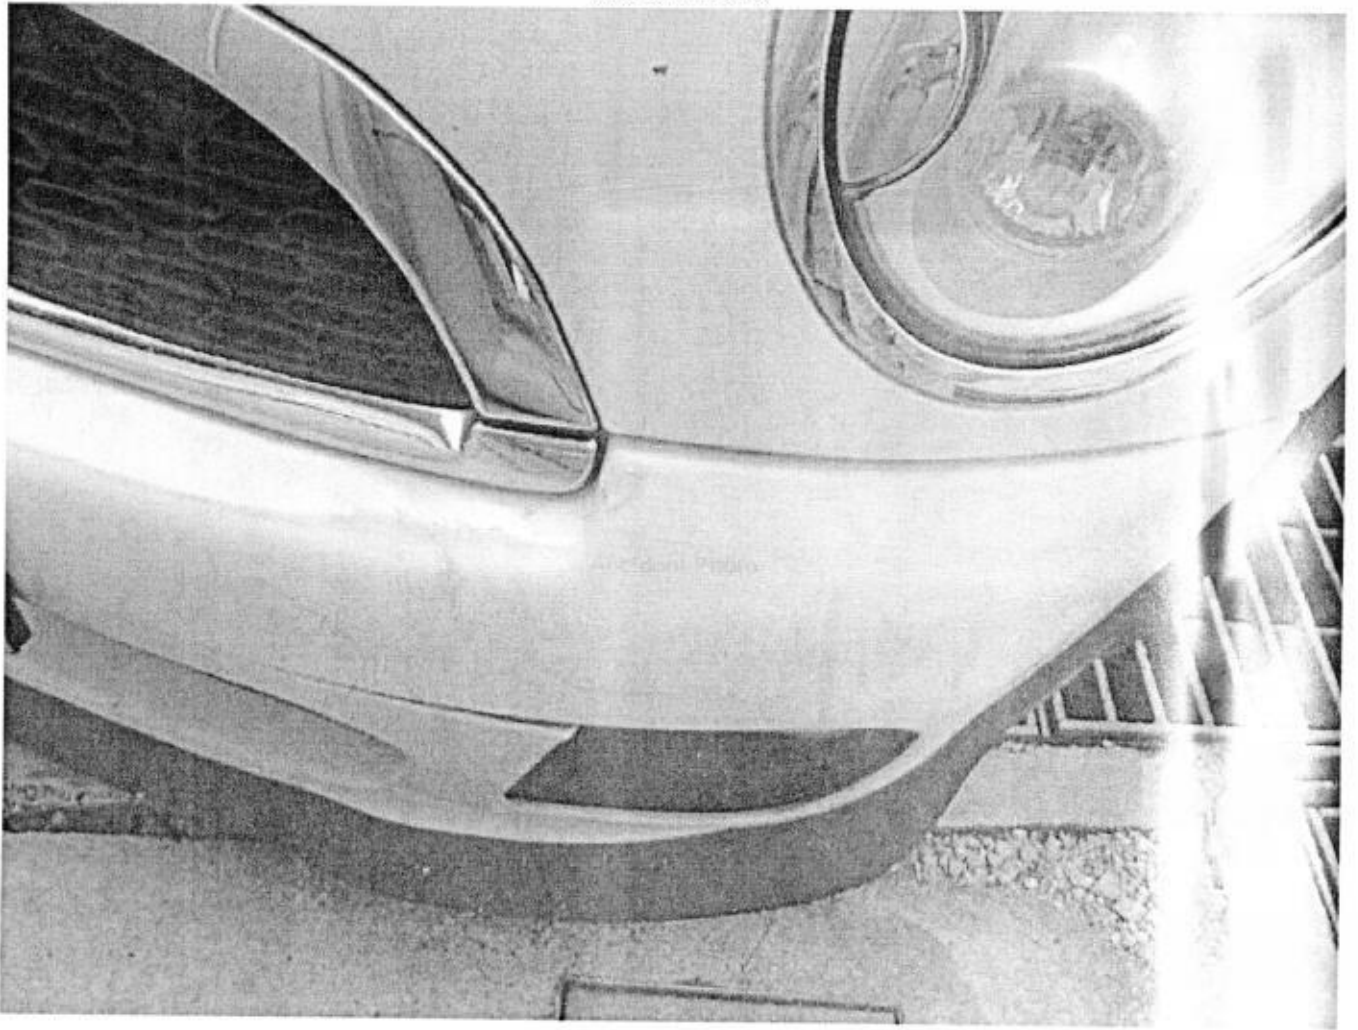
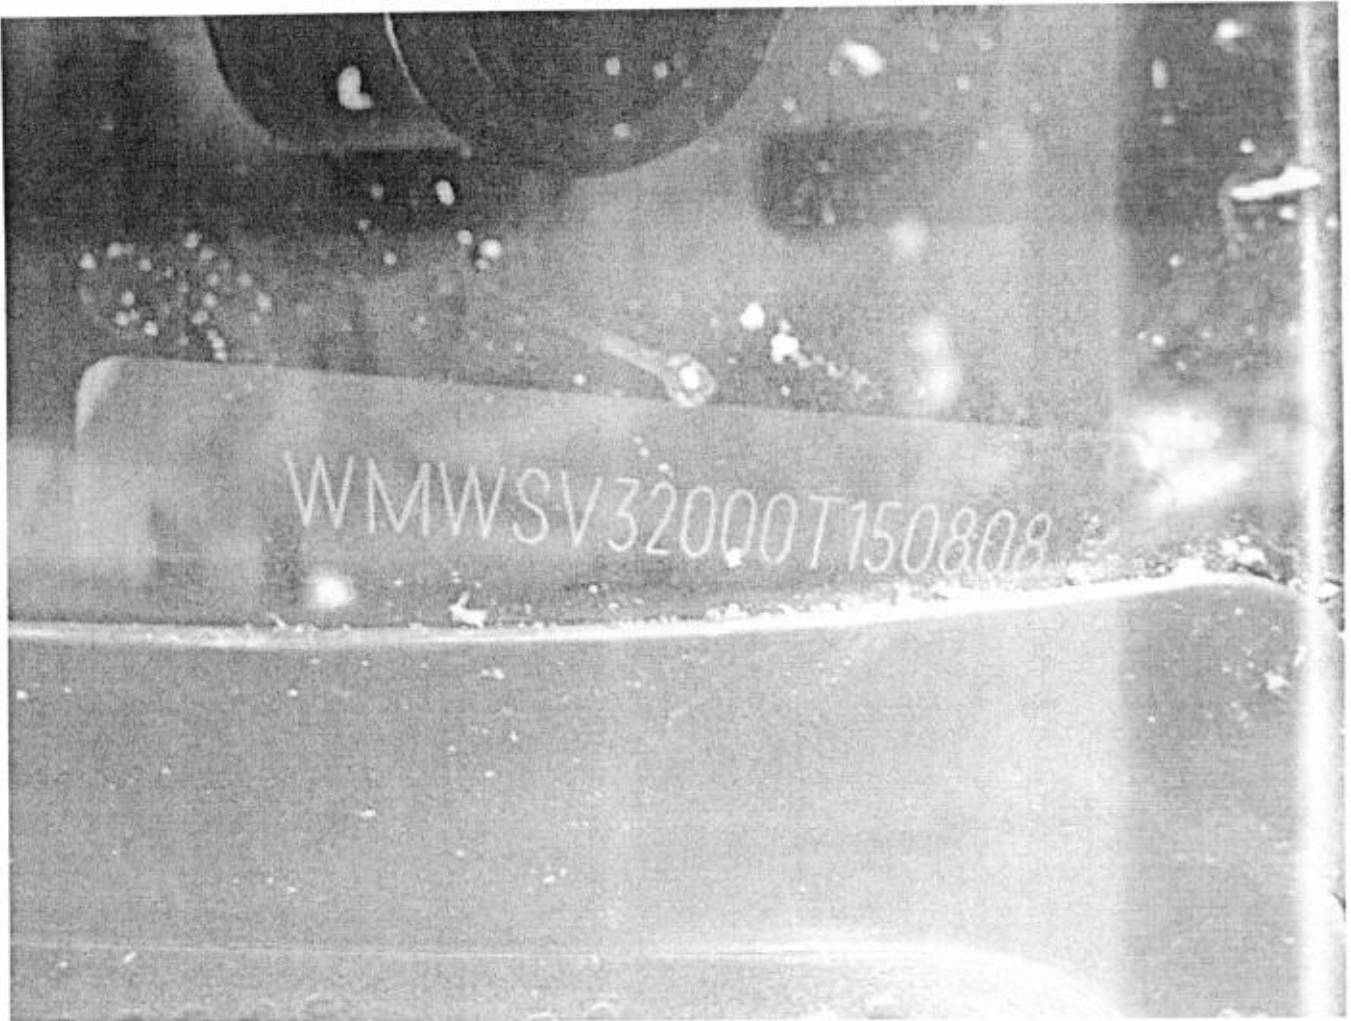
The U/C / Chassis frame / Body Structure affected due to collision.

Accident Photo

| Qty | Description of Parts | Condition | Estimate By Workshop (\$) | Our Adjusted (\$) |
|---|---|---|---|---|
| | <b>RECOMMENDED COST OF LUMP SUM REPAIRS (TO ITS PRE-ACCIDENT CONDITION)</b> | | | <b>3,800.00</b> |
