VEHICLE NO : SHC 8548Z

MODEL : HYUNDAI i40

**RE: ACCIDENT INVOLVING SHC 8548Z / SJZ 8246A On 13.07.2018**

## VEHICLE DAMAGE INSPECTION REPORT

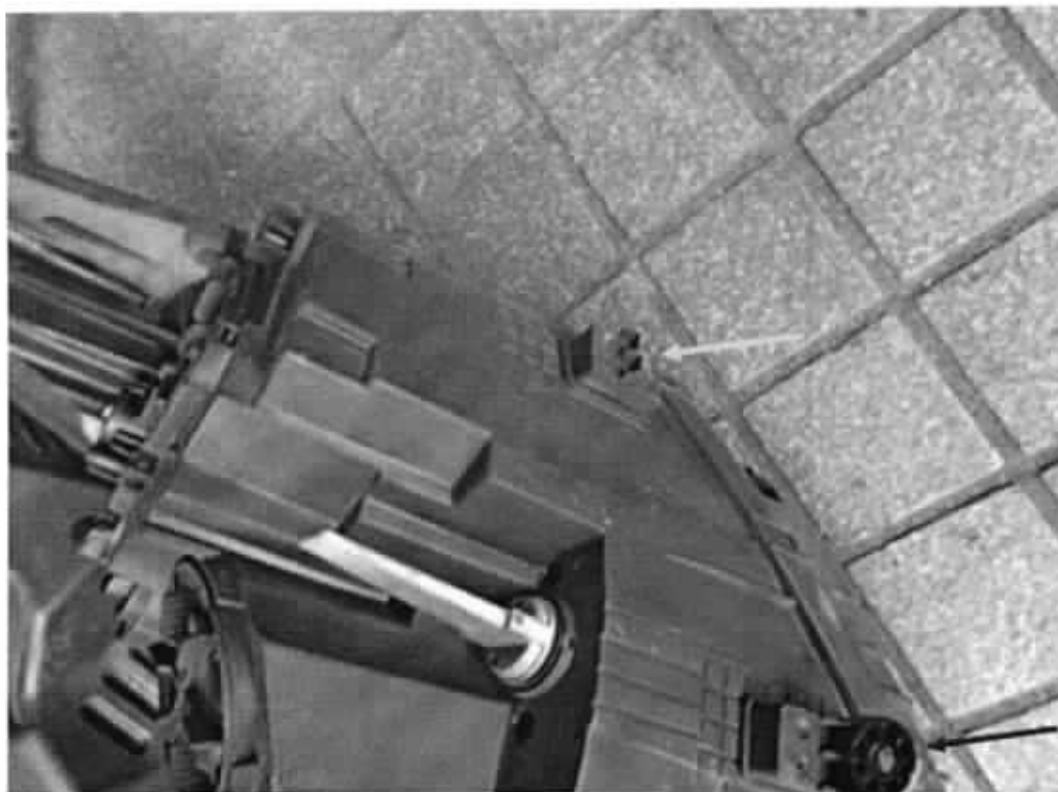
1. Front right headlamp. Photo 73 to 76 in Merimen. The mounting at the bottom of the front right headlamp was found to be broken (yellow arrow vs red arrow in below photo). This mounting is bolted onto the front support panel to secure the headlamp. The front support panel was found to be broken.

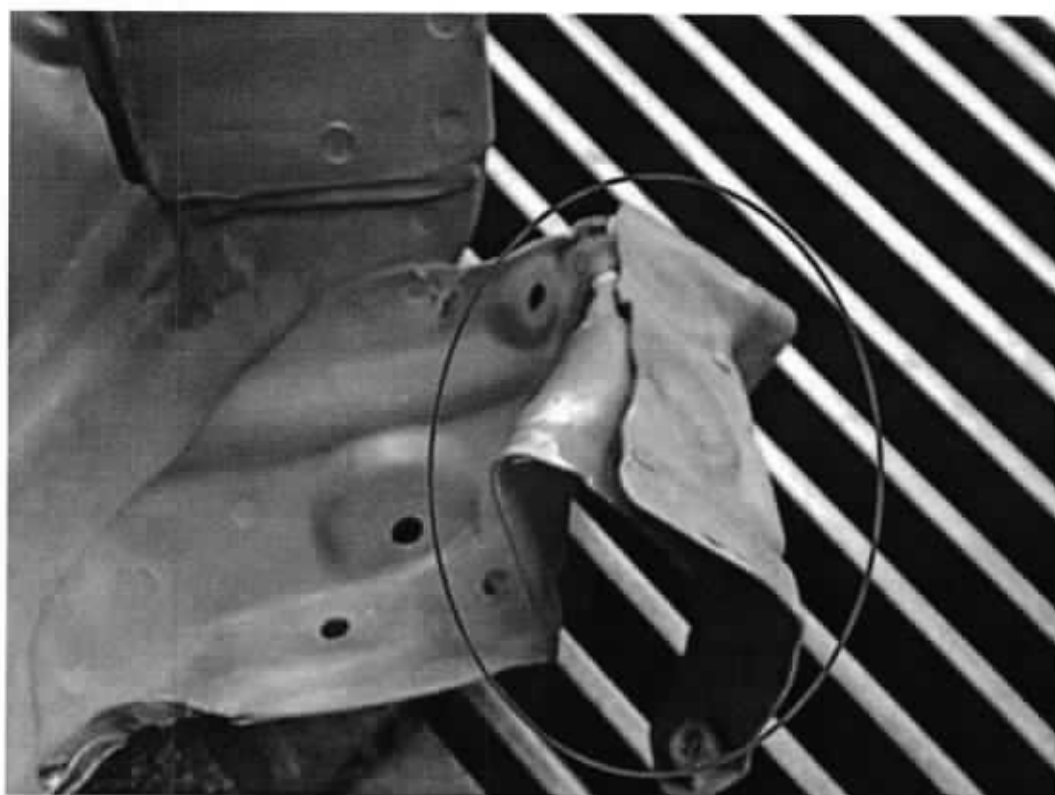
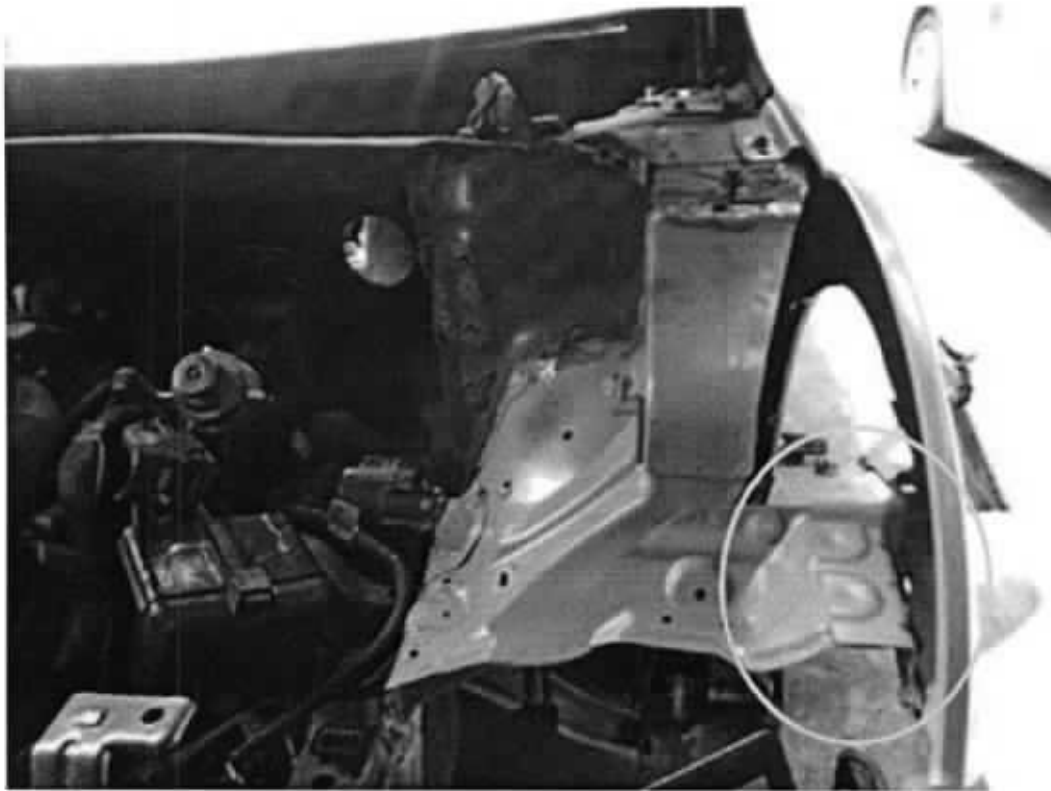
2. LH front fender apron panel. Photo 53 to 58 in Merimen. The apron panel was found to be dented (red circle). The dented area joins onto the inner side of the front left fender, which is circled yellow in the second photo below for your comparison and easy understanding. This second photo is photo 130 in Merimen.

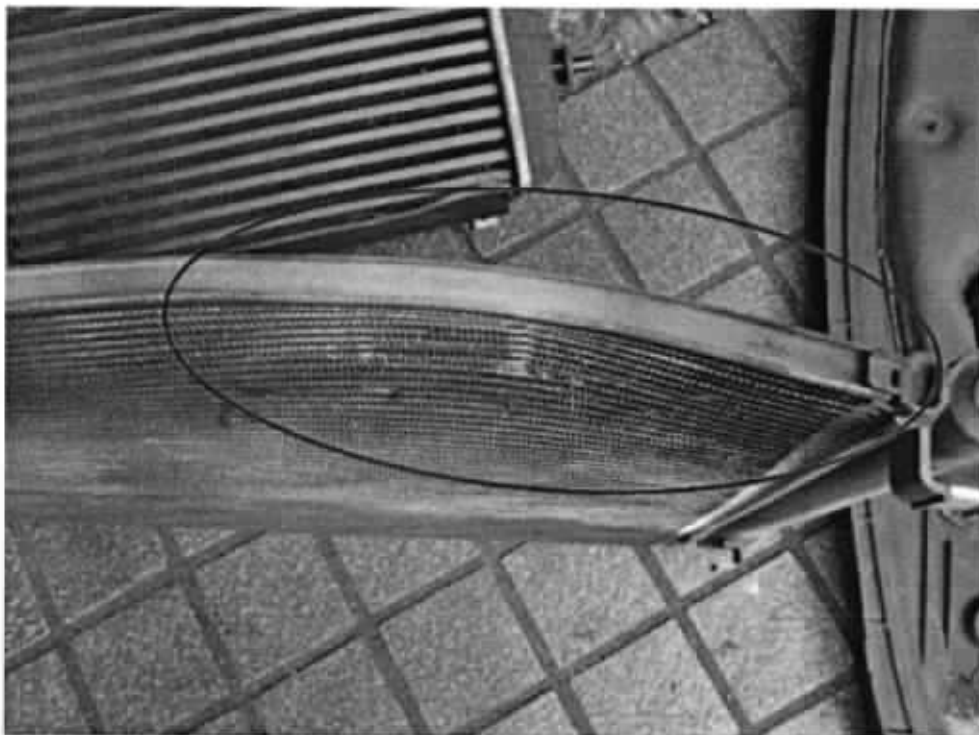
3. Aircon condenser. Photo 112 to 114 in Merimem. The condenser was found to be bent (arrowed) below photo.

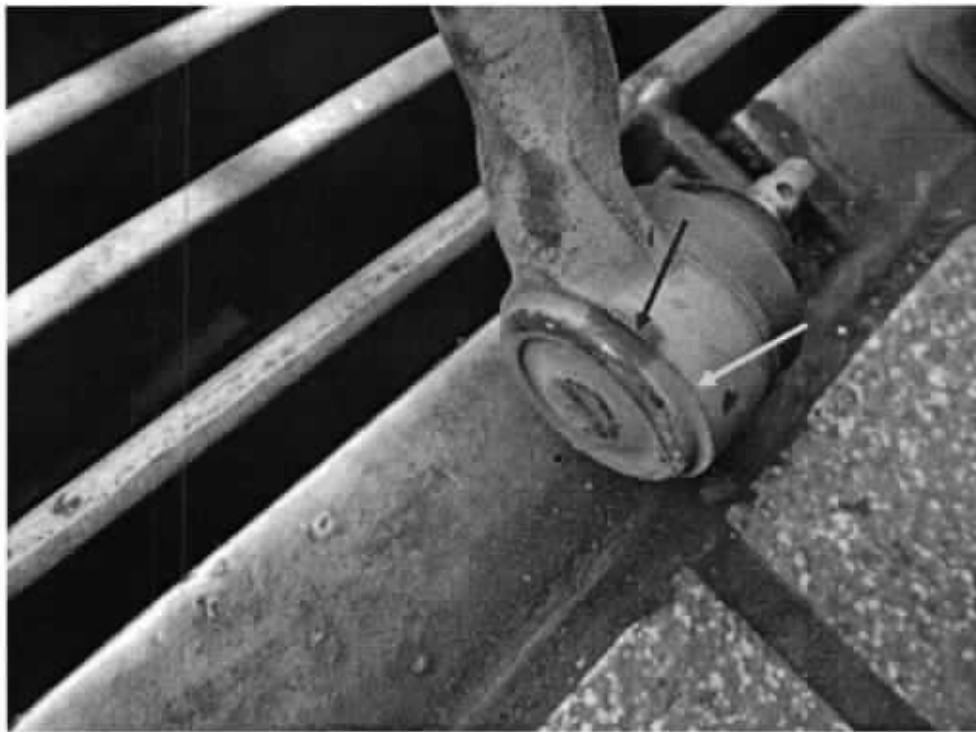
4. Steering tie rod. Photo 90 to 93 in Merimen. Slight distortion (red arrow vs yellow arrow) below photo.

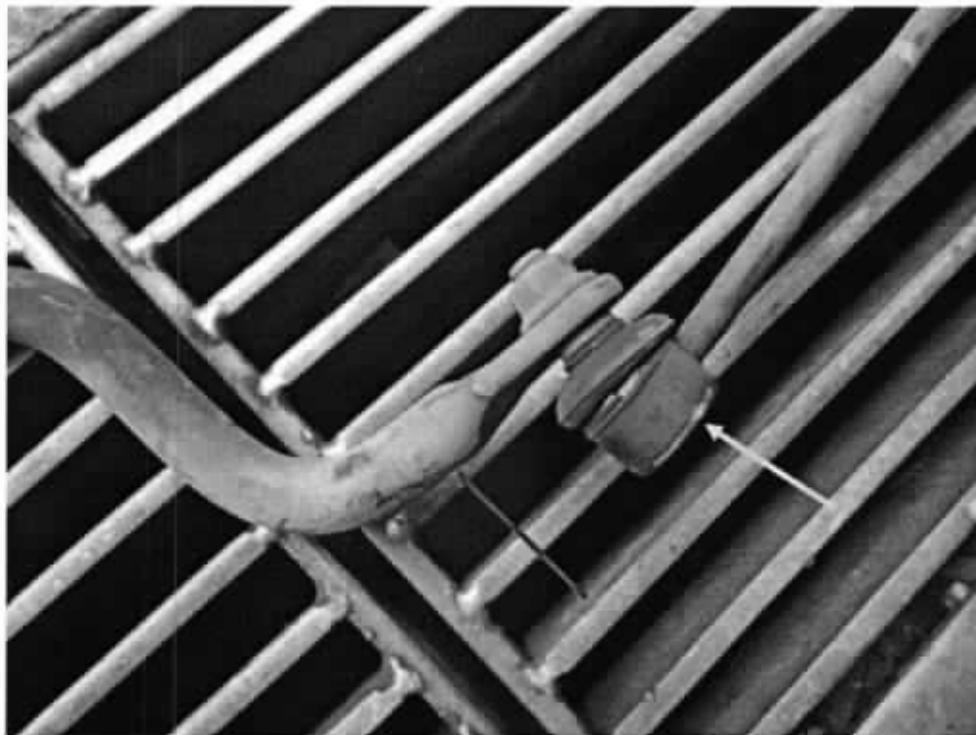
5. Stabilizer bar / link. Photo 94 to 98 in Merimen. Both parts slightly distorted (red arrow for the stabilizer bar and yellow arrow for the link). See photo below.

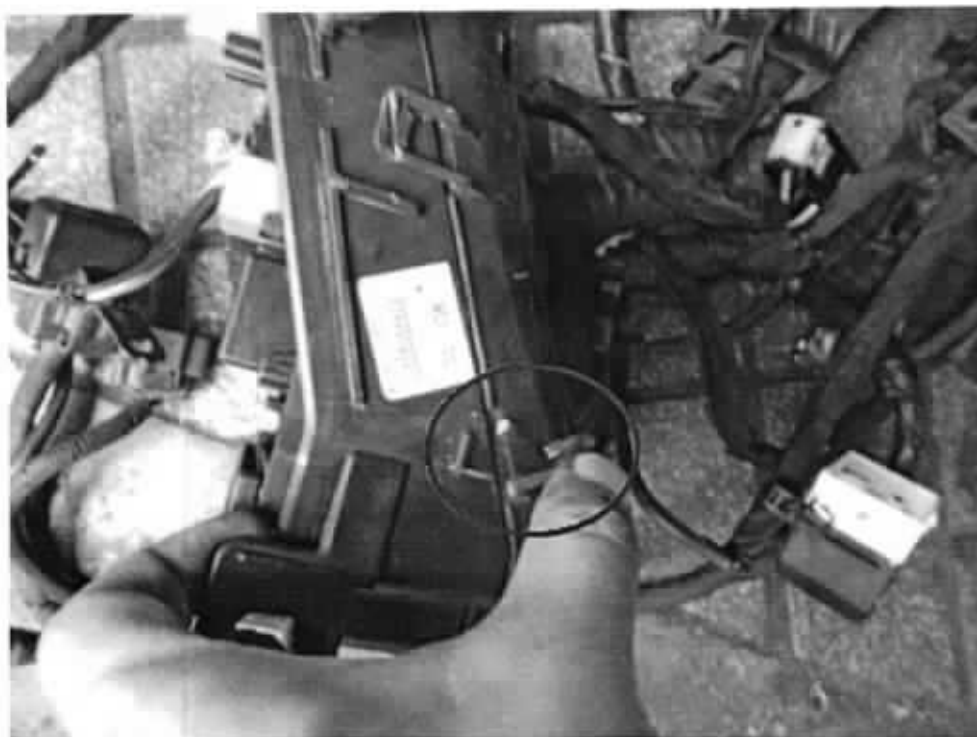
6. Wiring engine. Photo 40 to 43 and photo 121 to 125 in Merimen. The mounting of the housing for the wiring was found to be broken. Photo 40 to 43 shows the housing shifted position before dismantle whereas photo 121 to 125 show the wiring after dismantle with the mounting broken (circled in the below photo).

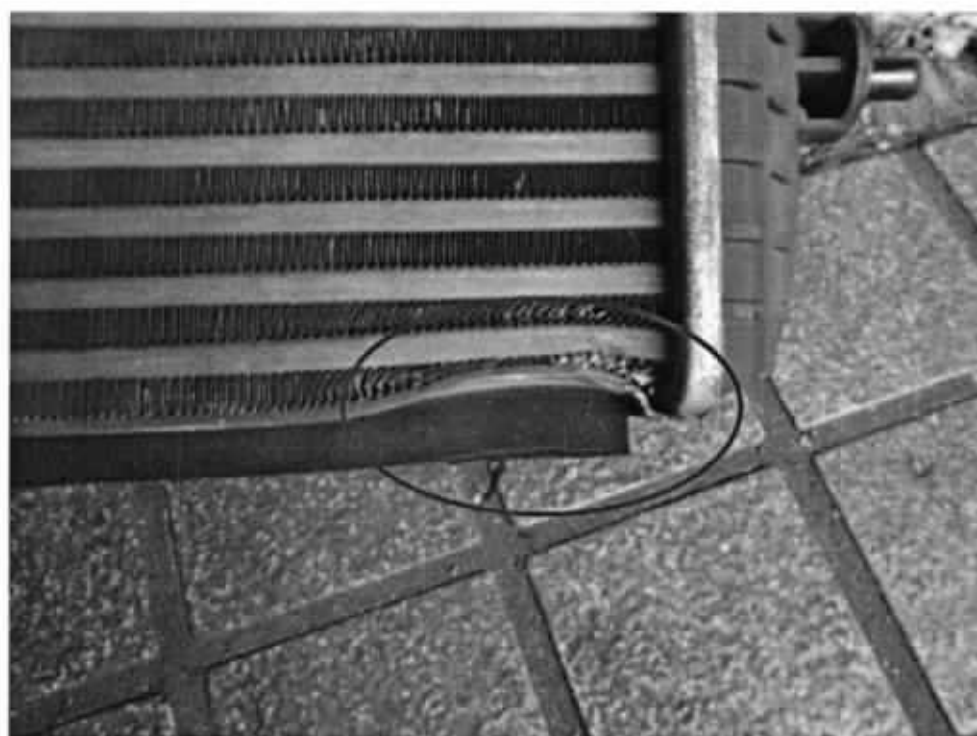
7. Intercooler. Photo 115 to 117 in Merimen. Bent (circled) below photo.
