## SINGAPORE ACCIDENT STATEMENT

### ACCIDENT STATEMENT

Date Of Report	16/07/2018 13:55
Date Of Accident	14/07/2018 20:05
Exact Location Of Accident	JUNCTION OF CCK NORTH 5 / CCK STR 51/52
Country/State of Loss	SINGAPORE

**Accident at the traffic light junction of Choa Chu Kang (CCK) North 5 and CCK Street 51/52 between car number SGT6820 (white BMW520i) driven by Tang Chong Ming (NRIC2504949G) and car number SKG22U (white Alfa Romeo Guiliata) driven by Edison Tan Keng Hui (NRIC S7477110F)**

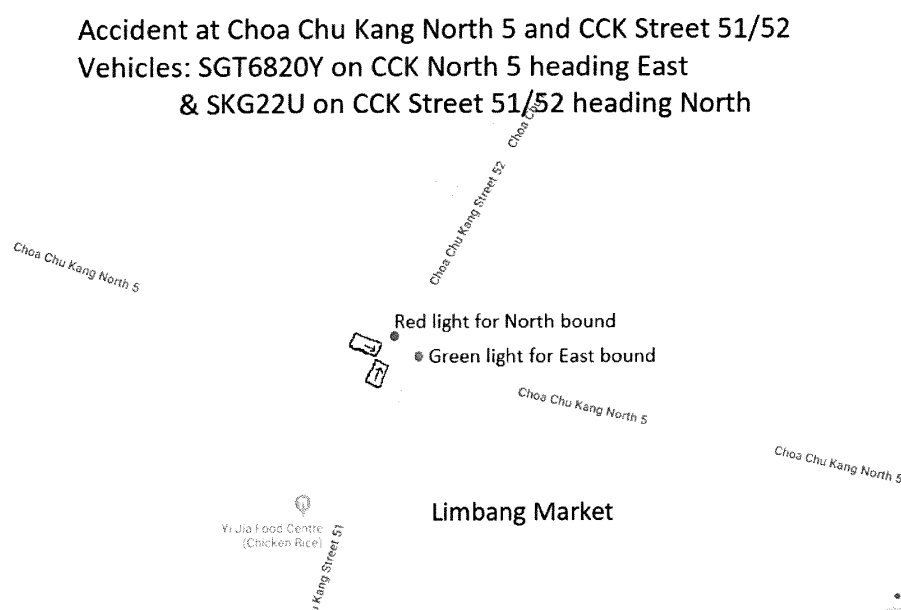
The BMW of Tang was travelling on CCK North 5 East bound.

The Alfa Romeo of Edison was travelling on CCK Street 51 North bound towards CCK Street 52.

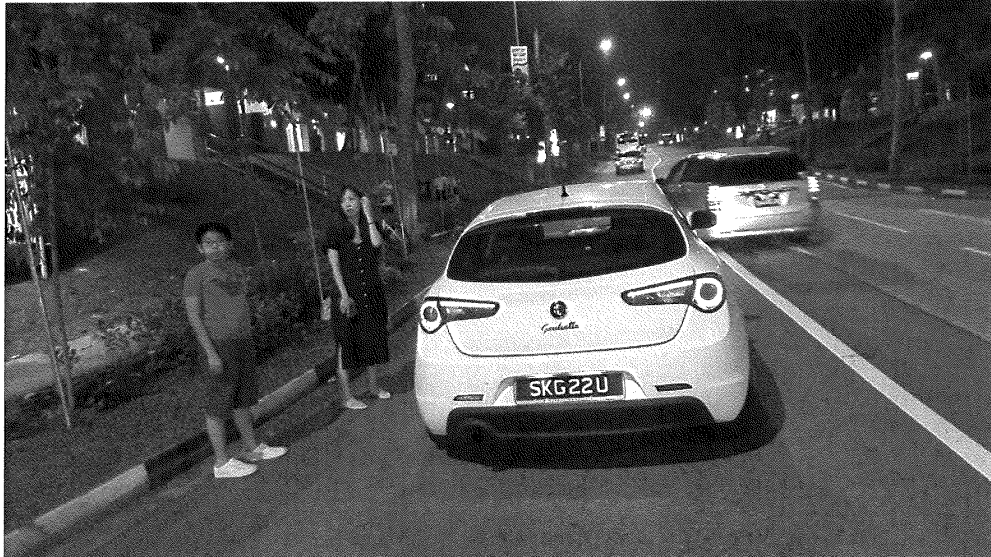
Alfa Romeo SKG22U stopped quite a distance from the traffic junction after the accident. Also showing left rear wheel axil broken (car tilting to left) and woman and boy who were passengers.

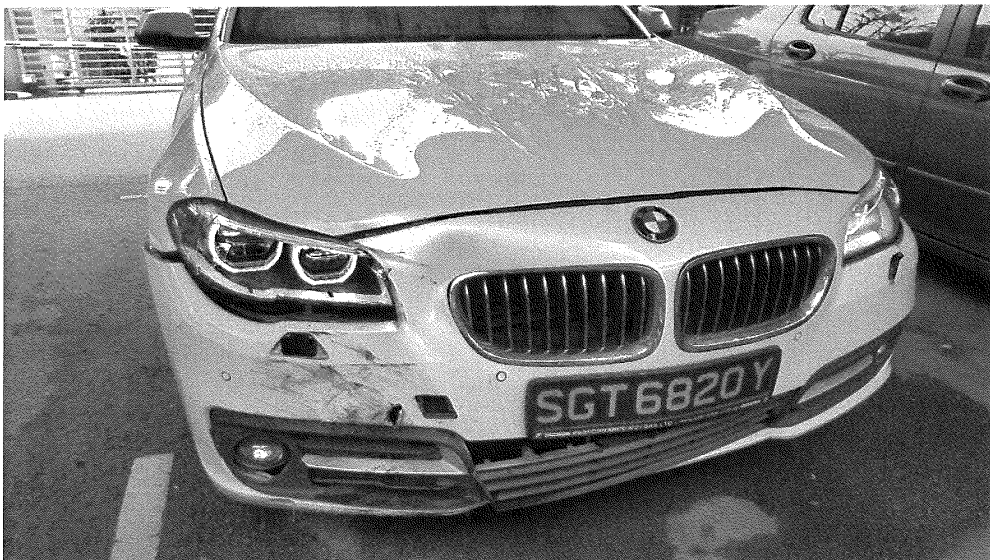
Damage to my BMW520i
