Report Reference : TP / 02-18053/AY / 2018
Date of Report : 23 Mar 2018

THIRD PARTY SURVEY ACCIDENT HAPPENED ON 20 Feb 2018

As per your instruction dated 28 Feb 2018 with regard to the above matter. We have carried out a physical inspection on the said vehicle SJG 8391 M. We enclosed herewith our report and findings as follows:

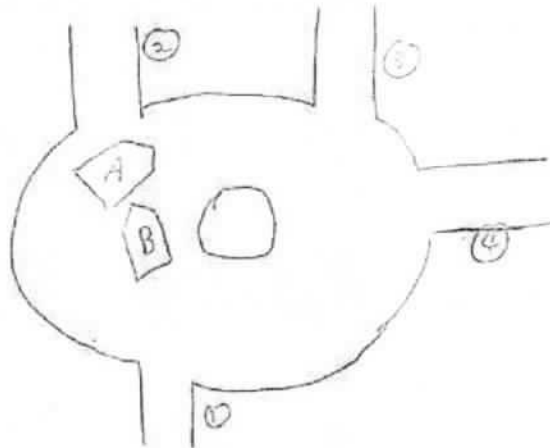
Sketch Plan #2 Pg. 1

Road was clear, hence exited from exit ① using the most outer lane.
 Nearing to exit ②, car ET9RK was trying to exit ^{from the inner lane} and barged into my car.

One car, ET919K, had collided onto the right driver's side and I was unaware where she came from. The impact also caused my car to hit the nearby kerb causing damages on the left side of the car. I then managed to brake fully and resumed control of my car about four car lengths away from the original accident location. I got out of my car and spoke to the driver to assess the damages and exchange particulars. No one was injured at that time.
