To Inspect Vehicle No:

# LKK Auto Consultants Pte Ltd

## 1. Policy Particulars :- THIRD PARTY CLAIM

## VEHICLE DAMAGE INSPECTION REPORT

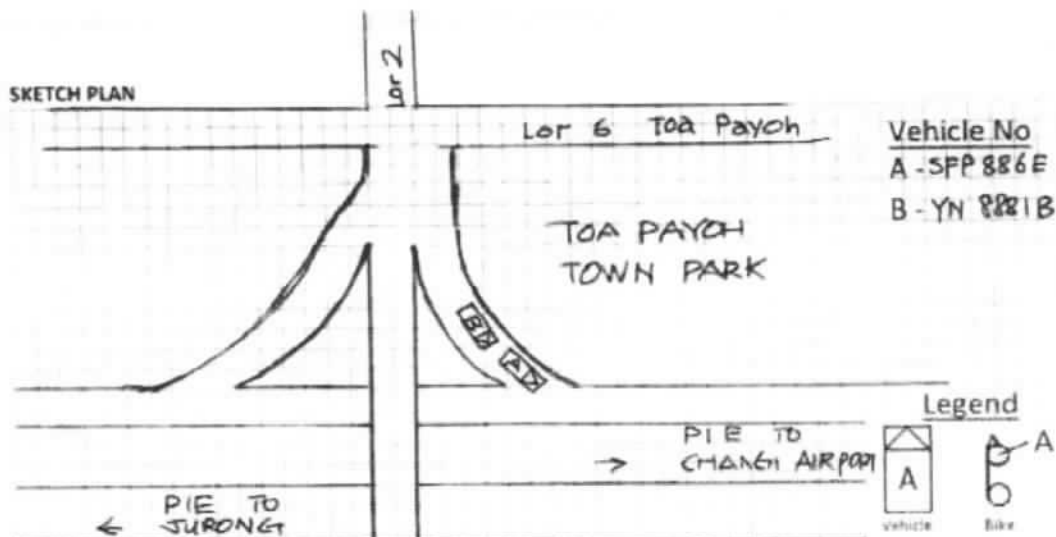
# Sketch Plan #2

Vehicle No  
A - SFP 886 E  
B - YN 8881 B

On 18/07/2018 around 11:45 AM, I was driving along Toa Payoh Lor 2 towards PIE ~~town~~, and I was at giving way, Suddenly the vehicle B (YN 8881 B) behind me hit the rear of my vehicle. Because of that my vehicle rear portion has accident damaged serious.
