## 1. Policy Particulars :- THIRD PARTY CLAIM

THE VEHICLE SUSTAINED DAMAGES AT THE O/S BODY. DAMAGES SEE DETAILS.
--

## ADJUSTMENT ON REPAIR COST FOR VEHICLE NO. SLB 9131T

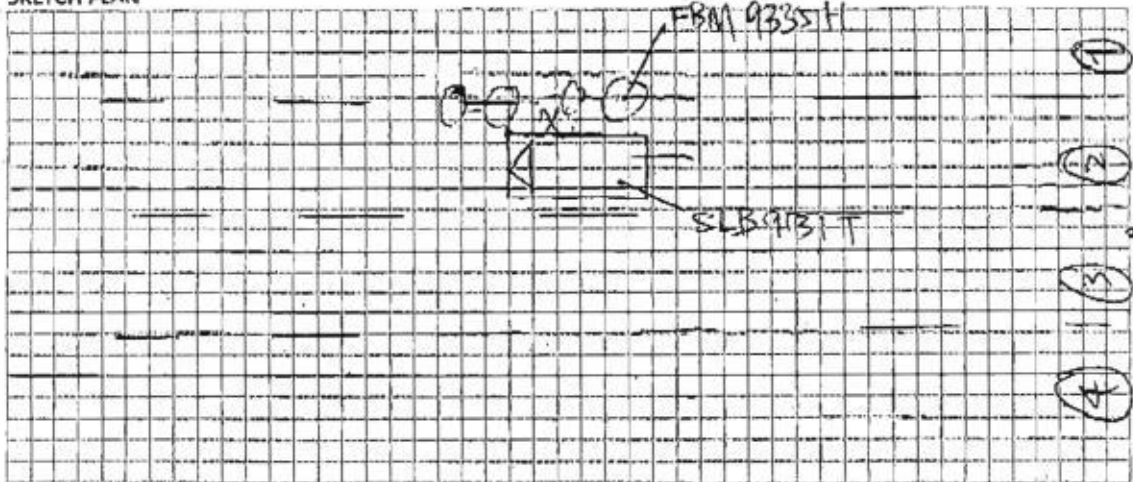
SKETCH PLAN

I was driving along Jalan Taci Payoh (PIE) on 12/7/18 at about 645pm. Traffic volume was moderate. I was driving on the second lane. I saw two bikes on my right side in between lane 1 and lane 2. Suddenly I heard a bang on the right side of my car. I stopped my car in front. I alighted from my car and I saw the bike, <sup>and the rider</sup> lying on the road. Immediately I ran over to assist him. The rider told me that he tried to avoid a car on his right side. His bike swerved and skidded thus hit the right side of my car. We exchanged our particulars.
