## ASSIGNMENT

Veh No: GBD898G Yr Regn: 2014 Jne

Make: Citroen Berlingo cc: 1560Colour: white Insured / Std / NI / NASp. Reading: 102385 T/Radio: Insured / Std / NI / NA

## VEHICLE DAMAGE INSPECTION REPORT

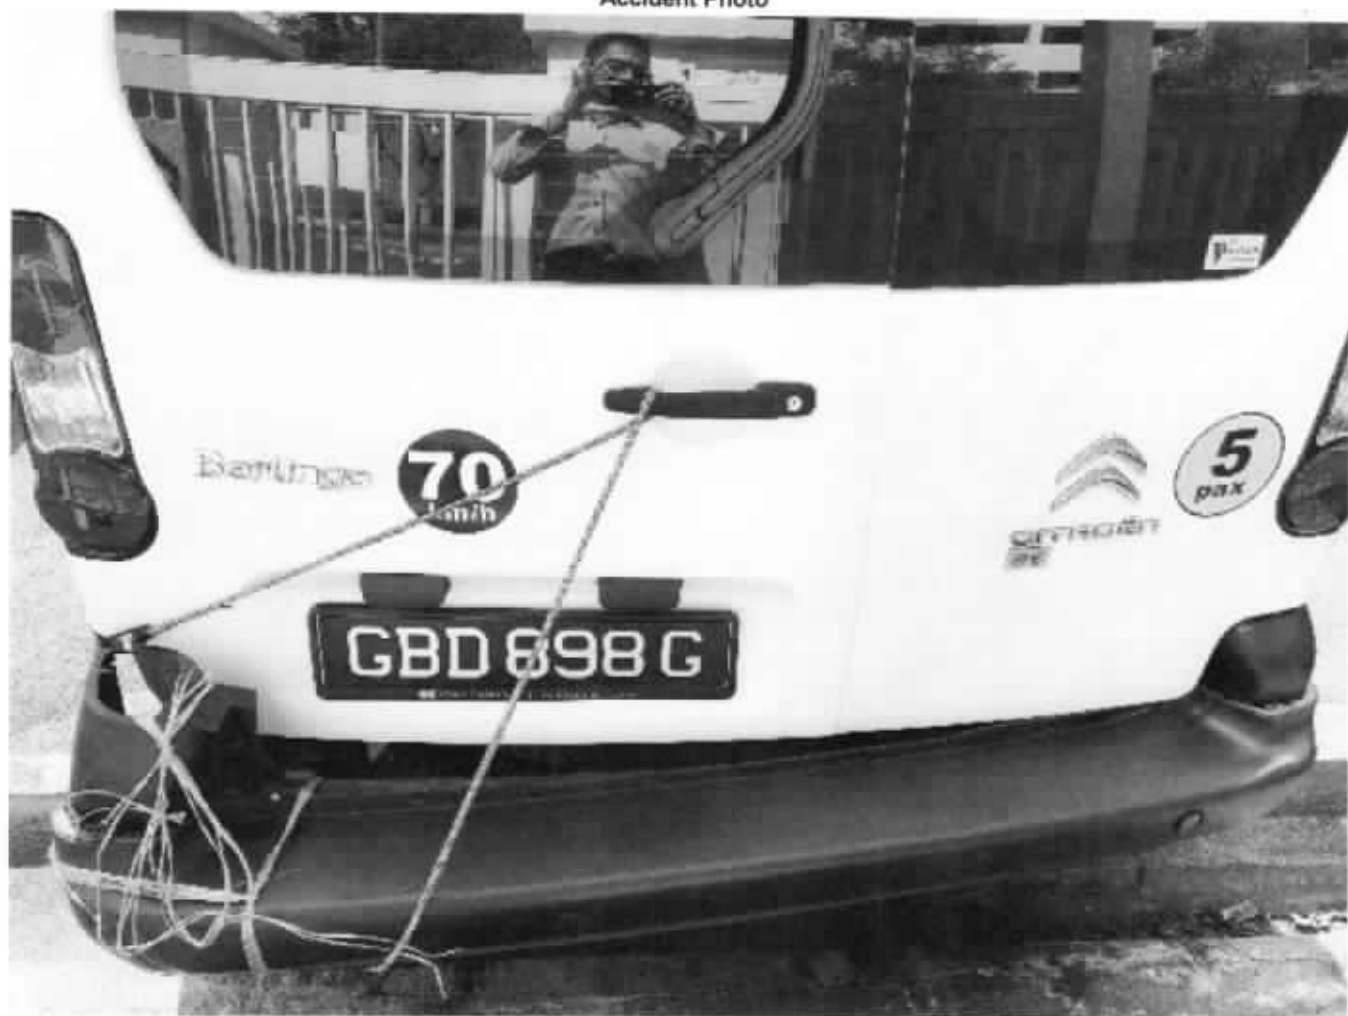
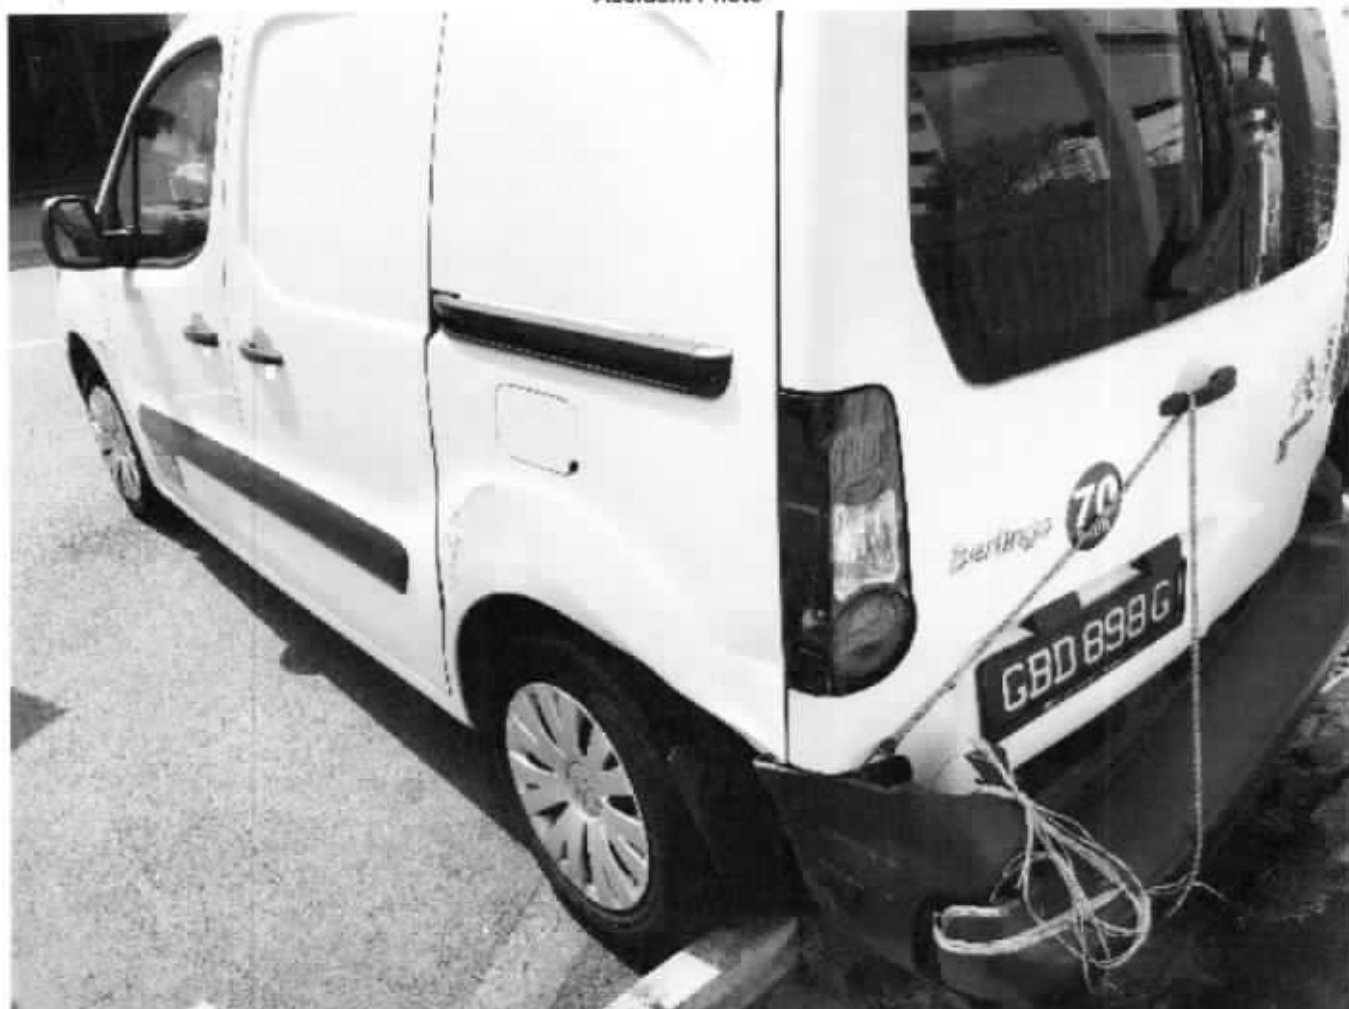
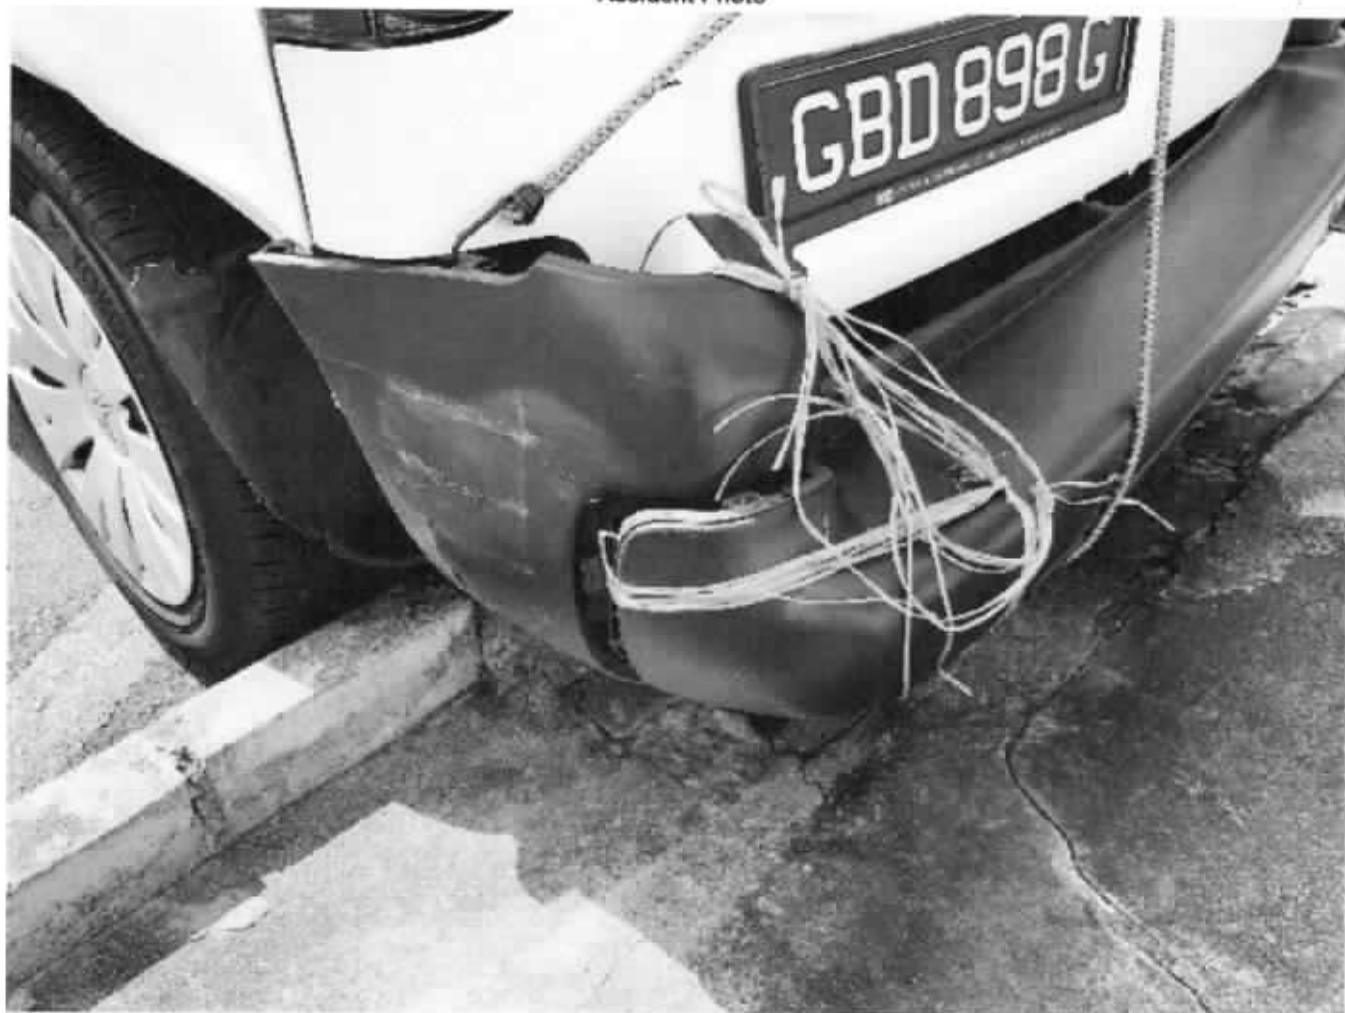
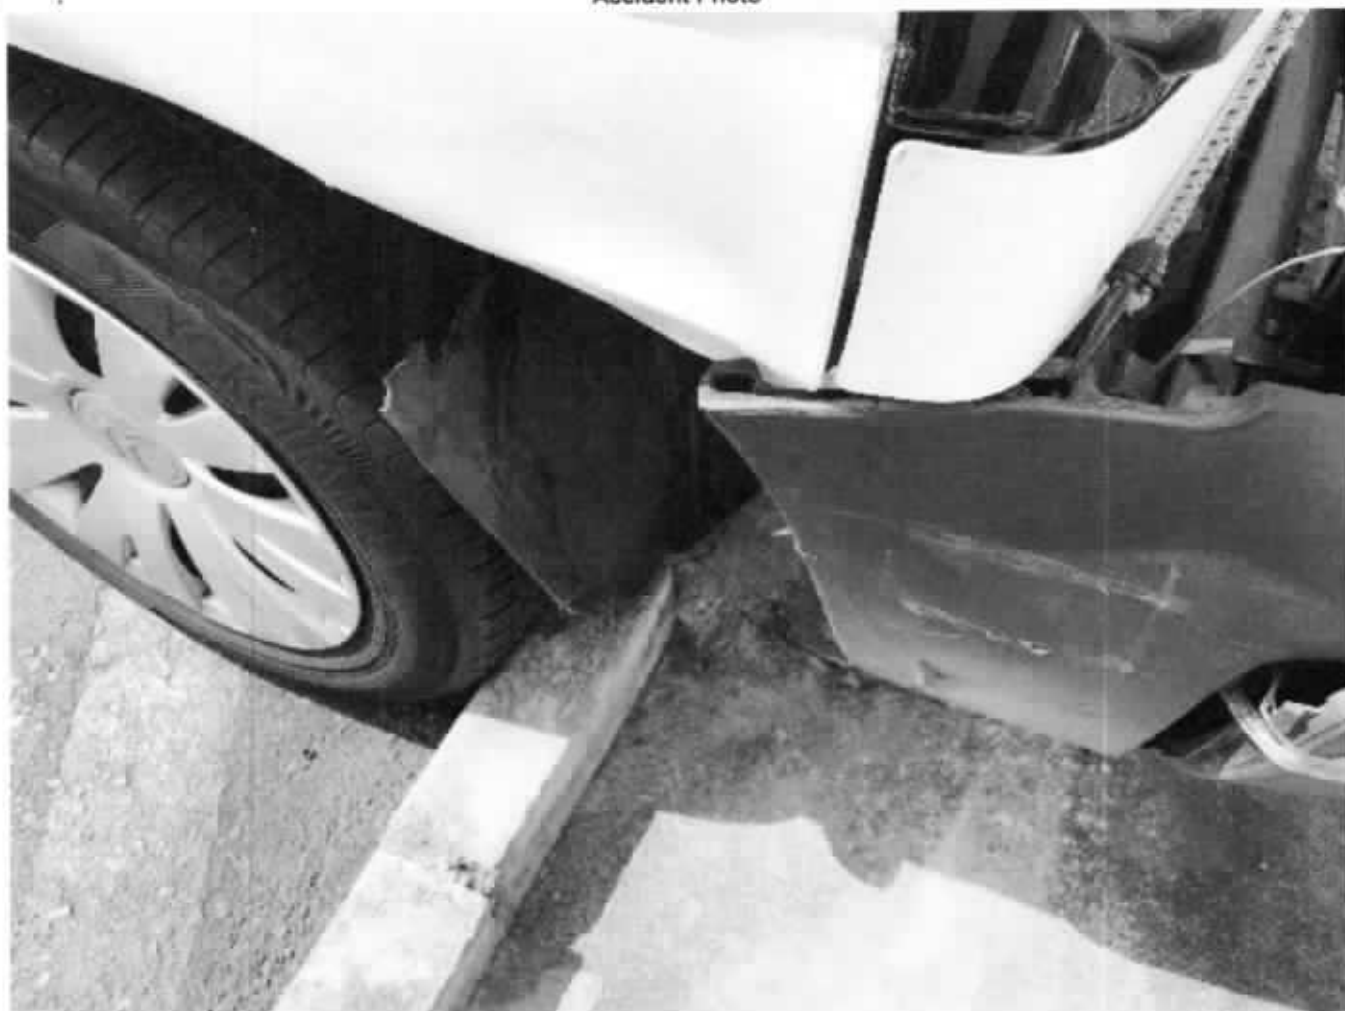
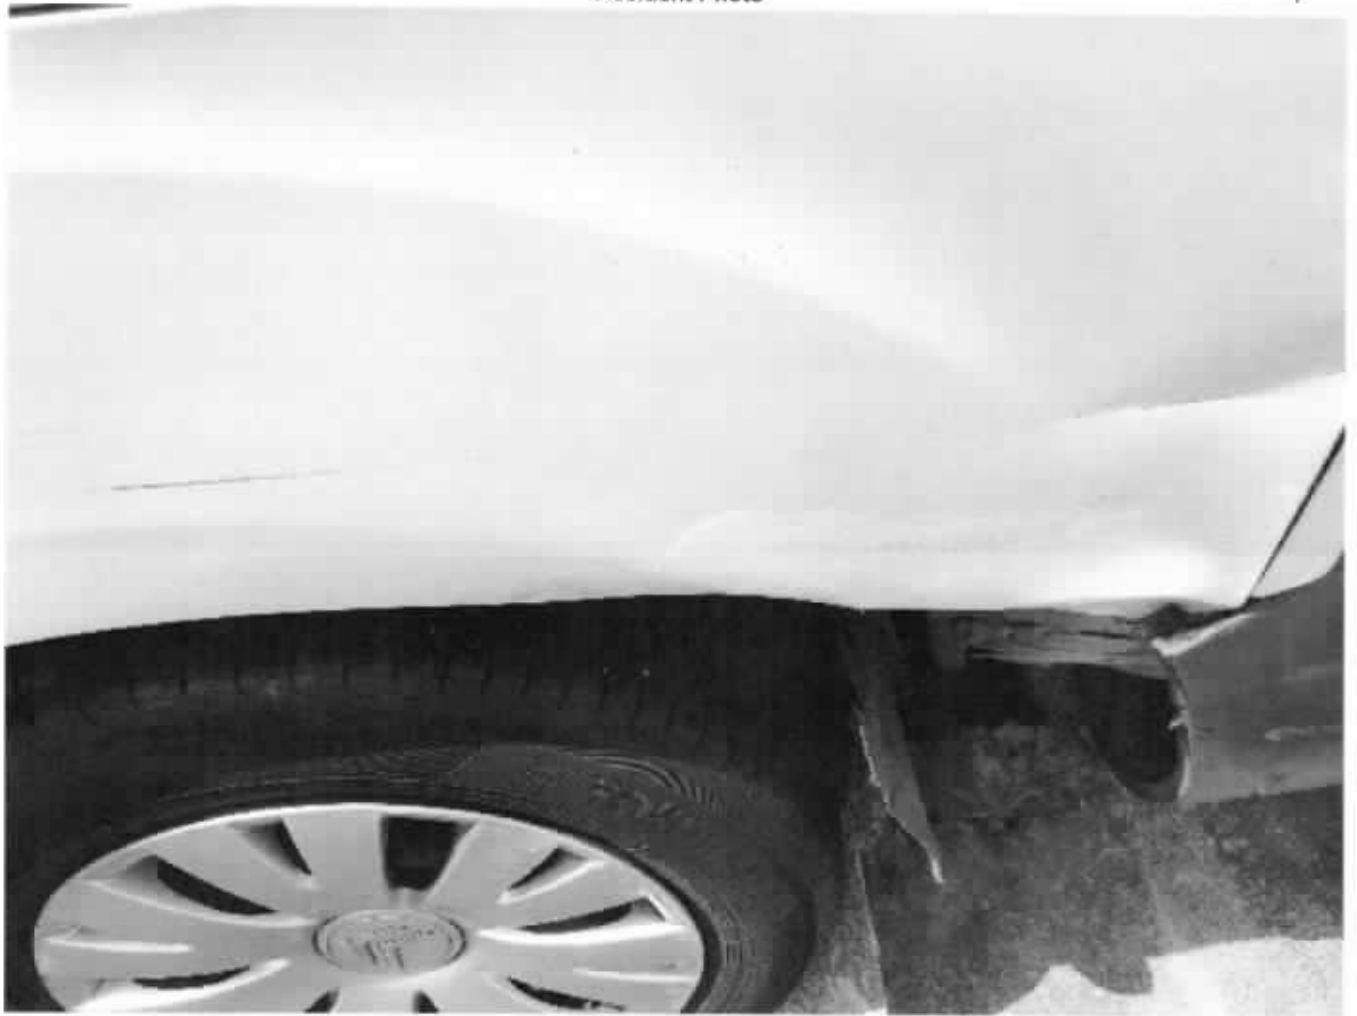
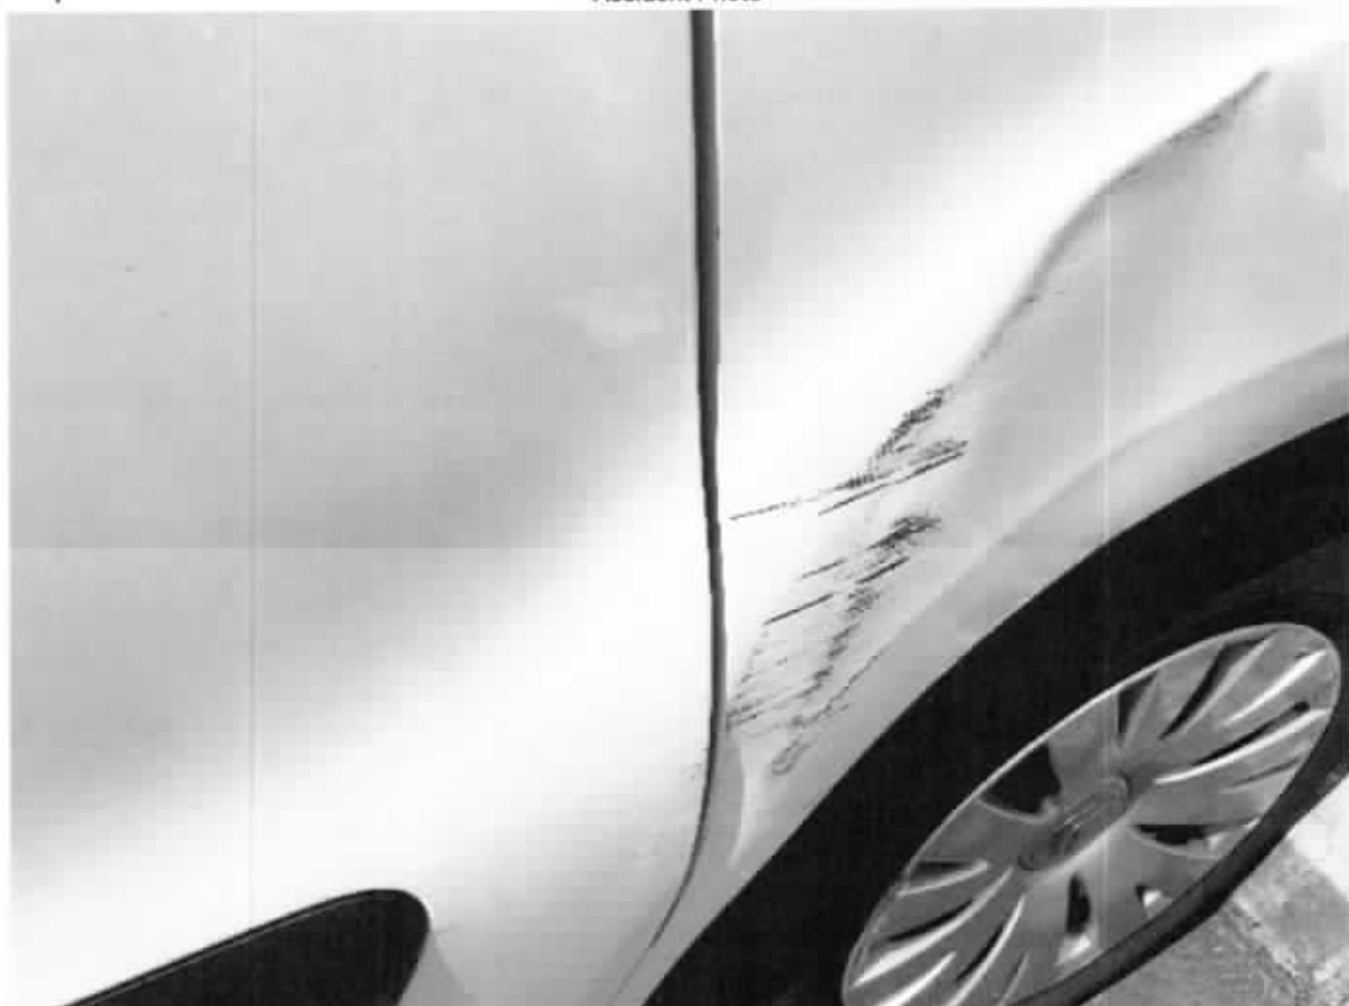
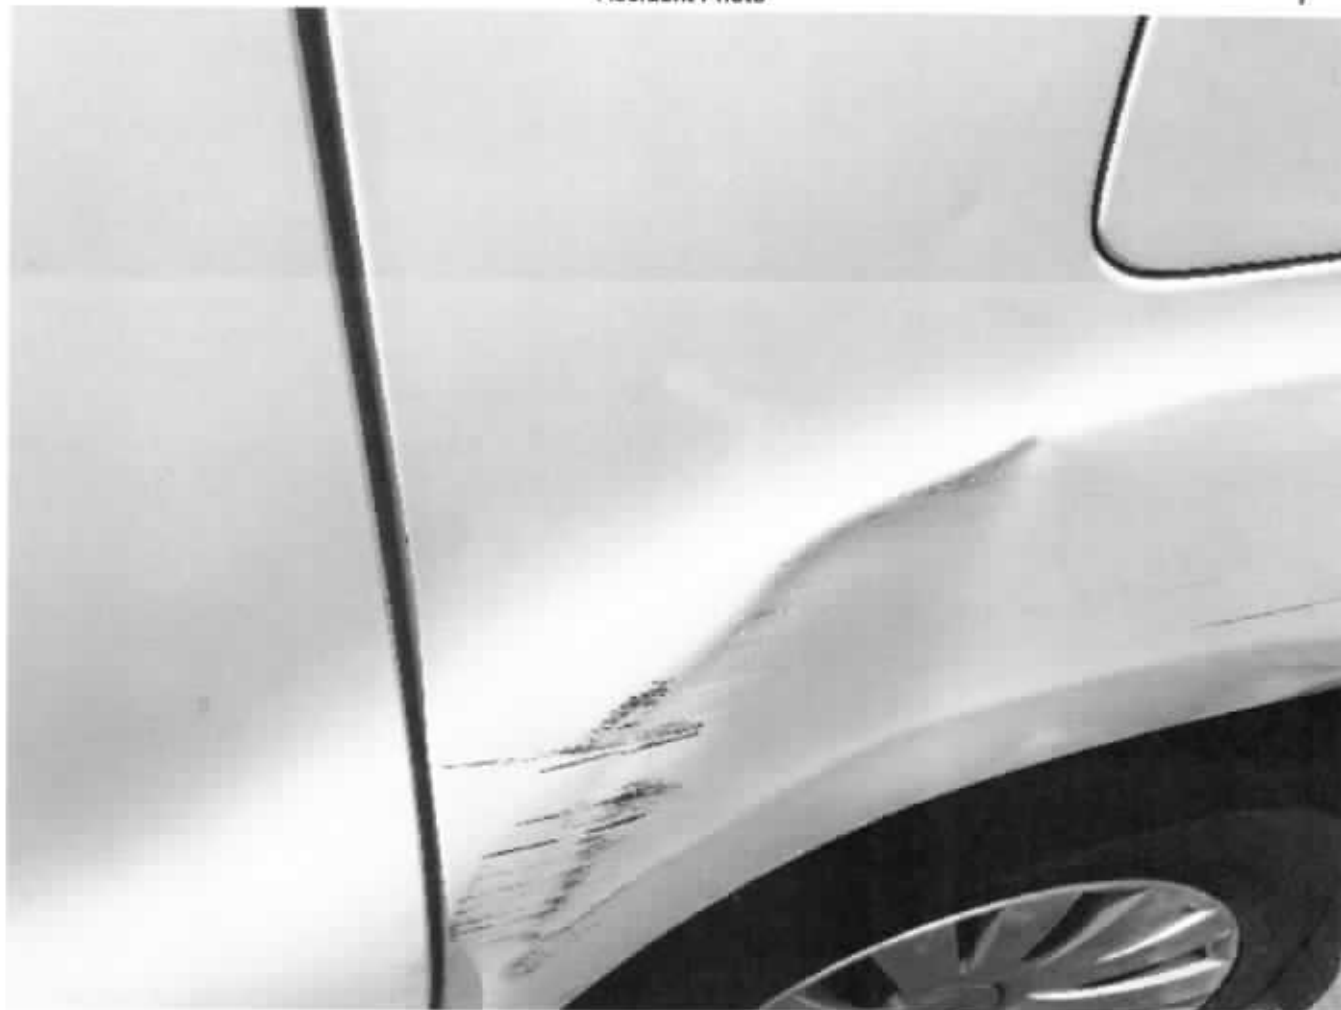
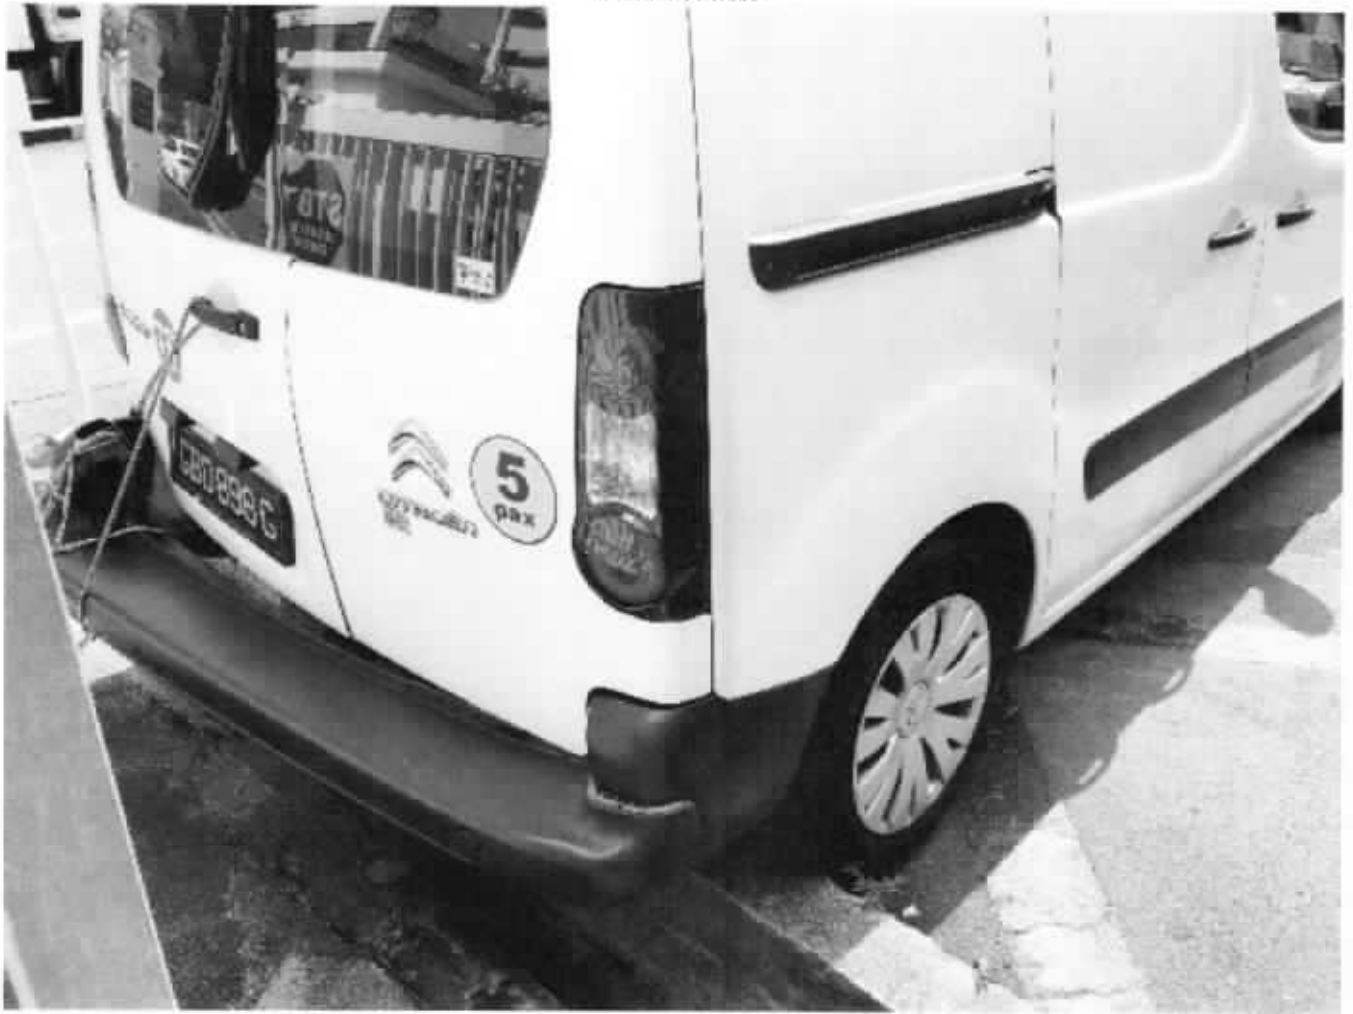
The U/C / Chassis frame / Body Structure affected due to collision.

- To transfer trunklid mechanism
- To remove and refix trunklid windscreen
- To computerise four wheel alignment
- To remove and replace rear axle beam
- To apply undercoating
- To check wiring system
- To remove and refix reverse sensor
- To jacking, knocking, welding and repair above parts
- To spray painting on affected areas
