REF: CS3/GAL16022416/TAB<sup>2</sup>

OD (TP Re-inspection) / Evaluation

To Inspect Vehicle No: SBT 5H

## ADJUSTMENT ON REPAIR COST FOR VEHICLE NO. SBT 5H

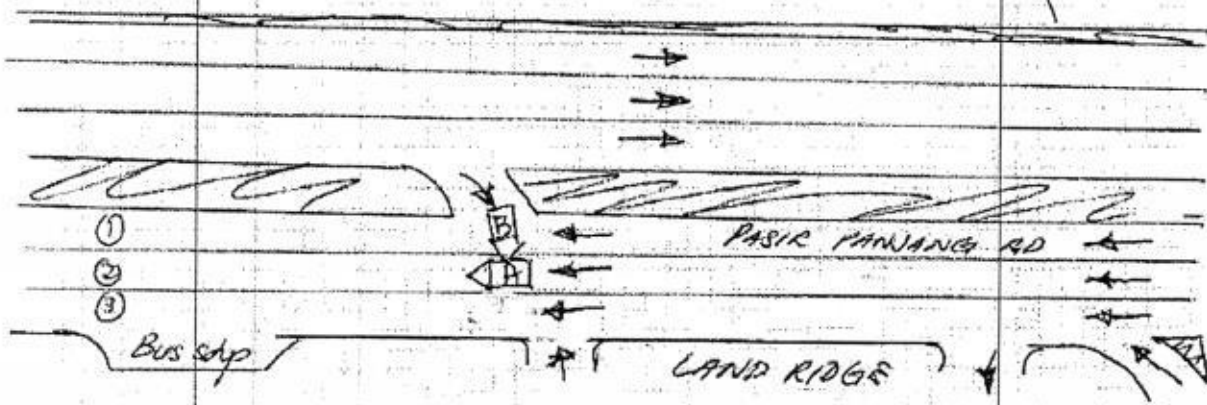
**Sketch Plan**

I was travelling along the said Road on the 2nd lane going straight. Suddenly a vehicle 'B' from the opposite make a U turn & hit into my car right centre portion pushes my car to the 3rd lane causing serious damages.

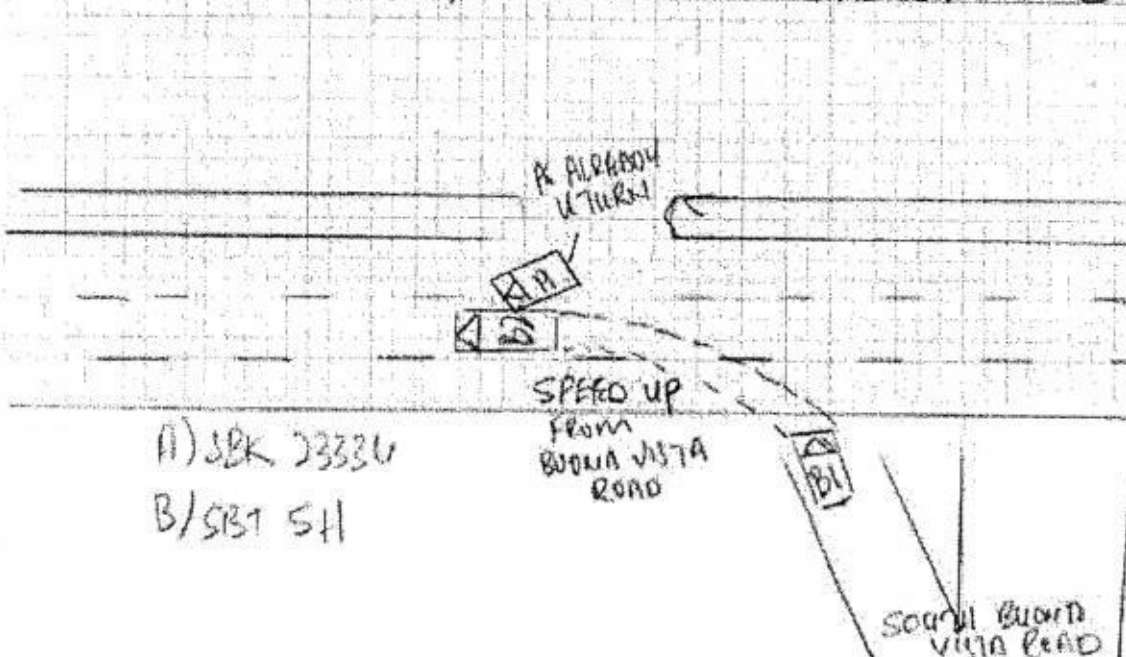
Sketch Plan ALONG BUKIT PONDONG RD (IN FRONT OF LANDRIDGE CONDO)

ON 21/11/2016 AT ABOUT 14:00 HRS I WAS TRAVELLING ALONG  
 HAZE POINT ROAD & WANTED TO MAKE A U-TURN BACK HOME  
 AT CHURCH CUM ROAD I STOP MY CAR BEFORE THE U-TURN  
 TO CONFIRM THAT THERE IS NO CAR COME MY LEFT SIDE  
 SO WHEN THE ROAD WAS CLEAR I MOVE MY CAR SLOWLY  
 SUDDENLY FROM SOUTH BOUND VISTA A WHITE LUXUS CAME &  
 HIT MY FROM LEFT HAND SIDE BUMPER & THE DAMAGE  
 OF THE LUXUS IS FROM THE RIGHT FRONT DOOR UNTIL THE  
 REAR DOOR & WE CANE DOWN & RATIONALE PARTICULAR  
 THAT ALL.
