To Inspect Vehicle No:

- PRE-REPAIR INSPECTION - ACCIDENT INVOLVING OUR INSURE...

Affiliated to Federation Internationale Des Experts En Automobile				
AIG ASIA PACIFIC INSURANCE PTE LTD		Ref : CS3/AIG18014007/Uz4d3		
78 SHENTON WAY #08-16 CHARTIS BUILDING SINGAPORE 079120		Date : 01-08-2018

VEHICLE DAMAGE INSPECTION REPORT

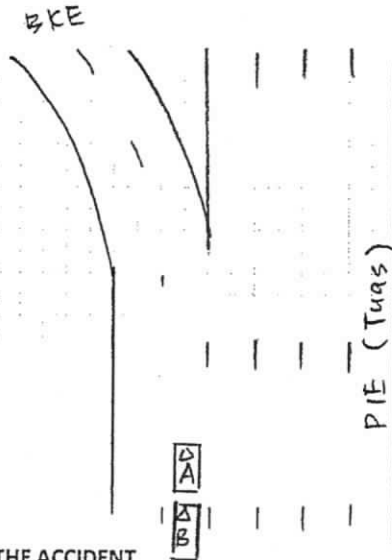
SKETCH PLAN

A - SKU7277G

B - YP7597T

The incident happened at approximately 10.30 pm, on the second lane along PIE towards Tuas after Top New exit. on 26th July 2018.	
I was driving along PIE (Tuas), on the second lane from the left and was heading towards BKE. Traffic was heavy and there were a few cars filtering into my lane ahead of me, after Top New exit.	
They cut into 4-5 cars ahead of me. Suddenly, the car in front of me abruptly applied his brakes. I reacted instinctively and also applied my breaks. I then heard a loud bang from the rear of my car and noticed that my rear windscreen had shattered.	
The driver of truck YP7597T (who slammed) into my car from behind and I drove to the road shoulder on the left, and we were parked near lamp post 1126. I exchanged particulars with Mr Lim Kia Khee, took photos and drove off thereafter.	
<p>AGG Ins.</p> <p>Policy No. <u>SKU7277G</u></p> <p>Date of Accident <u>26.7.2018</u></p> <p><input type="checkbox"/> Reporting Only</p> <p><input type="checkbox"/> Own Damage Claim</p> <p><input type="checkbox"/> Third Party Claim</p> <p><input checked="" type="checkbox"/> Other Workshop</p> <p><u>Yeow Koon Motor</u></p> <p><u>Spray painting</u></p>
