**TP Claims against NTUC Income: Follow-Through Survey**

## 1. Policy Particulars :- THIRD PARTY CLAIM

## ADJUSTMENT ON REPAIR COST FOR VEHICLE NO. SHA 1764Y

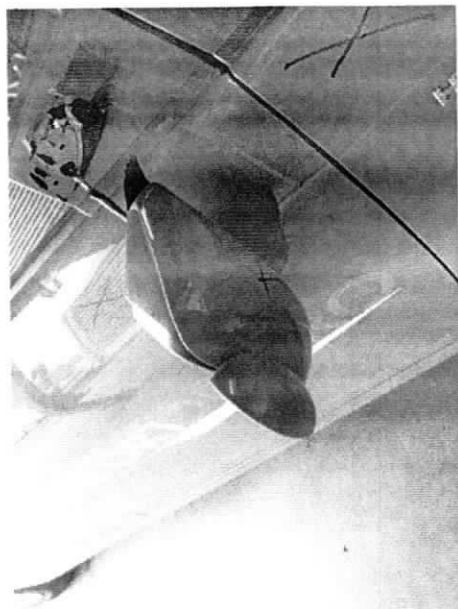
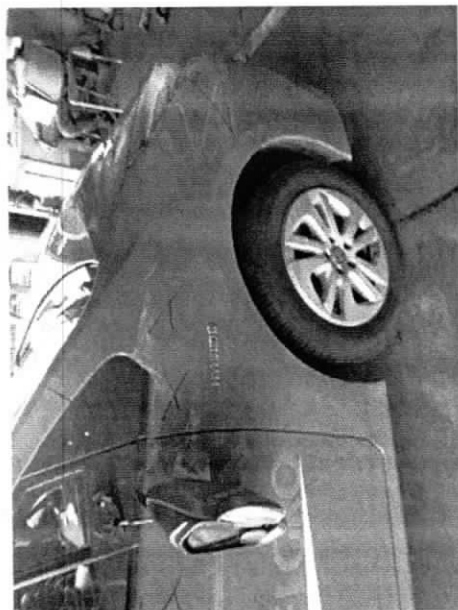
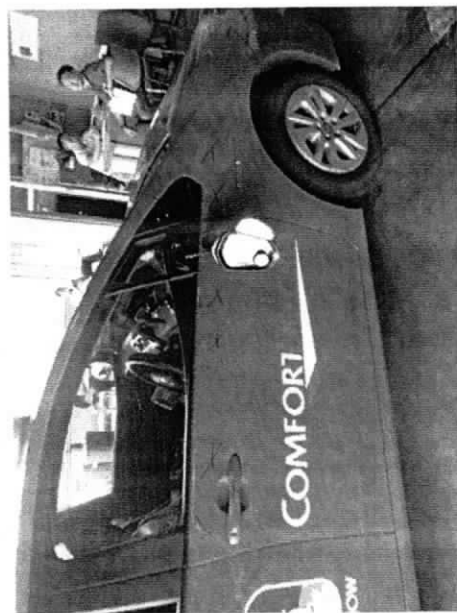
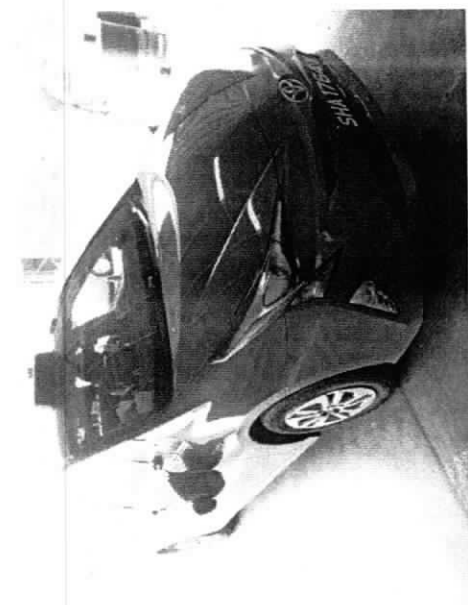
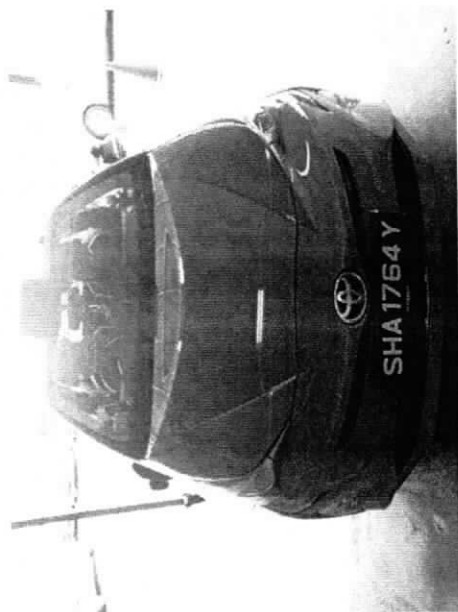
THE VEHICLE SUSTAINED DAMAGES AT THE O/S BODY. DAMAGES SEE DETAILS.
--

Qty	Description of Parts	Condition	Estimate By Workshop (\$)	Our Adjusted (\$)
<b>REPLACEMENT OF PARTS</b>				
1	FRONT FENDER-RH	TO REPAIR SEE LABOUR	933.10	-
1	FRONT DOOR-RH	BENT	1,227.00	1,227.00
1	SIDE MIRROR-RH	BROKEN	1,374.00	1,374.00
1	PRIG4 EMBLEM SIDE PANEL	NECESSARY	52.40	52.40
1	PRIG4 COVER OUTER MIRROR	CUT	107.40	107.40
	LESS 25% DISCOUNT		-923.48	-690.20
			2,770.42	2,070.60
<b>SPECIAL NETT ITEMS</b>				
1	FRONT DOOR LOGO-COMFORT (SN)	NECESSARY	75.00	75.00
1	I40V3 APP LOGO REAR DOOR (SN)	NECESSARY	80.00	80.00
			155.00	155.00
<b>LABOUR</b>				
	PANEL BEATING.INCLUSIVE OF THE REPAIR OF FRONT FENDER-RH.		600.00	400.00
	SPRAY PAINTING CHARGE.		500.00	500.00
	TUFF KOTE. }		50.00	40.00
	TUFF KOTE. }		100.00	-
			1,250.00	940.00
<b>GRAND TOTAL</b>			<b>4,175.42</b>	<b>3,165.60</b>
<b>RECOMMENDED COST OF REPAIRS (CONFIRMED)</b>				<b>3,165.60</b>
