ASSIGNMENT

Insured: SKM 9296E

Veh No: SHC 2783A Yr Regn: 6 Jan, 2013

ADJUSTMENT ON REPAIR COST FOR VEHICLE NO. SHC 2783A

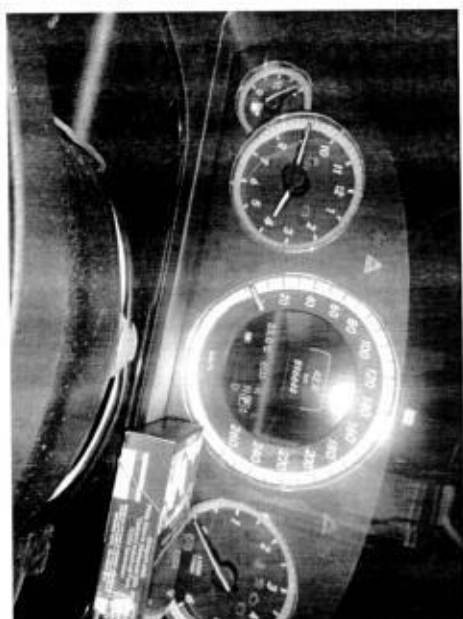
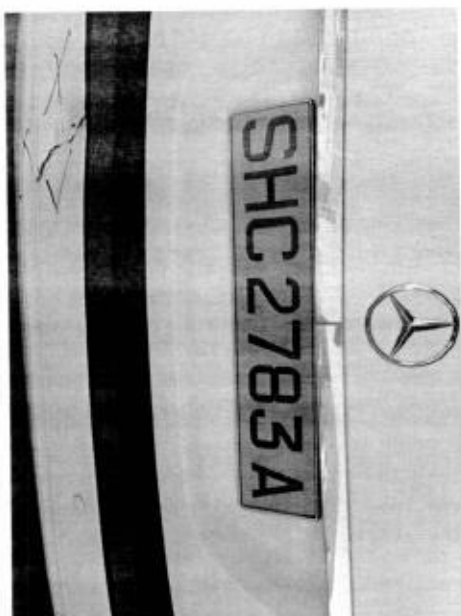
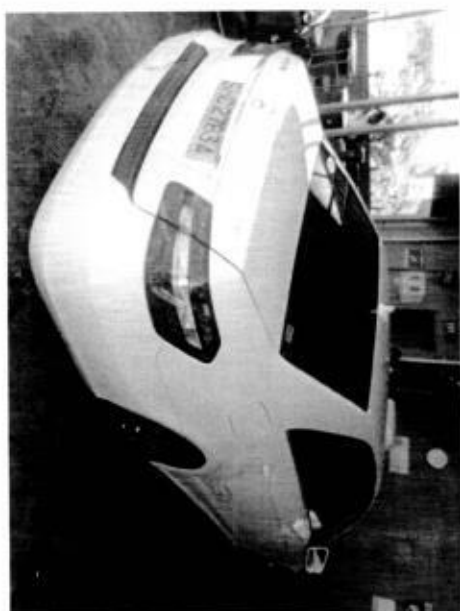
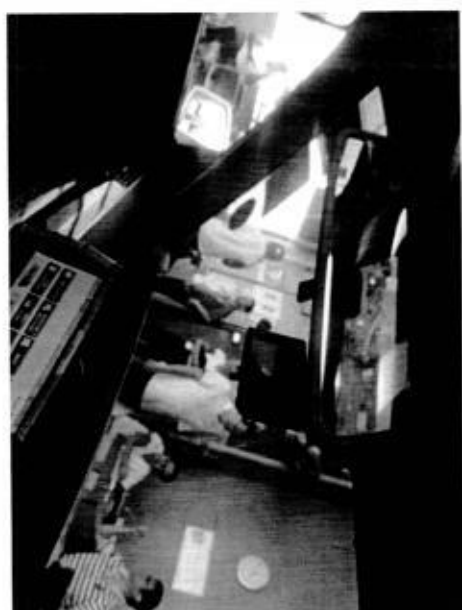
Remark: The veh had commenced its repair at the time of inspection.

The U/C / Chassis frame / Body Structure affected due to collision.

4. Description of Damages				
THE VEHICLE SUSTAINED DAMAGES AT THE REAR N/S PORTION. DAMAGES SEE DETAILS.				
5. General Information				
Accident Date	01/08/2018	Inspection Date	03/08/2018	
Survey held at	COMFORTDELGRO ENGINEERING PTE LTD 59 LOYANG DRIVE SINGAPORE 508969			
5a. Remarks				
A)THE INSPECTION WAS CONDUCTED ON A"WITHOUT PREJUDICE" BASIS. B)IN ACCORDANCE TO YOUR INSTRUCTIONS, WE HAVE NOT AUTHORISED REPAIRS.				
5b. Estimate Days of Repair				
ESTIMATED NORMAL PERIOD FOR REPAIR:		2 Working Days

Qty	Description of Parts	Condition	Estimate By Workshop (\$)	Our Adjusted (\$)
REPLACEMENT OF PARTS				
1	REAR BUMPER	DEFORMED	1,510.00	1,510.00
1	REAR BUMPER REINFORCEMENT	SERVICEABLE	1,150.00	-
2	REAR BUMPER BRACKET LOWER (LH/RH) @\$135.00	SERVICEABLE	270.00	-
2	REAR BUMPER BRACKET TOP (LH/RH) @\$125.00	SERVICEABLE	250.00	-
2	REAR BUMPER RETAINER MOUNTING (LH/RH) @\$115.00	SERVICEABLE	230.00	-
	LESS 20% DISCOUNT		-682.00	-302.00
			2,728.00	1,208.00
SPECIAL NETT ITEMS				
1	REAR BUMPER SENSOR (SN)	SHORTED	388.00	388.00
1	REAR BUMPER RUBBER MAT (SN)	NECESSARY	50.00	50.00
			438.00	438.00
LABOUR				
	PANEL BEATING.		400.00	200.00
	SPRAY PAINTING CHARGE.		250.00	200.00
	WIRING CHARGE.	NOT NECESSARY	50.00	-
	REMOVE/REFIX REVERSE SENSOR.		120.00	30.00
			820.00	430.00
GRAND TOTAL			3,986.00	2,076.00
RECOMMENDED COST OF LUMP SUM REPAIRS (TO ITS PRE-ACCIDENT CONDITION) (CONFIRMED)				1,650.00
