## SINGAPORE ACCIDENT STATEMENT

FINAL BILL REPAIR COSTS VEHICLE NO: SGS 1075 U (MITSUBISHI LANCER 1.6 A)

## ACCIDENT DAMAGED VEHICLE INSPECTION REPORT

#### EVALUATION REPORT (PAPER SURVEY) OF ACCIDENT VEHICLE NO: SGS 1075U INSURED VEHICLE: GBD 3110B ACCIDENT DATE: 15/06/2016

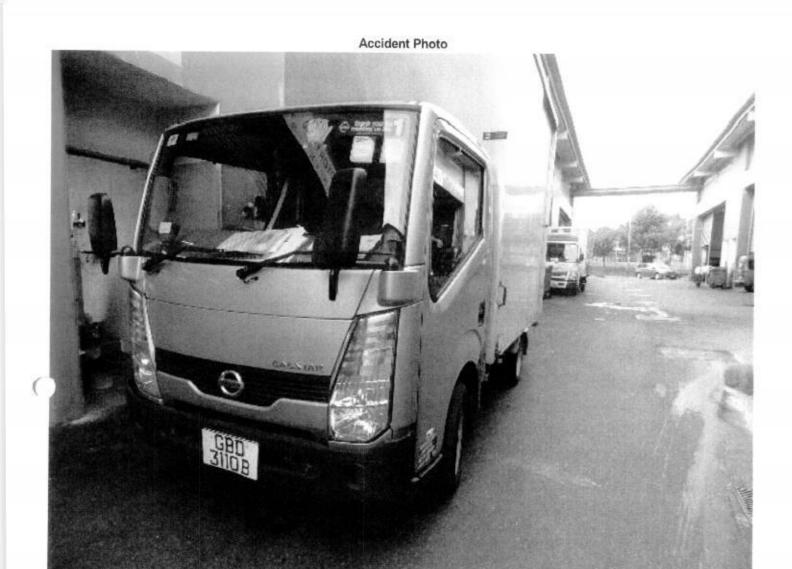
Sketch Plan

the.	mo	dent	hap	nened	DW	15	06/20	Lla	at	91.37	am)		alon	7 70	ok
Blang	ah	cres	cent	COMPO	ark.	Mu	Lorgi	was	De	arked	ih	let.	2.9	and	I mode
EDUN	ard	alre	adu	sud	denlu	vehi	de B	be	ade	opene	ed h	is	24	#ron+	door
and	hi4	the	LH	side	OF,	My	lorra.							1	i mover door
						,	1

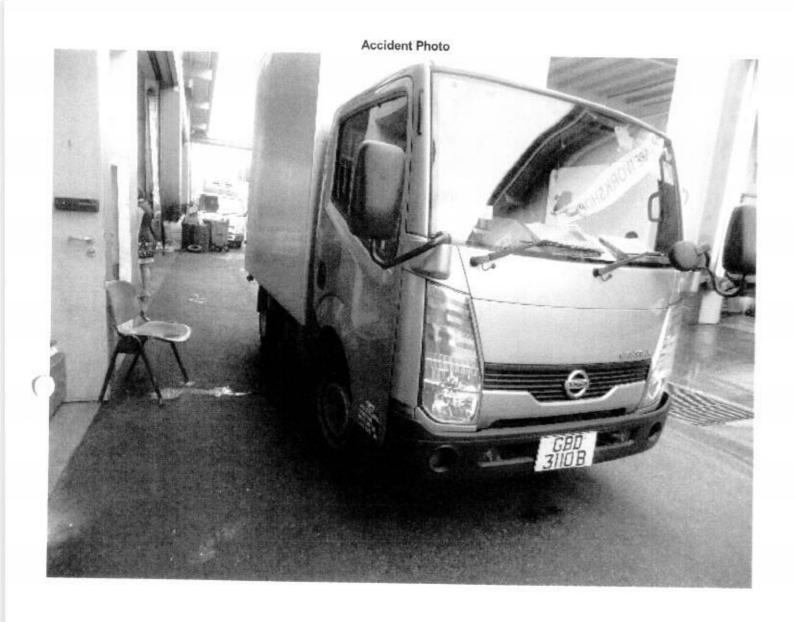
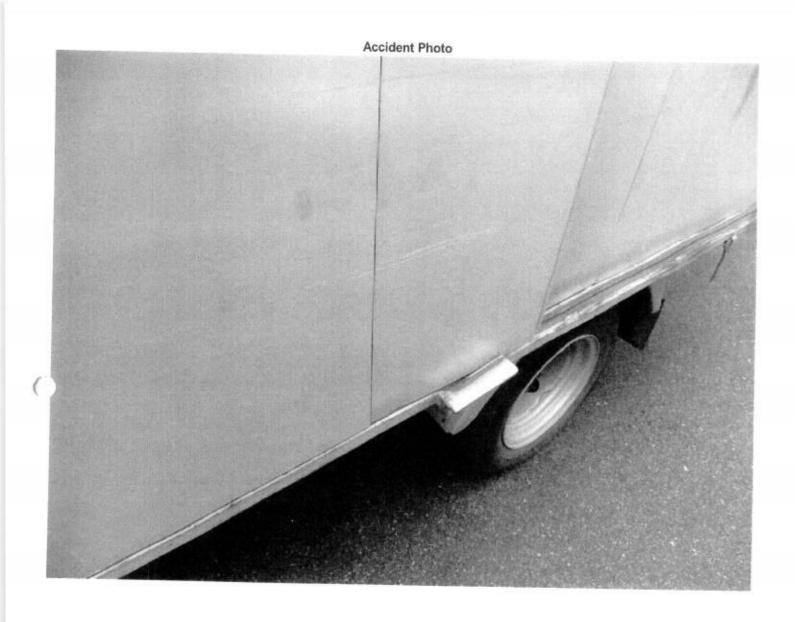
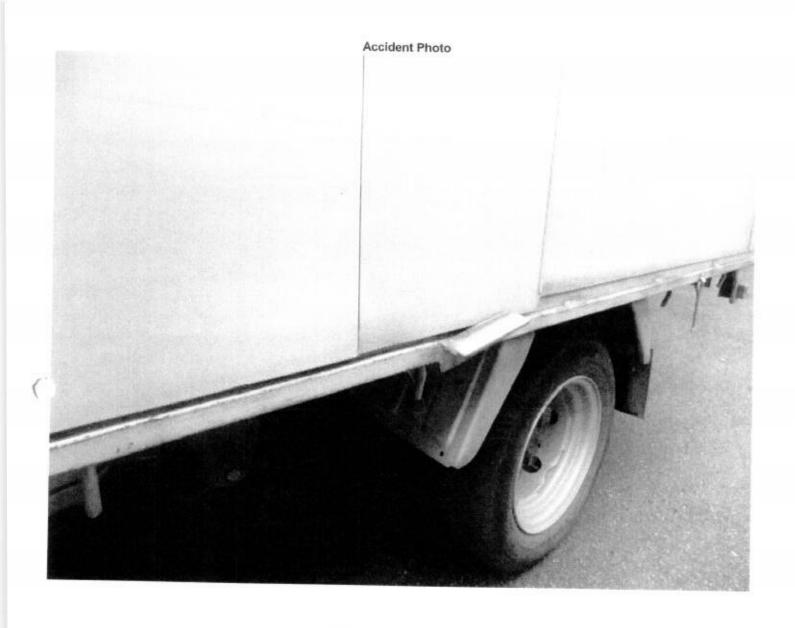
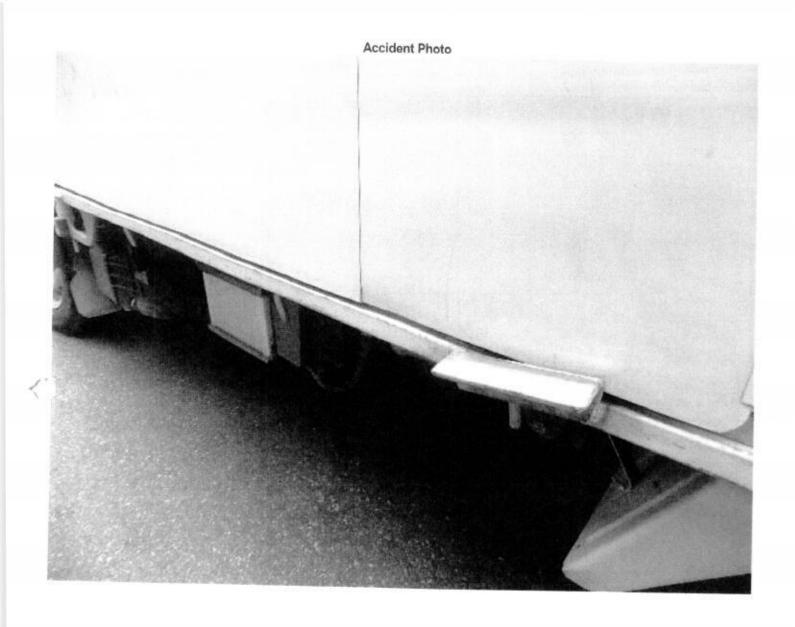
The vehicle sustained damage at the right side front door

The impact was confined to the right side front door portion of the vehicle. The damages appeared to be consistent as per the accident report statement. Please refer the attached schedule and photographs for details.

Our assessment of the repair costs to pre-accident condition was \$3,100.00 nett at lump sum basis. (Subject to GST if applicable)

The repairer has agreed to undertake repair the vehicle at a lump sum basis of \$3,100.00 nett corresponding to replacement of parts, spray painting and labour charges. We now revert for your decision on the above claim.
