1. Policy Particulars :- THIRD PARTY CLAIM

THE VEHICLE SUSTAINED DAMAGES AT THE REAR O/S PORTION. DAMAGES SEE DETAILS.
--

ADJUSTMENT ON REPAIR COST FOR VEHICLE NO. SHB 4225L

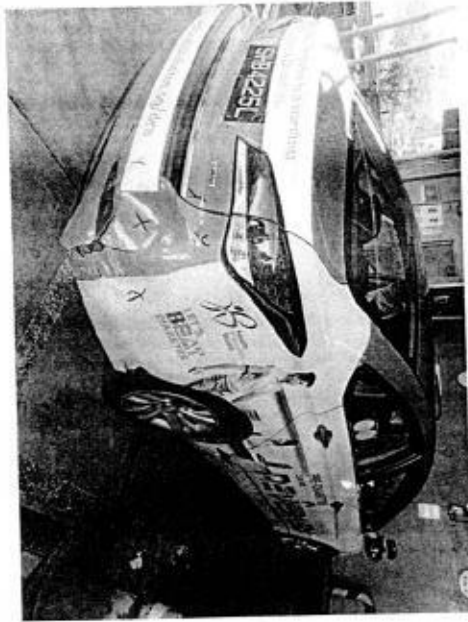
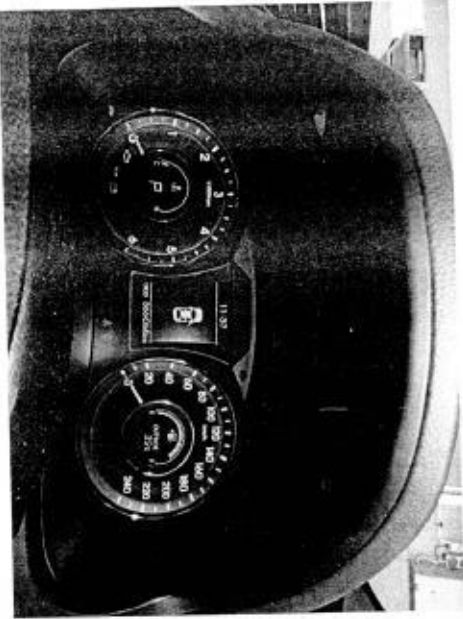
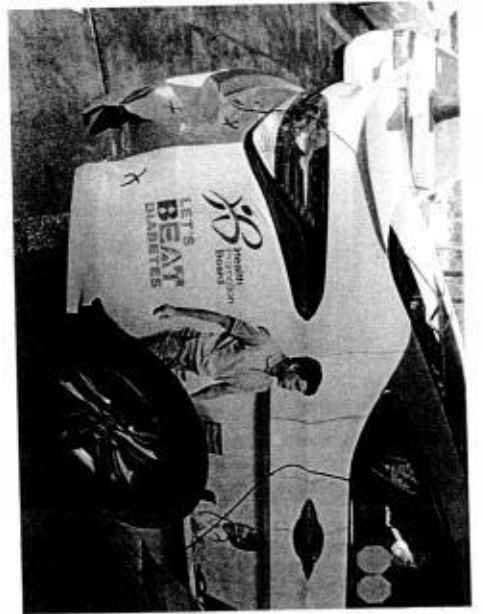
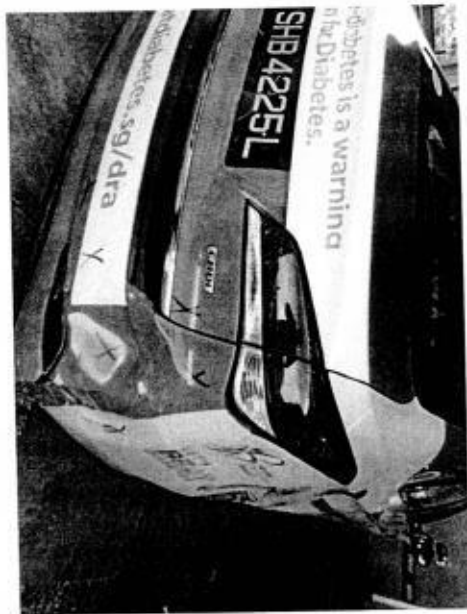
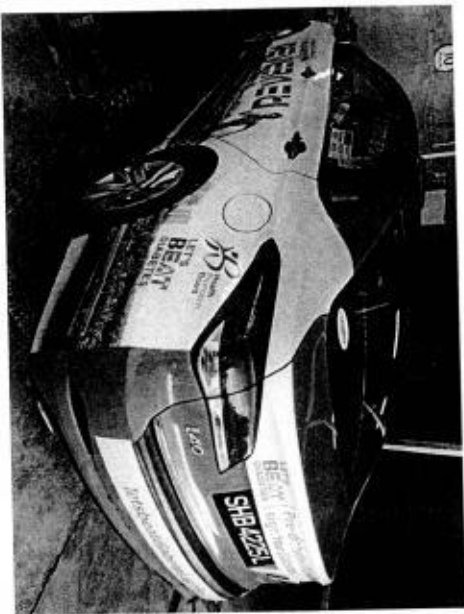
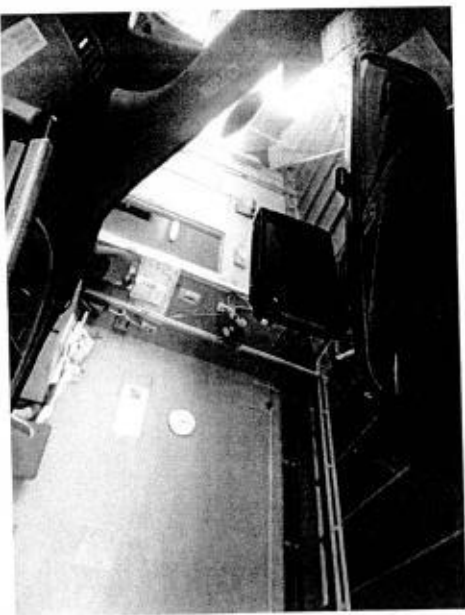
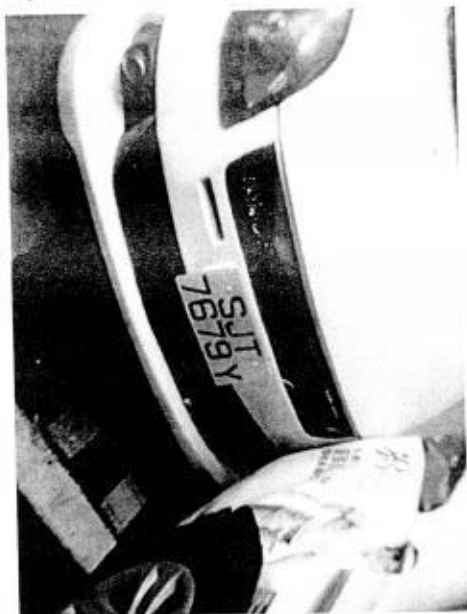
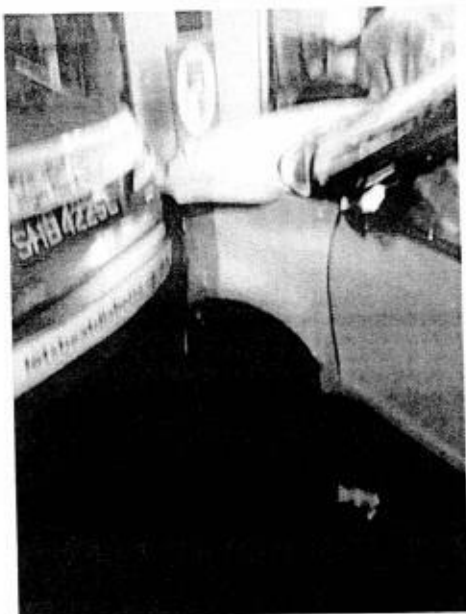
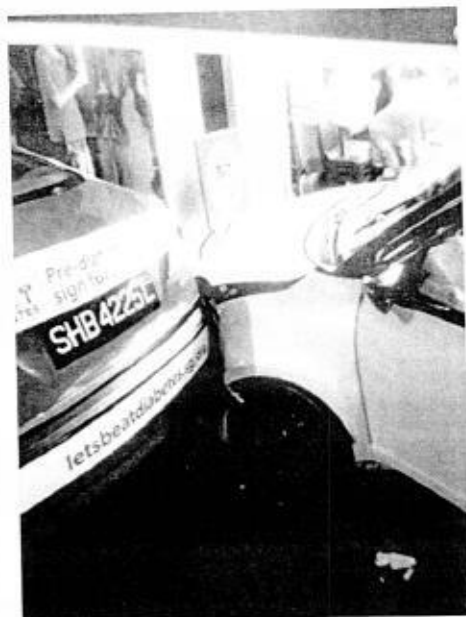
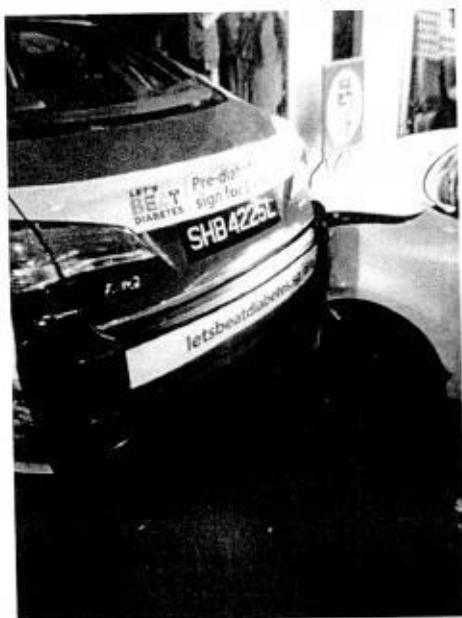
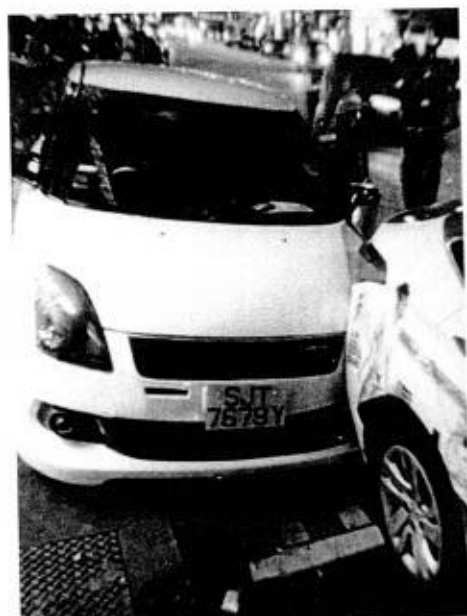
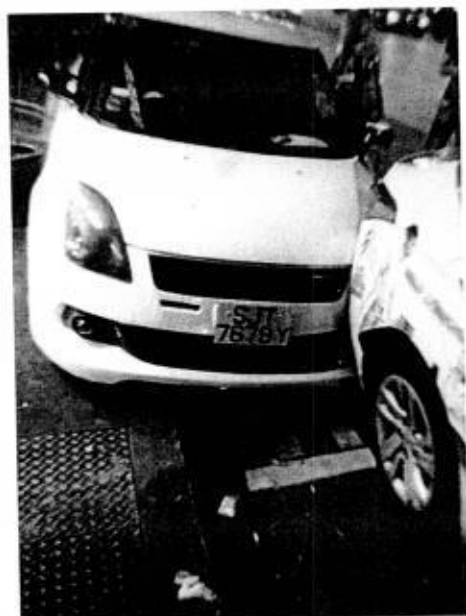
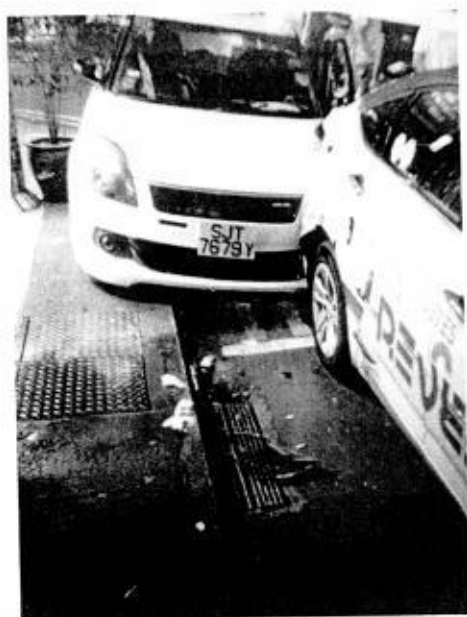
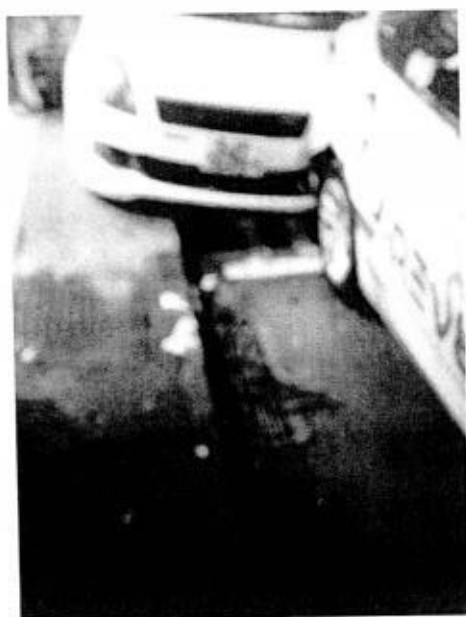
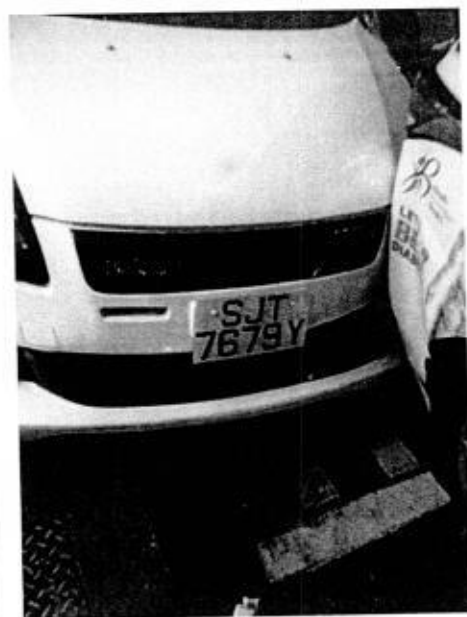
My taxi sustained dents and cracks on the right rear bumper of the taxi. I am lodging this report to assist in Police investigation and to facilitate in following up with my insurance company.

Qty	Description of Parts	Condition	Estimate By Workshop (\$)	Our Adjusted (\$)
REPLACEMENT OF PARTS				
1	BOOT LID "H" EMBLEM	NOT NECESSARY	27.20	-
1	BOOT LID CRDI PLATE	NECESSARY	41.00	41.00
1	BOOTLID MOULDING	SERVICEABLE	85.00	-
1	BOOTLID I40 EMBLEM	NECESSARY	41.00	41.00
1	BOOTLID LOWER GARNISH	TO REPAIR SEE LABOUR	398.00	-
1	REAR BUMPER	DEFORMED	603.60	603.60
1	REAR BUMPER REINFORCEMENT	SERVICEABLE	504.35	-
2	REAR BUMPER REINFORCEMENT BRACKET (LH/RH) @\$180.00	SERVICEABLE	360.00	-
2	REAR BUMPER SIDE BRACKET @\$49.00	SERVICEABLE	98.00	-
10	REAR BUMPER CLIPS	NECESSARY	22.00	22.00
1	REAR BUMPER SPONGE	SERVICEABLE	143.40	-
1	REAR BUMPER UNDER COVER	CUT	225.00	225.00
1	REAR BUMPER REFLECTOR LAMP (RH)	CRACKED	32.00	32.00
1	EXHAUST PIPE INSULATOR,RH	SERVICEABLE	58.55	-
1	EXHAUST SILENCER,RH	SERVICEABLE	954.00	-
1	EXHAUST PIPE HANGER,RH	SERVICEABLE	58.55	-
1	EXHAUST PIPE CENTRE	SERVICEABLE	1,150.30	-
	LESS 20% DISCOUNT		-960.39	-192.92

Qty	Description of Parts	Condition	Estimate By Workshop (\$)	Our Adjusted (\$)
	LABOUR			
	PANEL BEATING INCLUSIVE OF THE REPAIR OF BOOTLID LOWER GARNISH.		350.00	200.00
	SPRAY PAINTING CHARGE.		500.00	400.00
	WIRING CHARGE.	NOT NECESSARY	50.00	-
	TUFF KOTE.	NOT NECESSARY	50.00	-
	REMOVE/REFIX REVERSE SENSOR.		120.00	30.00
	REMOVE/REFIX EXHAUST PIPE.	NOT NECESSARY	150.00	-
			1,220.00	630.00
	GRAND TOTAL		5,577.26	1,651.68
	RECOMMENDED COST OF LUMP SUM REPAIRS (TO ITS PRE-ACCIDENT CONDITION) (CONFIRMED)			1,300.00
