REF: NS/INC 8014275/K16682

Veh No: SHC 2935D Yr Regn: 25 Oct, 2013

Report Format: Total Loss

1. Policy Particulars :- THIRD PARTY CLAIM				
Insured Veh.	SLQ 721X	Veh. Inspected	SHC 2935D	
Policy No.	5101432085	Coverage (\$)	0.00	
Claim No.		Excess (\$)	0.00	
Assign From		Assign Date	06/08/2018

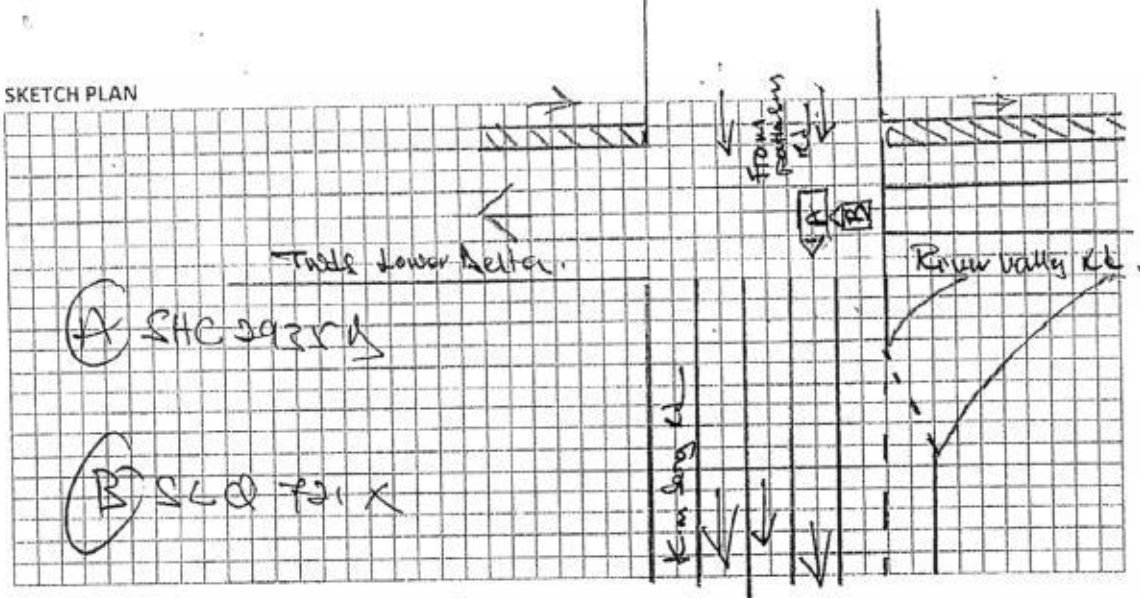
SKETCH PLAN

Remark: - Impact caused by van A to hit the post.

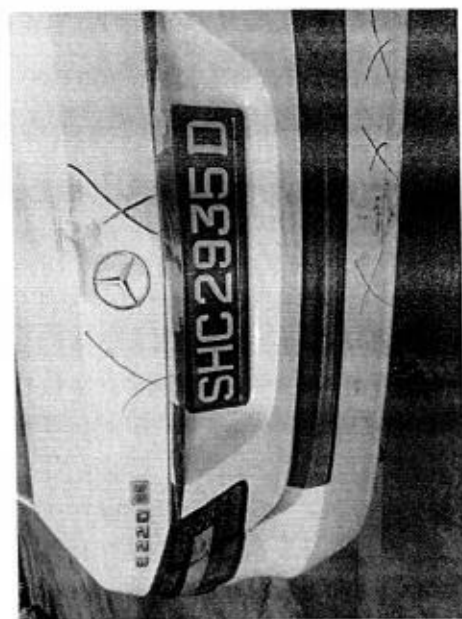
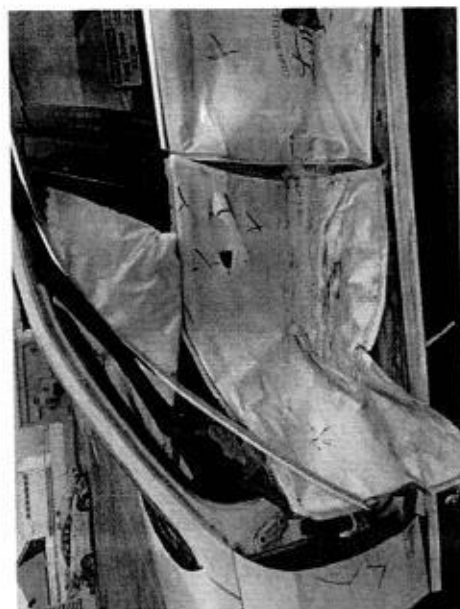
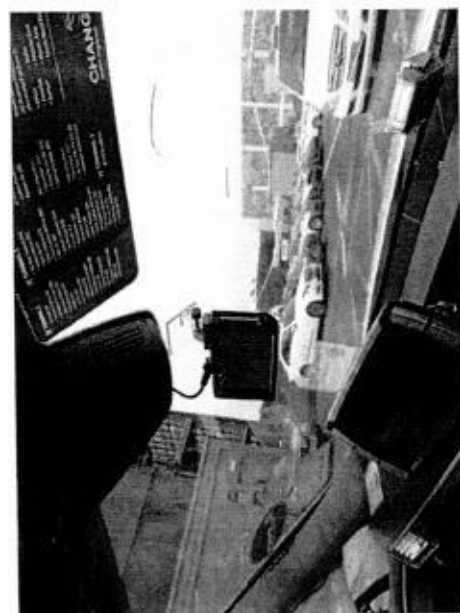
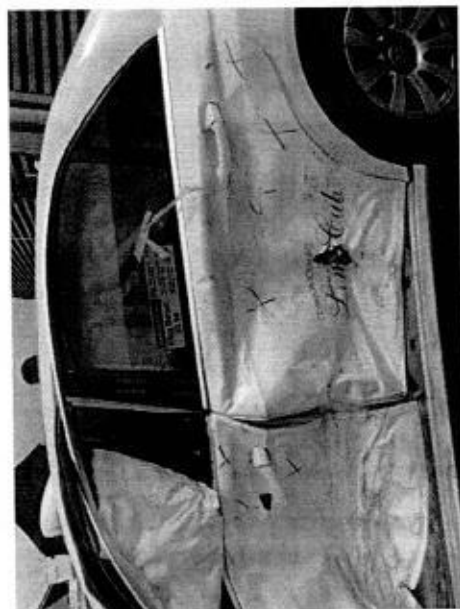
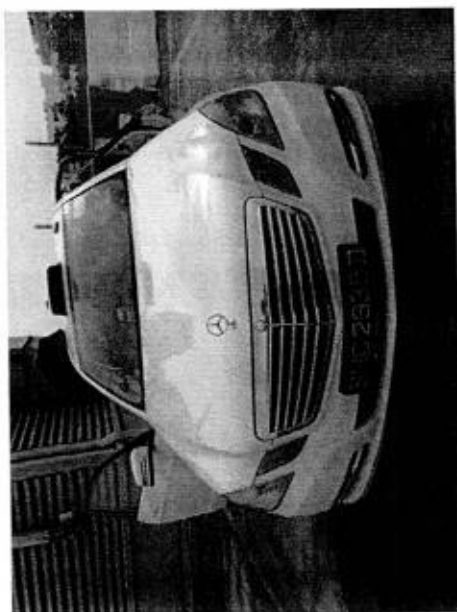
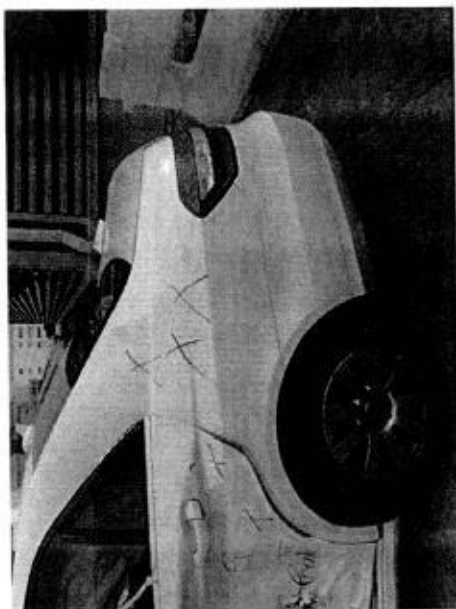
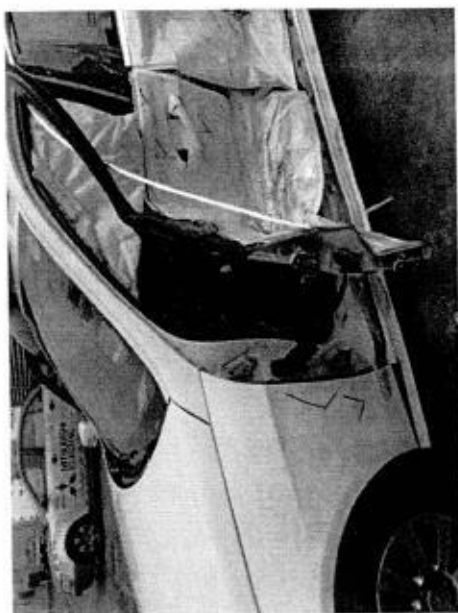
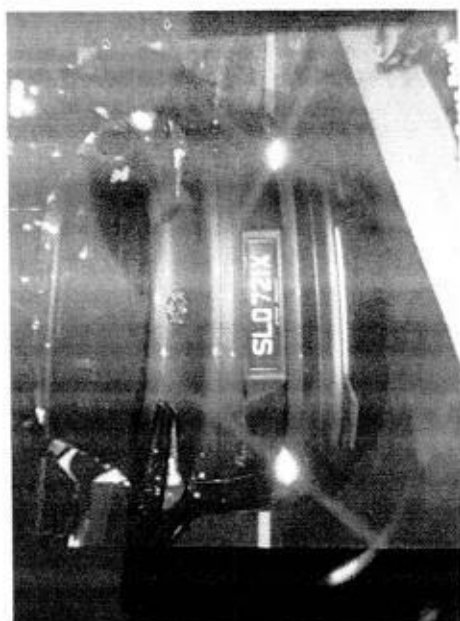
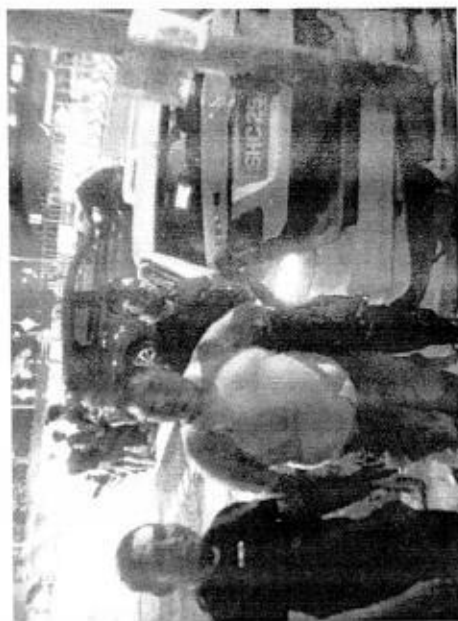
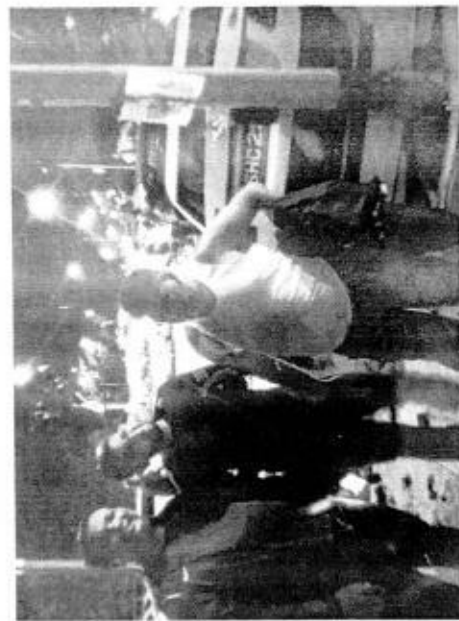
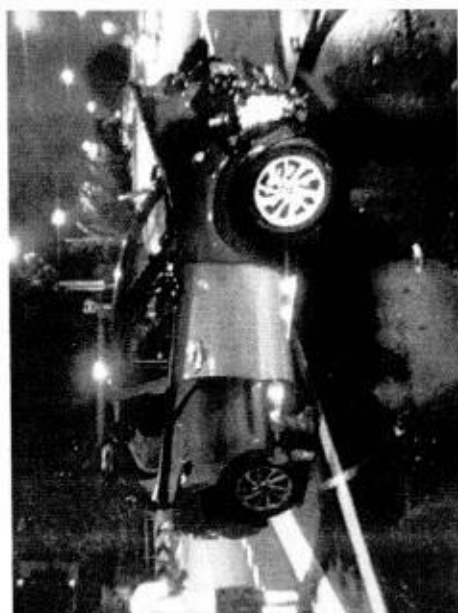
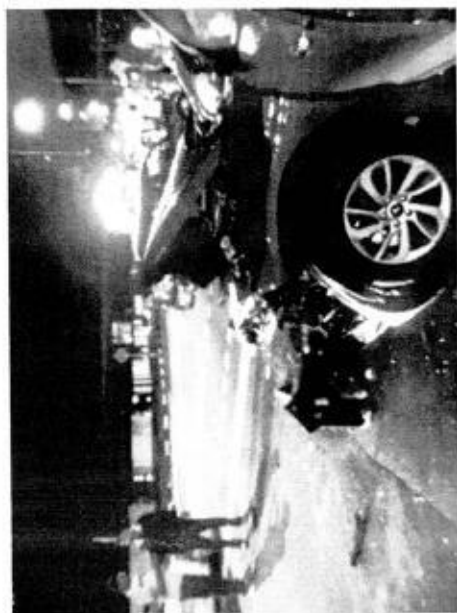
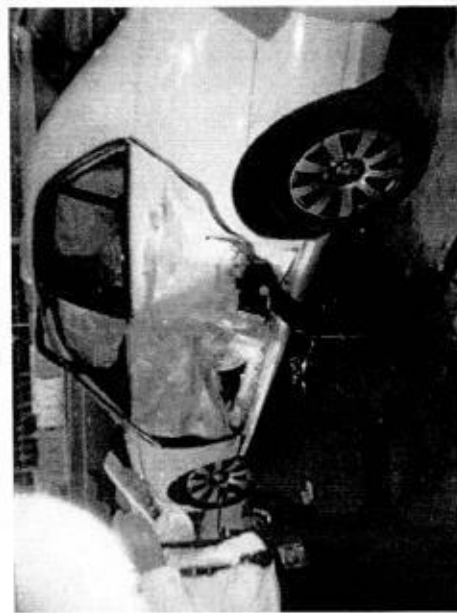
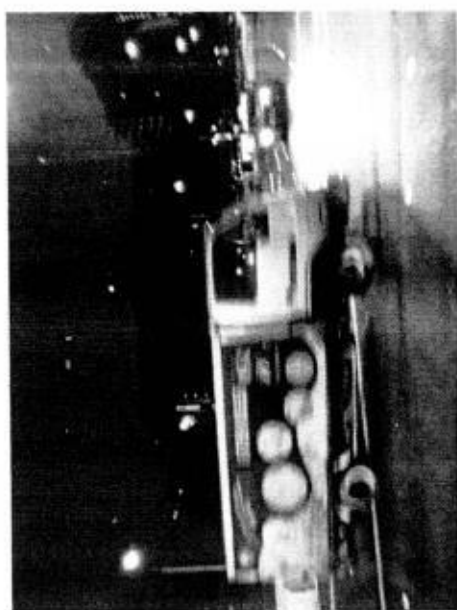
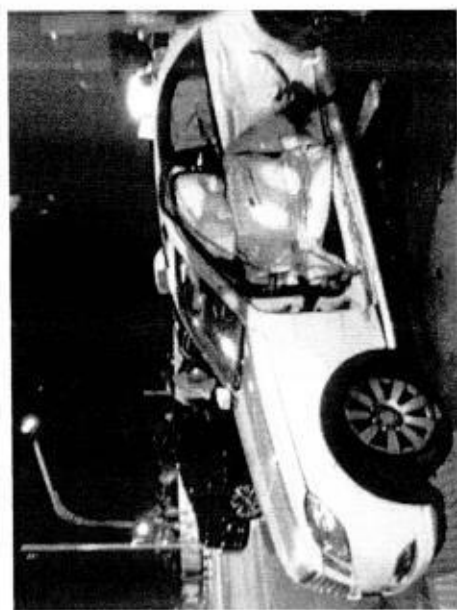
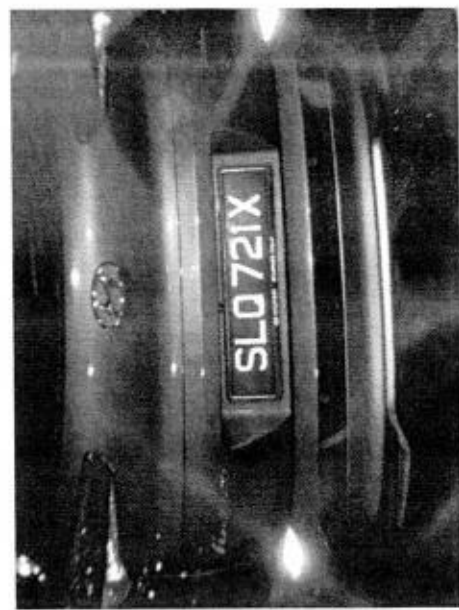
Photos

Rear / N/S Body / Rear / o/s Frt / U/C

The U/C / Chassis frame / Body Structure affected due to collision.

Kah's UCH
6/8/18 1505 hrs
unsafe to repair
Recommend to Scrap
Main structure Damaged

Date / Time	Action / Instruction
	SHC 2935D - (23/10/2013) / K16682 scrapped Def: 10/10/2018 JMC
	SLQ 721X - x Total Loss. 45
	Main Structure Damaged
14/03/13	Submit Total Loss as constructive due to unsafe.
	RECEIVED 14 AUG 2018
	Net Value: \$ 22,354.40
