TP Claims against NTUC Income: Follow-Through Survey

1. Policy Particulars :- THIRD PARTY CLAIM			
Insured Veh.	XD 7911U	Veh. Inspected	SHD 3005B
Policy No.	5073322670-02	Coverage (\$)	0.00
Claim No.	MT/1006565-002	Excess (\$)	0.00
Assign From		Assign Date	08/08/2018

4. Description of Damages			
THE VEHICLE SUSTAINED DAMAGES AT THE O/S FRONT PORTION. DAMAGES SEE DETAILS.			
5. General Information			
Accident Date	07/08/2018	Inspection Date	08/08/2018
Survey held at	COMFORTDELGRO ENGINEERING PTE LTD 59 LOYANG DRIVE SINGAPORE 508969		
5a. Remarks			
A)THE INSPECTION WAS CONDUCTED ON A"WITHOUT PREJUDICE" BASIS. B)IN ACCORDANCE TO YOUR INSTRUCTIONS, WE HAVE NOT AUTHORISED REPAIRS.			
5b. Estimate Days of Repair			
ESTIMATED NORMAL PERIOD FOR REPAIR:		3 Working Days

ADJUSTMENT ON REPAIR COST FOR VEHICLE NO. SHD 3005B

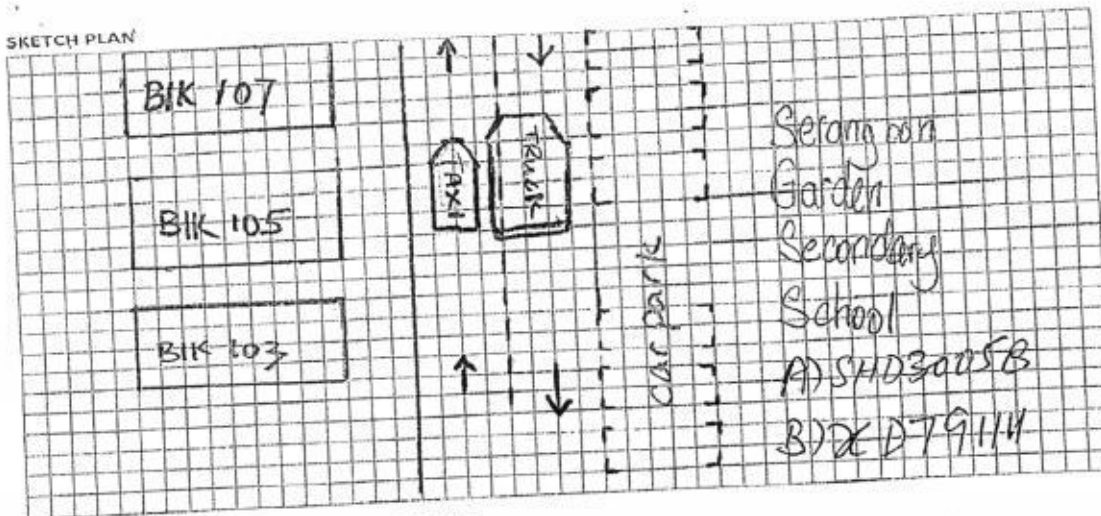
SKETCH PLAN

In Serangoon North Ave 1 car park. Near Block 103 Rubbish dump. Rubbish truck stop at right lane (2 way carriage) He just drove out of rubbish dump. I waited on left lane for him to move forward. After few second, no movement from truck driver. I slowly move left to overtake truck. Almost parallel with truck. He suddenly swerve towards my taxi and cause damage to right side of taxi.
