REF: NS/INC18014479/Kld 302

1. Policy Particulars :- THIRD PARTY CLAIM			
Insured Veh.	FW 822C	Veh. Inspected	SHC 239T
Policy No.	5092896239-01	Coverage (\$)	0.00
Claim No.		Excess (\$)	0.00
Assign From		Assign Date	10/08/2018

4. Description of Damages				
THE VEHICLE SUSTAINED DAMAGES AT THE O/S FRONT PORTION. DAMAGES SEE DETAILS.				
5. General Information				
Accident Date	07/08/2018	Inspection Date	08/08/2018	
Survey held at	COMFORTDELGRO ENGINEERING PTE LTD 59 LOYANG DRIVE SINGAPORE 508969			
5a. Remarks				
A)THE INSPECTION WAS CONDUCTED ON A"WITHOUT PREJUDICE" BASIS. B)IN ACCORDANCE TO YOUR INSTRUCTIONS, WE HAVE NOT AUTHORISED REPAIRS.				
5b. Estimate Days of Repair				
ESTIMATED NORMAL PERIOD FOR REPAIR:		2 Working Days

ADJUSTMENT ON REPAIR COST FOR VEHICLE NO. SHC 239T

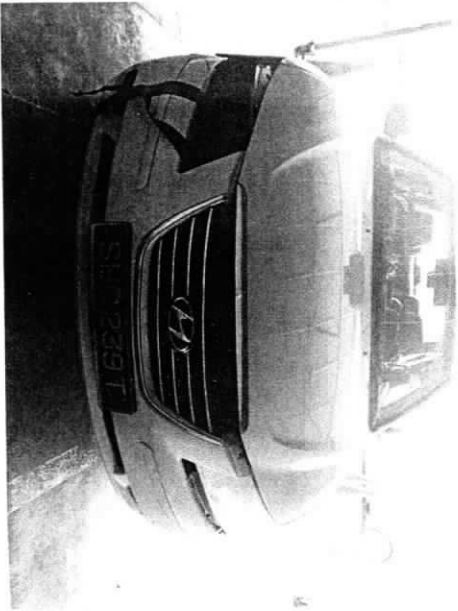
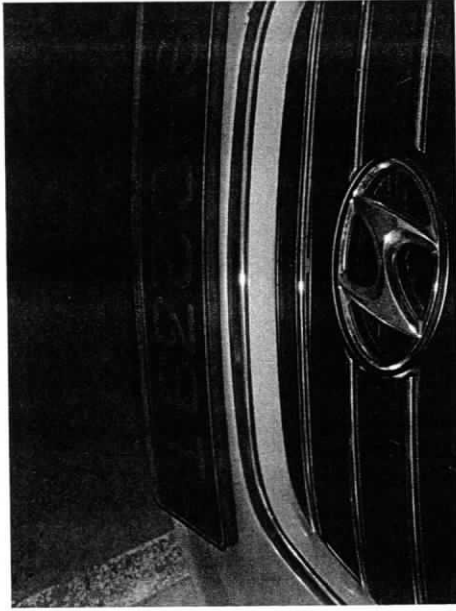
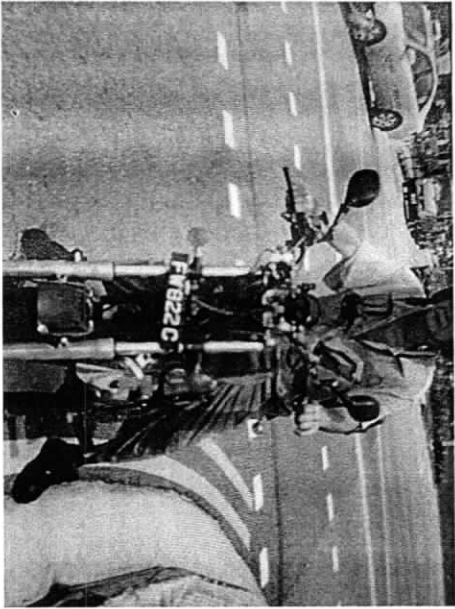
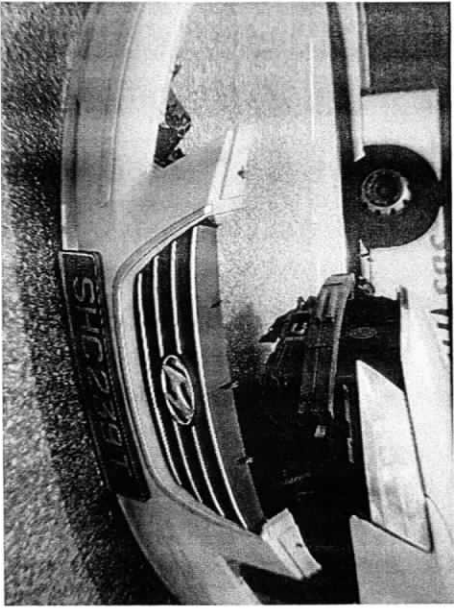
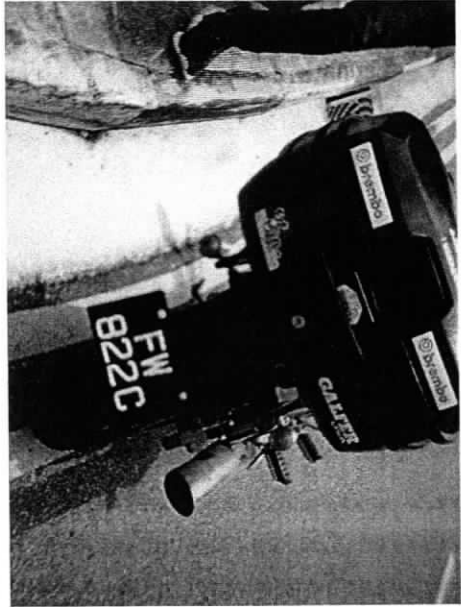
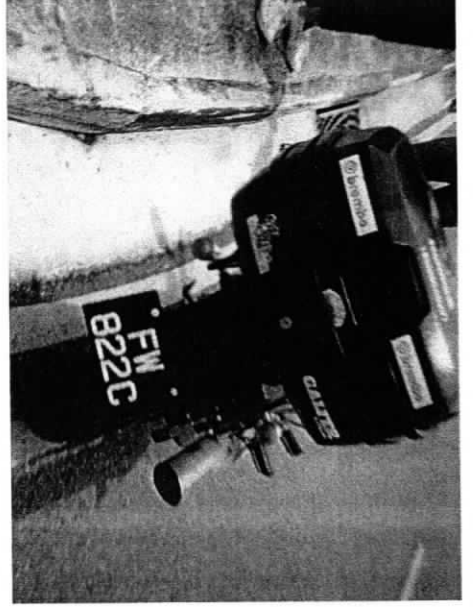
Qty	Description of Parts	Condition	Estimate By Workshop (\$)	Our Adjusted (\$)
REPLACEMENT OF PARTS				
1	FRONT BUMPER COVER	CRACKED	538.80	538.80
1	FRONT BUMPER BRACKET TOP (RH)	CRACKED	22.40	22.40
1	FRONT BUMPER PROTECTOR (RH)	SERVICEABLE	29.20	-
1	HEADLAMP (RH)	MISSING	797.90	797.90
1	FRONT FENDER (RH)	DENTED	593.00	593.00
1	FRONT FENDER SHIELD (RH)	CRACKED	86.00	86.00
1	FRONT FENDER RETAINER (RH)	SERVICEABLE	9.20	-
1	FRONT WHEEL HUB CAP (RH)	GRAZED	145.00	145.00
	LESS 20% DISCOUNT		-444.30	-436.62
			1,777.20	1,746.48
LABOUR				
	PANEL BEATING.		560.00	300.00
	SPRAY PAINTING CHARGE.		500.00	400.00
	WIRING CHARGE.		30.00	30.00
	TUFF KOTE.		50.00	30.00
	TOWING CHARGE.		60.00	-
	FRT WHEEL ALIGNMENT.	NOT NECESSARY	120.00	-
			1,320.00	760.00
GRAND TOTAL			3,097.20	2,506.48
RECOMMENDED COST OF LUMP SUM REPAIRS (TO ITS PRE-ACCIDENT CONDITION) (CONFIRMED)				2,000.00

1. The repair job shall bill to: **NTUC** --- **FW822C**
2. The finalized amount shall be:
 - (a) Spare Parts after List discount
 - (b) Labour Charges
 - Total for Part-By-Part Repair Cost**
 - (c) Lumpsum Repair (if applicable)
Total for Lumpsum repair cost after Less: 20% \$2,000.00
Final Lumpsum Repair cost **\$2,000.00**
