RE: Accident SH9323S at J96 on 20 Jul 2018 at 2330hr

# LKK Auto Consultants Pte Ltd

## 1. Policy Particulars :- THIRD PARTY CLAIM

**ADJUSTMENT ON REPAIR COST FOR VEHICLE NO. SH 9323S**

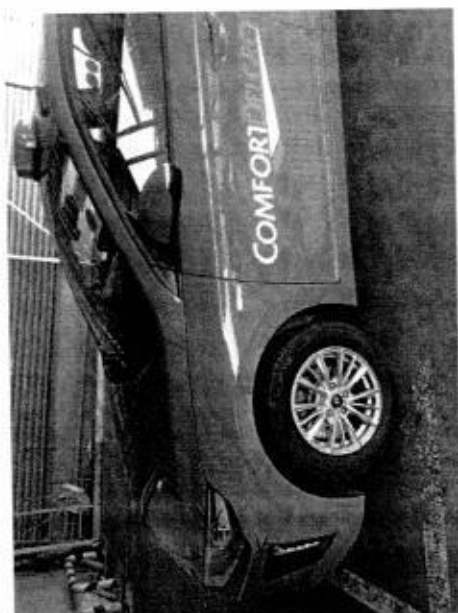
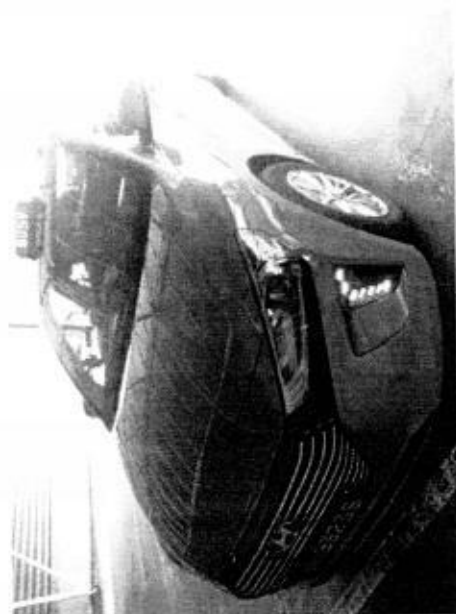
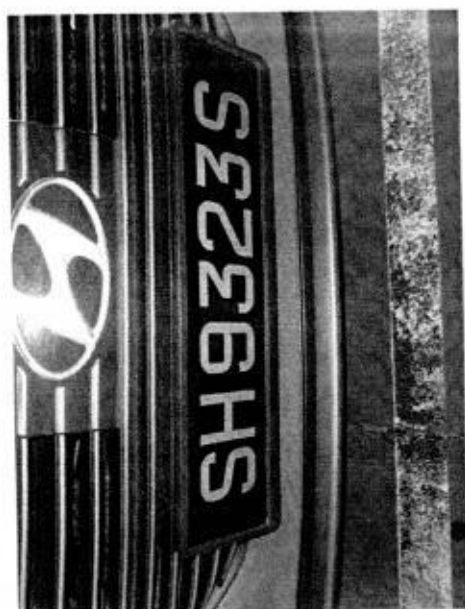
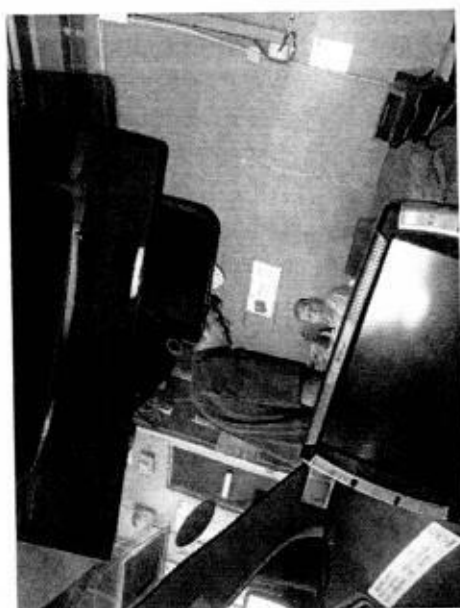
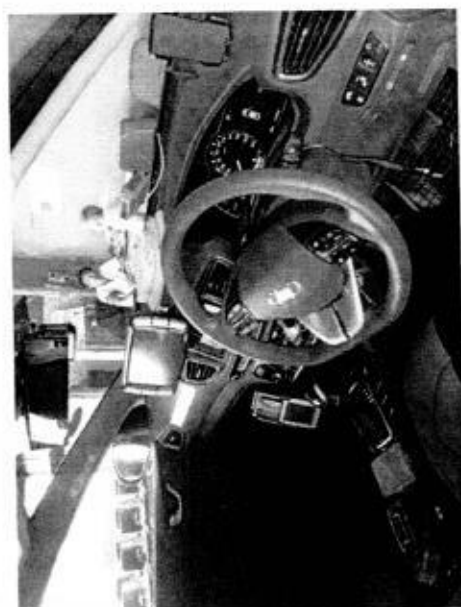
N/S Frnt.

THE VEHICLE SUSTAINED DAMAGES AT THE N/S FRONT PORTION. DAMAGES SEE DETAILS.
---

Qty	Description of Parts	Condition	Estimate By Workshop (\$)	Our Adjusted (\$)
	<b><u>REPLACEMENT OF PARTS</u></b>			
1	HEAD LAMP ASSY, LH	CRACKED TO REPAIR SEE LABOUR	1,198.80	1,198.80
1	FRONT BUMPER (NPA)		-	-
	LESS 20% DISCOUNT		-239.76	-239.76
			959.04	959.04
	<b><u>LABOUR</u></b>			
	PANEL BEATING, INCLUSIVE OF THE REPAIR OF FRONT BUMPER.		200.00	100.00
	SPRAY PAINTING CHARGE.		200.00	200.00
	WIRING CHARGE.		50.00	20.00
			450.00	320.00
	<b>GRAND TOTAL</b>		<b>1,409.04</b>	<b>1,279.04</b>
<b>RECOMMENDED COST OF REPAIRS</b>				<b>1,279.04</b>
