REF: NS/INC18014584/K1q3n2

1. Policy Particulars :- THIRD PARTY CLAIM

THE VEHICLE SUSTAINED DAMAGES AT THE O/S FRONT PORTION.
DAMAGES SEE DETAILS.

ADJUSTMENT ON REPAIR COST FOR VEHICLE NO. SHB 3552Z

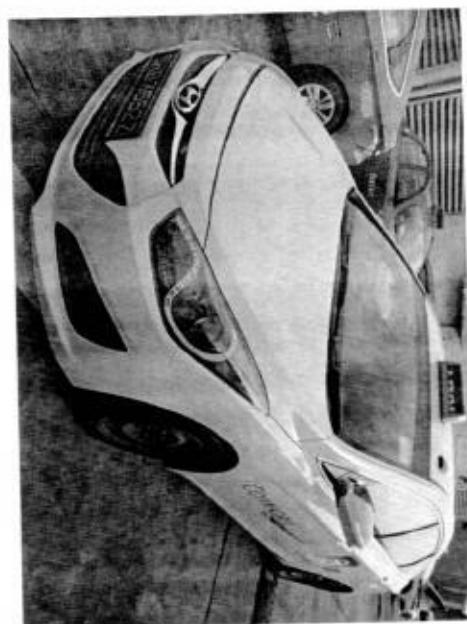
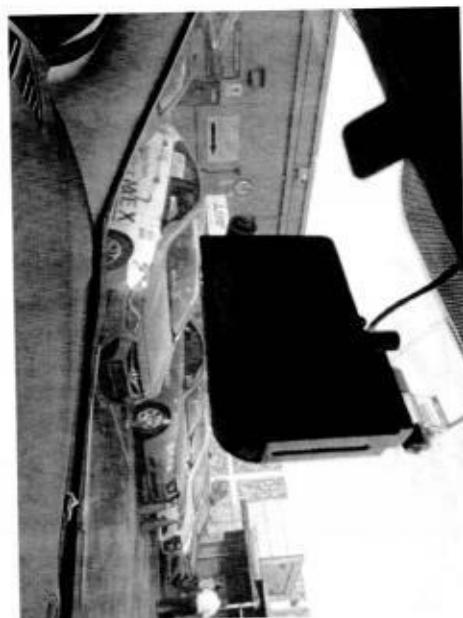
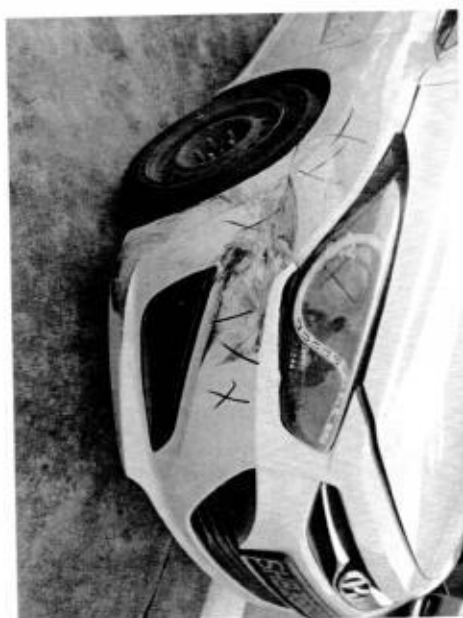
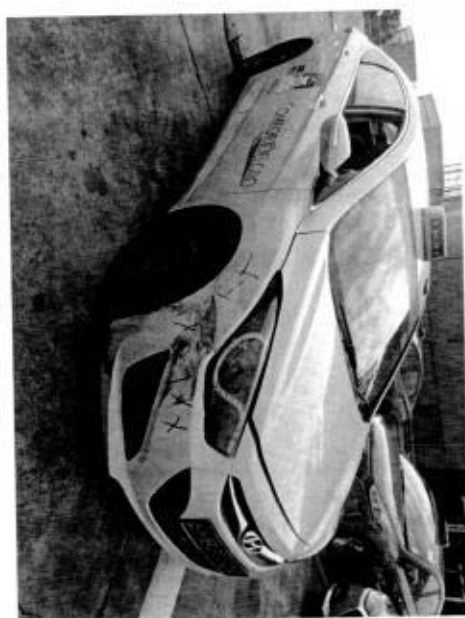
The U/C / Chassis frame / Body Structure affected due to collision.

Qty	Description of Parts	Condition	Estimate By Workshop (\$)	Our Adjusted (\$)
REPLACEMENT OF PARTS				
1	FRONT BUMPER COVER	DEFORMED	562.30	562.30
1	FRONT BUMPER GRILLE (RH)	CUT	40.30	40.30
1	FRONT BUMPER BRACKET TOP (RH)	SERVICEABLE	22.40	-
1	FRONT BUMPER RETAINER MOUNTING (RH)	SERVICEABLE	9.20	-
1	HEADLAMP (RH)	CRACKED	1,388.00	1,388.00
1	FRONT FENDER (RH)	DENTED	619.00	619.00
1	FRONT FENDER SHIELD (RH)	SERVICEABLE	86.00	-
1	FRONT FENDER RETAINER (RH)	SERVICEABLE	9.20	-
	LESS 20% DISCOUNT		-547.28	-521.92
			2,189.12	2,087.68
LABOUR				
	PANEL BEATING.		560.00	400.00
	SPRAY PAINTING CHARGE.		500.00	400.00
	WIRING CHARGE.		30.00	20.00
	TUFF KOTE.		50.00	20.00
			1,140.00	840.00
GRAND TOTAL			3,329.12	2,927.68
RECOMMENDED COST OF LUMP SUM REPAIRS (TO ITS PRE-ACCIDENT CONDITION) (CONFIRMED)				2,350.00
