### 1. Policy Particulars :- THIRD PARTY CLAIM

Make & Model	MERCEDES BENZ E220	c.c	2143
Engine No.	HIDDEN	Year of Reg.	2014
Chassis No.	WDD2120022A758673	Colour	WHITE
Odometer	545017	Steering	IN ORDER
Brakes	IN ORDER	Modification	STANDARD ALLOY RIM
General	FAIR

THE VEHICLE SUSTAINED DAMAGES AT THE REAR O/S PORTION. DAMAGES SEE DETAILS.
--

## ADJUSTMENT ON REPAIR COST FOR VEHICLE NO. SHB 6398H

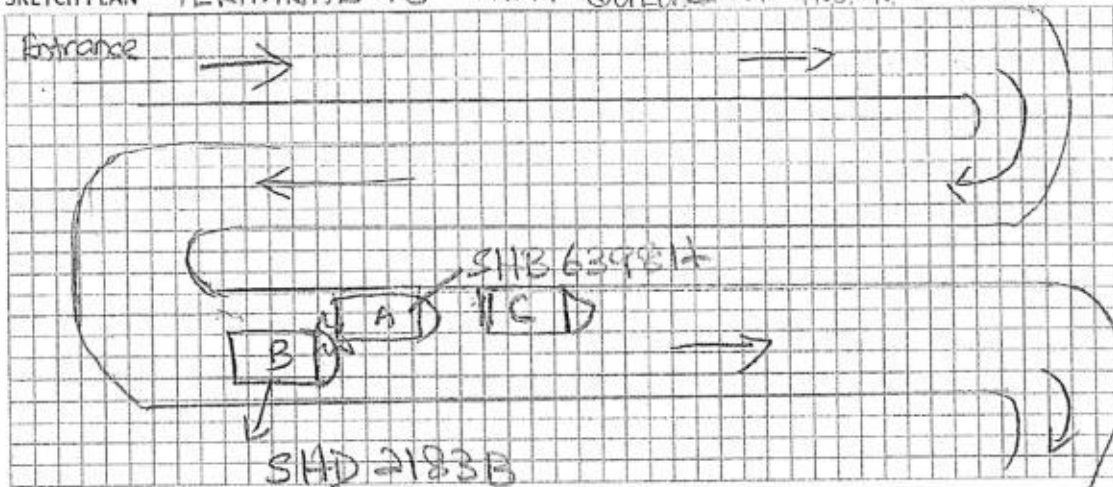
## SKETCH PLAN TERMINAL T3 TAXI QUEUE HOLDING AREA

On 10/08/2018 at about 13:40hrs, I was driving into Changi Airport Terminal 3 Taxi Queue Holding Area. As I navigate the second bend, a red Transcob SHB 7560Z (vehicle C) was stopped in front and I slowed down to check whether to overtake as the front (vehicle C) seems not moving.

Suddenly, I was jolted from my seat as another taxi SHD 2183B (vehicle B) hit my taxi SHB 6398H (vehicle A) from behind. He must be driving too fast and too close as traffic in the taxi holding area was clear.
