To: MSIG Insurance (Singapore) Pte. Ltd. 4 Shenton Way #21-01 SGX Centre 2 Singapore 068807	From: LKK Auto Consultants Pte Ltd 51 Ubi Ave 1 #01-25 Paya Ubi Industrial Park Singapore 408933
Attn: Irene Tan Gek Ing	Date: 03 Sep 2018
<b><u>Preliminary Advice</u></b>

Insured Vehicle No	: SKN7862D	Accident Date	: 12/08/2018
TP Vehicle No	: SHC1015R	Assignment Date	: 14/08/2018
Make	: TOYOTA PRIUS HYBRID	Est. Duration of Repair	: 13.00
Date of Inspection	: 15/08/2018		
Inspection At	: CHUNNI MOTOR WORK PTE LTD (HQ) BLK 10 ANG MO KIO INDUSTRIAL PARK 2A, #03-19 AMK AUTOPOINT SINGAPORE 568047

## VEHICLE DAMAGE INSPECTION REPORT

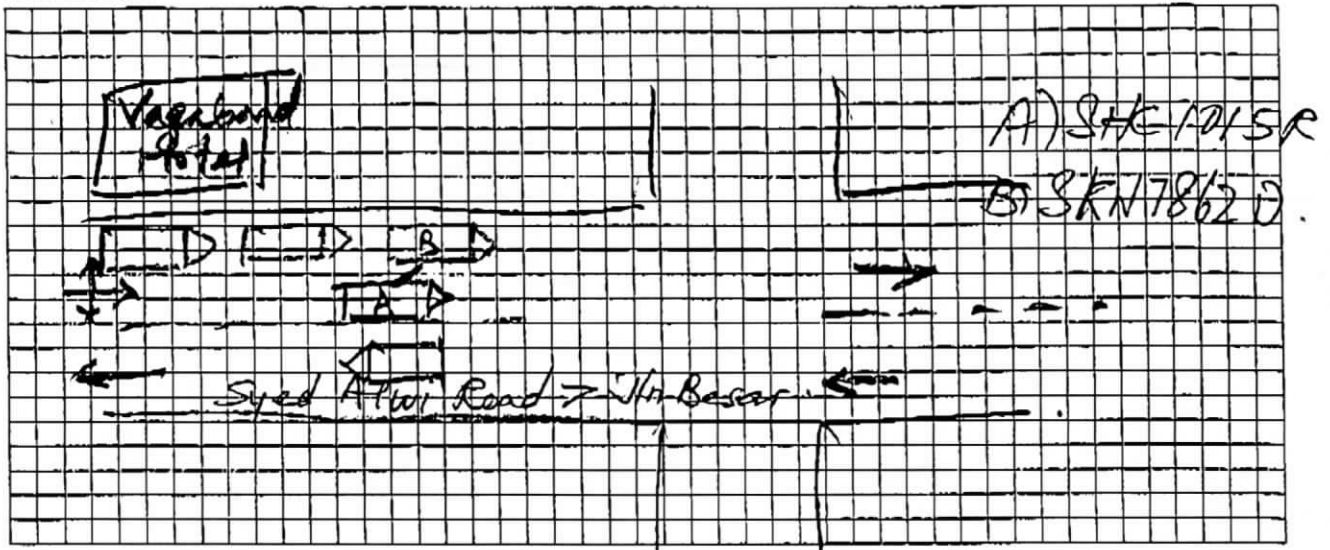
## SKETCH PLAN

On 12/8/18 at about 100thm while I Veh A was driving along the left lane, Veh B opened the Right Rear door and collided on the left portion of my moving vehicle.
