To inspect Vehicle No: SEA 4493X Insured: SKP 62976

**ACCIDENT INVOLVING SGA 4493 X & SKP 6297 G ON 01-APR-2018 AT JOHOR BAHRU CUSTOM AT ABOUT 15:45 HRS**

<b>4. Description of Damages</b>				
THE VEHICLE HAD COMPLETED ITS REPAIR WORKS.				
REPAIR CONDITION SEE DETAILS.				
<b>5. General Information</b>				
Accident Date	01/04/2018	Inspection Date	27/08/2018	
Survey held at	EM SOLUTION PTE LTD 160 SIN MING DRIVE #03-18/19 SIN MING AUTOCITY SINGAPORE 575722			
<b>5a. Remarks</b>				
A)THE INSPECTION WAS CONDUCTED ON A"WITHOUT PREJUDICE" BASIS. B)IN ACCORDANCE TO YOUR INSTRUCTIONS, WE HAVE NOT AUTHORISED REPAIRS.				
<b>5b. Estimate Days of Repair</b>				
ESTIMATED NORMAL PERIOD FOR REPAIR:		<b>5 Working Days</b>

## ADJUSTMENT ON REPAIR COST FOR VEHICLE NO. SGA 4493X

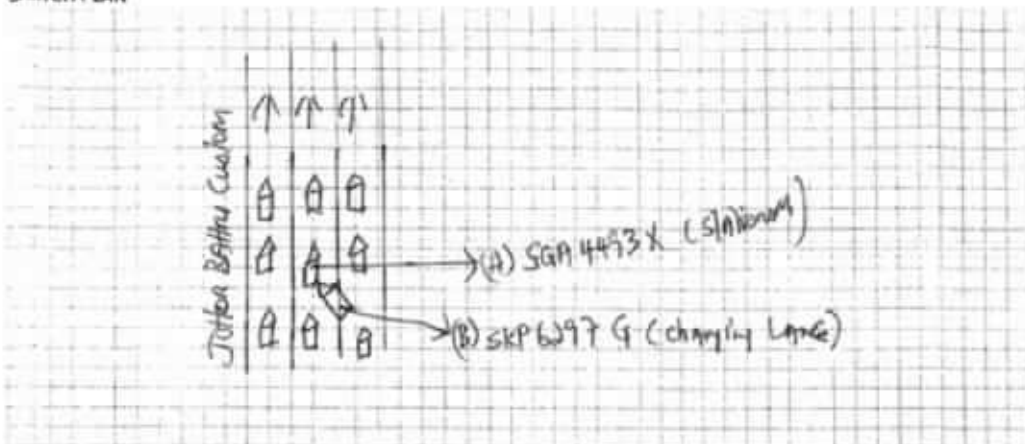
# SKETCH PLAN

I arrived at about 12:45pm I was about my vehicle  
 SGA 4493 X not under battery custom. As I was about  
 12:45 I noticed traffic lane in front there was a vehicle which  
 stopped it was stopped my vehicle while waiting for my turn  
 to move off. But it is a sudden a vehicle - not both of  
 them behind along with my vehicle some portion taking my  
 vehicle into the lane. At accident, my vehicle was stationary.

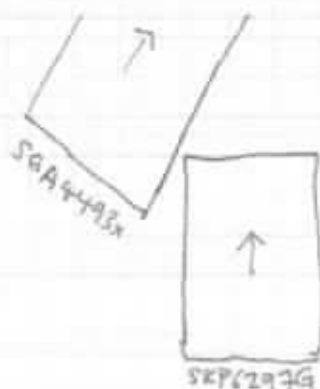
# SKETCH PLAN

LICENSE PLATE: SKP6297G	ACCIDENT DATE & TIME: 1 APRIL 2018 3:35AM
CONTACT NUMBER: 98563829	E-MAIL ADDRESS: CHIDIA.MD@gsa.i.com
LOCATION: SULTAN ISKANDAR CHECKPOINT	
<p>While queuing to get into Sultan Iskandar Checkpoint to return back to Singapore, 6 lanes were merging into 2 lanes and subsequently 1 lane. There are no clear markings on the road to separate the lanes.</p>	
<p>While merging into my direction, the back right fender of vehicle SGA4493X had grazed my front left bumper and subsequently moved forward until I moved to my right creating a gap between us to avoid further damage.</p>	
<p>Direction of the scratches will confirm this and the photos provided shows the gap between the 2 vehicles as mentioned.</p>	
<p>NOTE: PLEASE NOTE THAT YOUR INSURER MAY HAVE 14 DAYS TIME FRAME FOR YOU TO SUBMIT AN OWN DAMAGE CLAIM UNDER YOUR OWN POLICY. PLEASE CHECK YOUR POLICY FOR MORE INFORMATION</p>	
Please state:
